**SLOPE STABILITY REVIEW
DRAKE DEVONSHIRE HOTEL ADDITION**

June 10, 2021

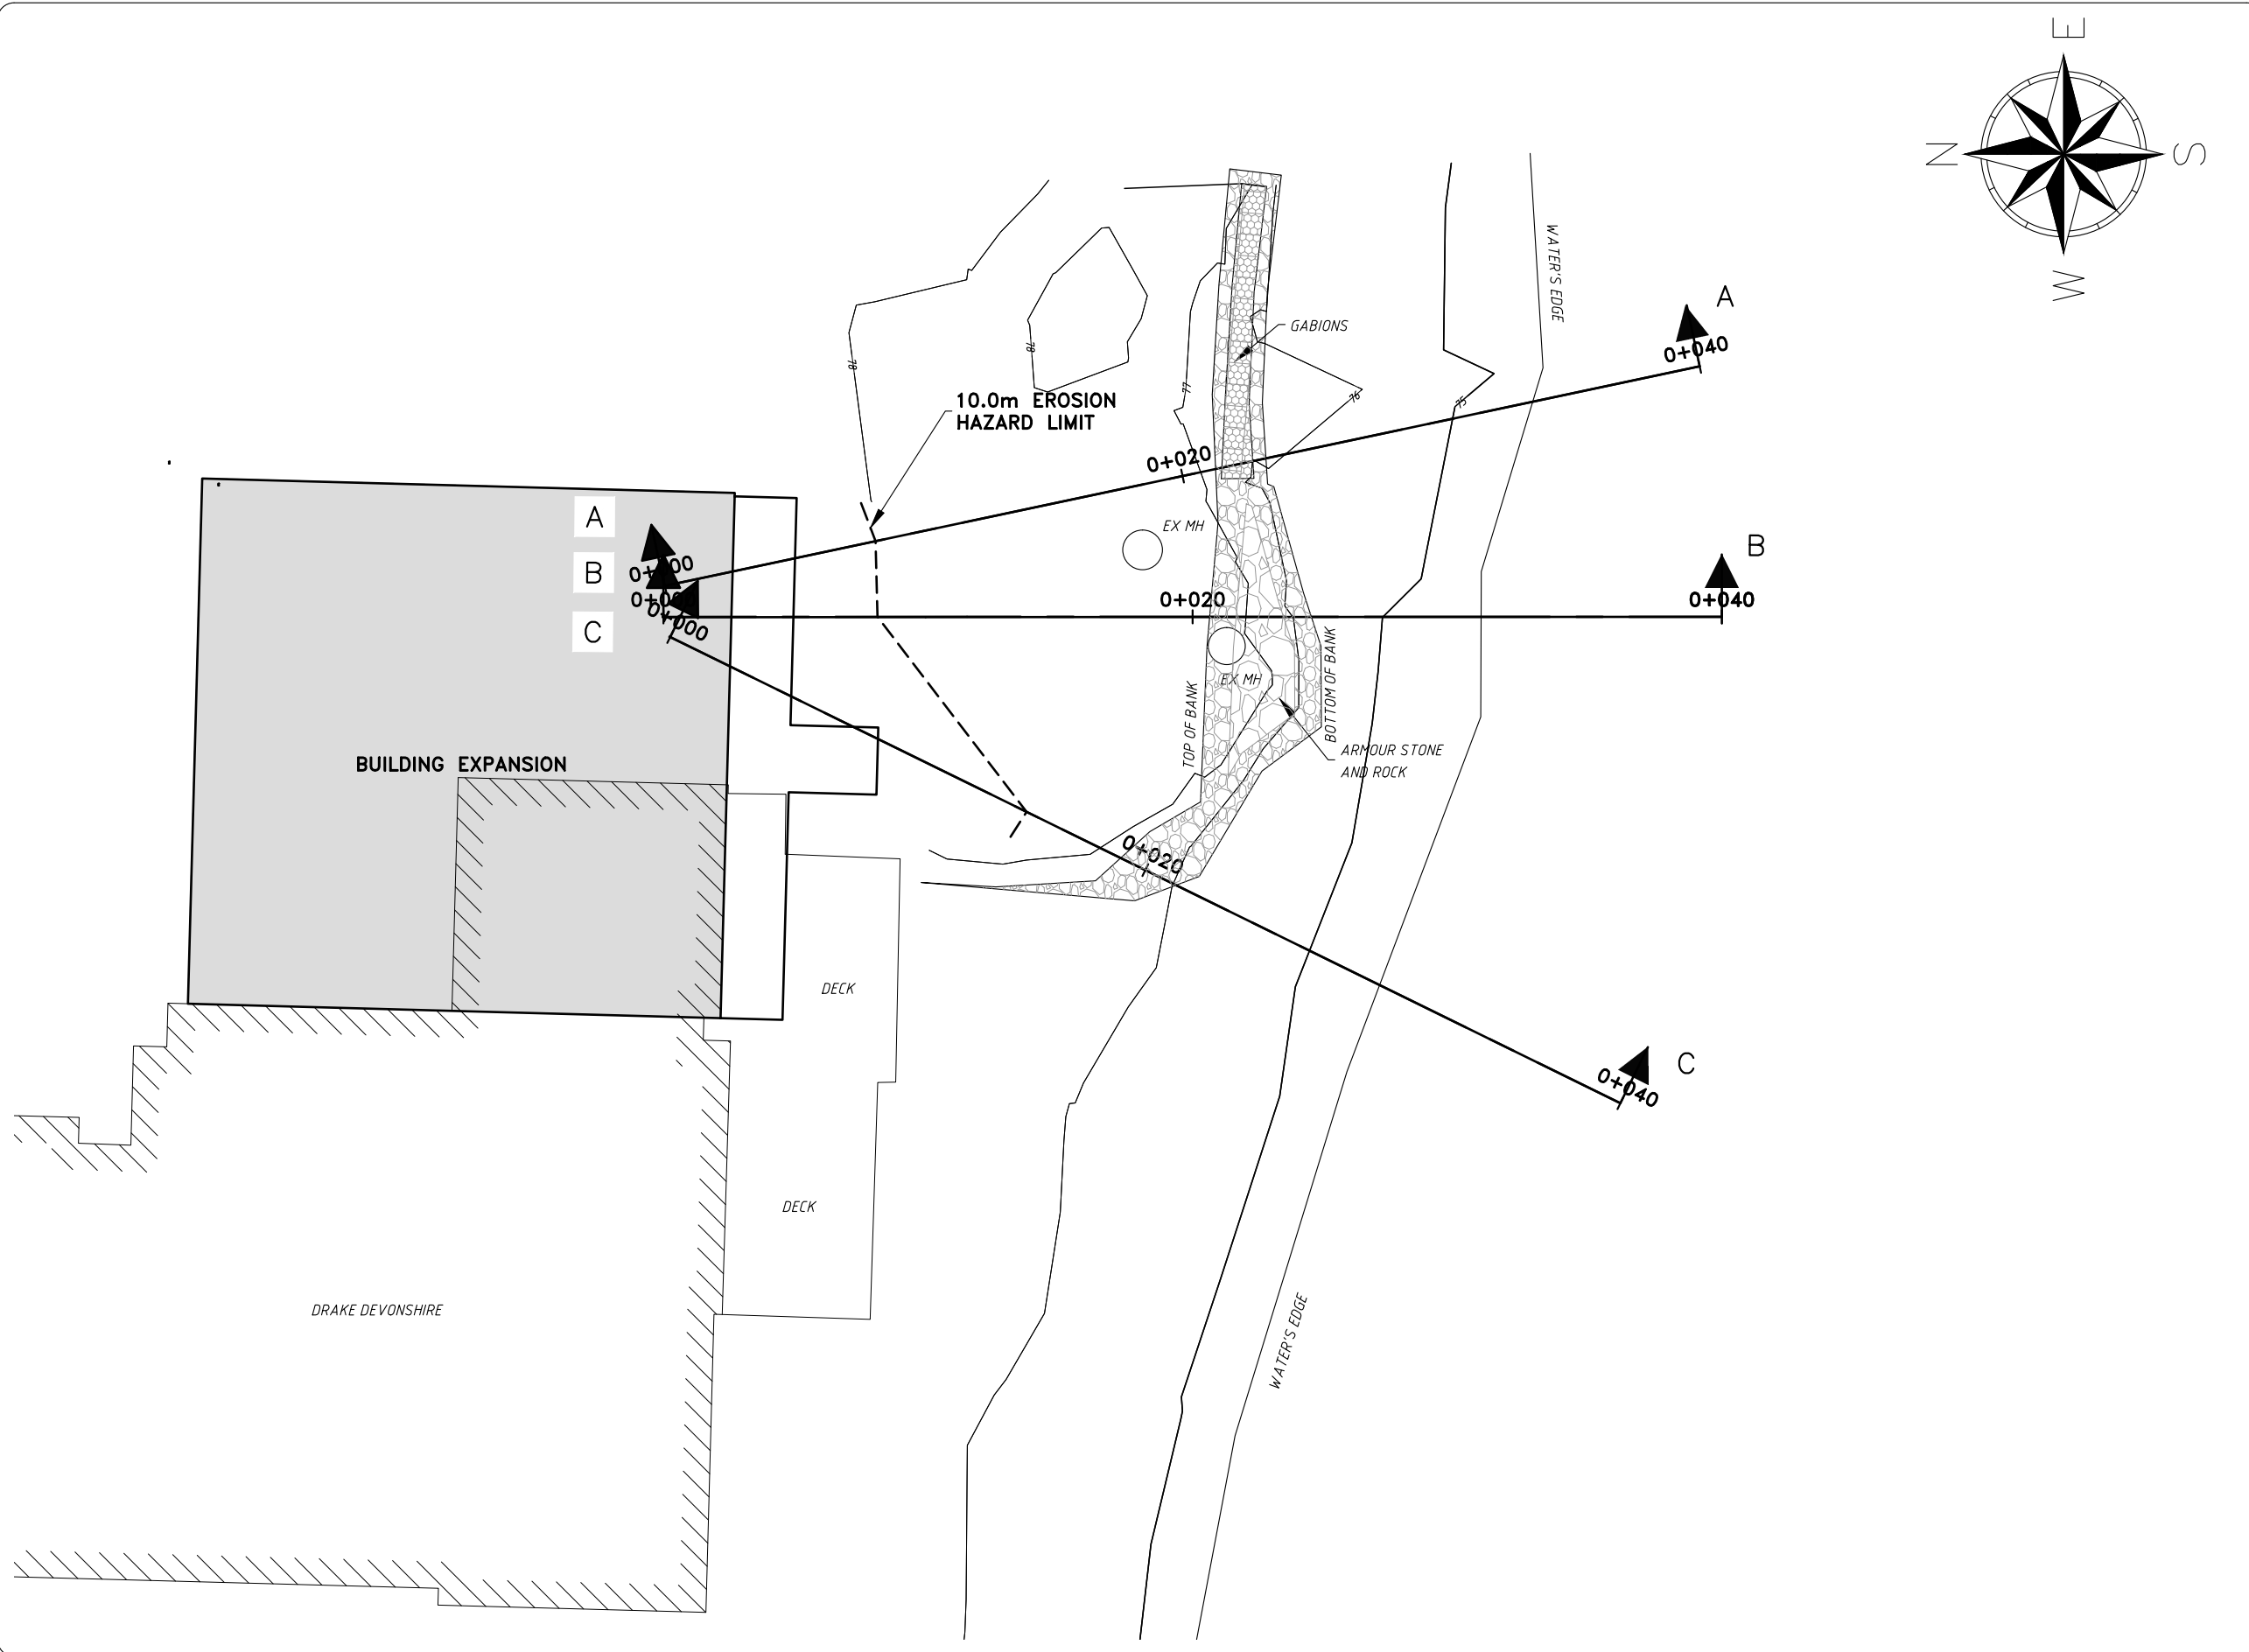
EROSION HAZARD LIMIT

The position of the erosion hazard limit was established for each of the three profiles as a sum of the stable slope allowance and the erosion allowance. The erosion hazard limit has been depicted on the drawing in Appendix B. Sections 2.1 and 2.2 describe how the erosion hazard limit was estimated.

For each of the three profiles studied by Jewell, the erosion hazard is illustrated in Appendix B and the proposed building will be outside of the erosion hazard limit. Thus, the development is consistent with the policy direction given for Natural Hazards (Erosion Hazard) by the Provincial Policy Statement.

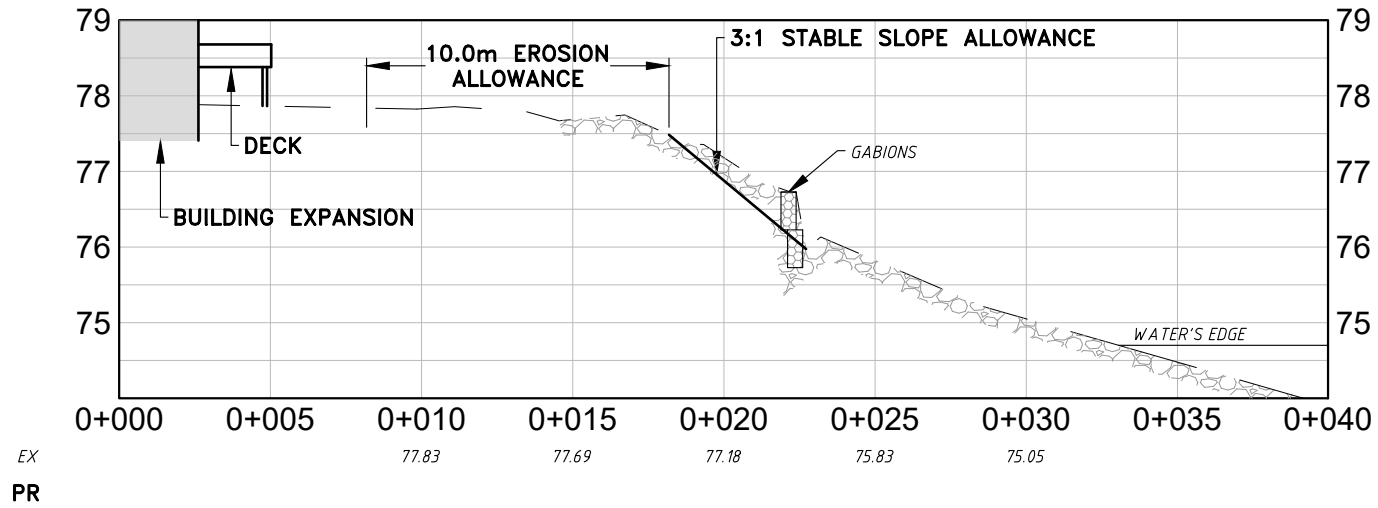
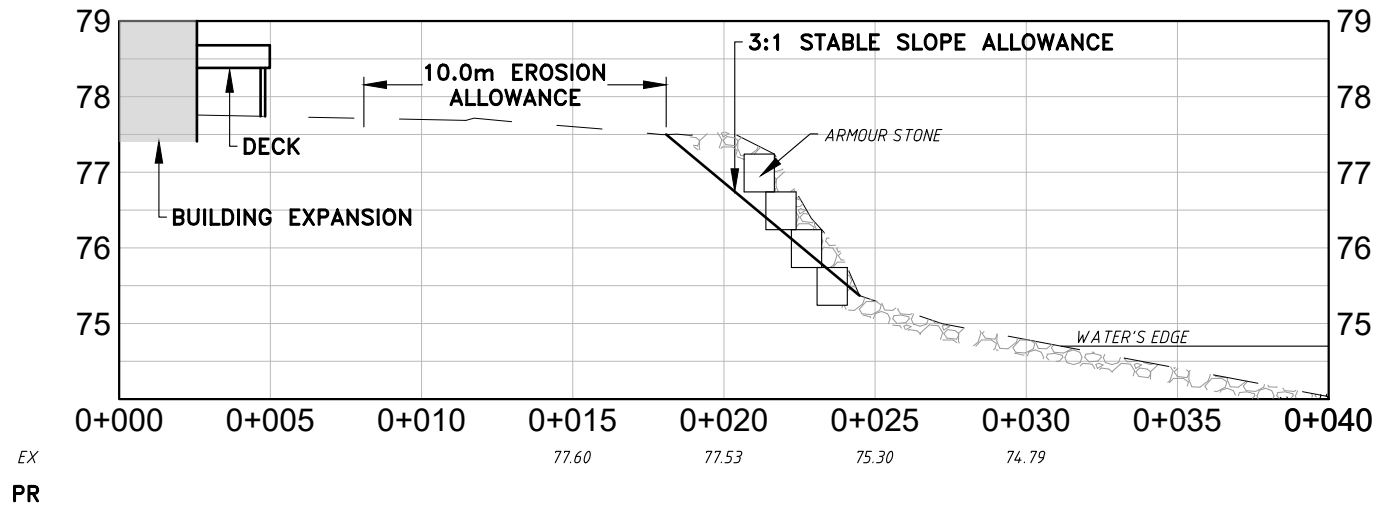
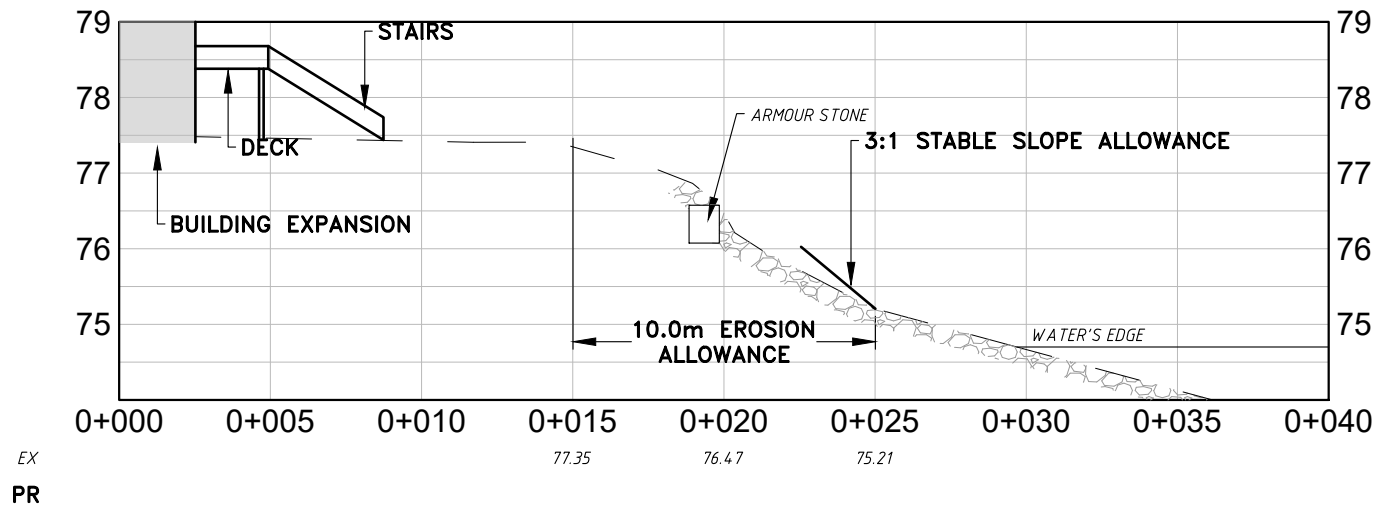
PROFILES

Jewell reviewed the slope at three discrete cross sections shown in Appendix B using MNR's Slope Stability Rating System (2002). The rating system scores different characteristics of the slope and determines its level of stability. A completed field inspection form is included within Appendix A. A total score of 17 was assigned as per the detailed discussion below.

A maximum slope inclination of 15% was recorded in the middle cross section with a height of 3.00 m. A score of 0 was assigned for the slope inclination and a score of 2 was assigned for the slope height.

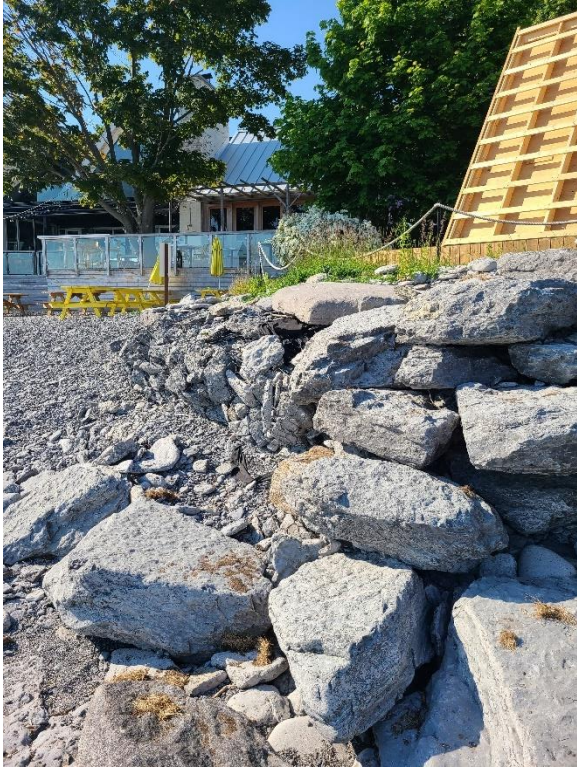
Figure C1 – West end of gabion wall facing Drake Devonshire rear beach.

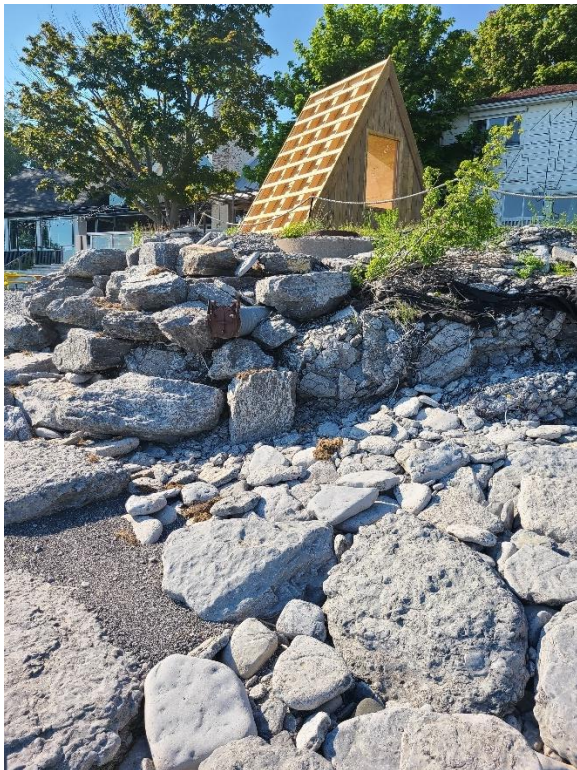
Figure C2 – West end of gabion wall facing northwest, with manhole and culvert.

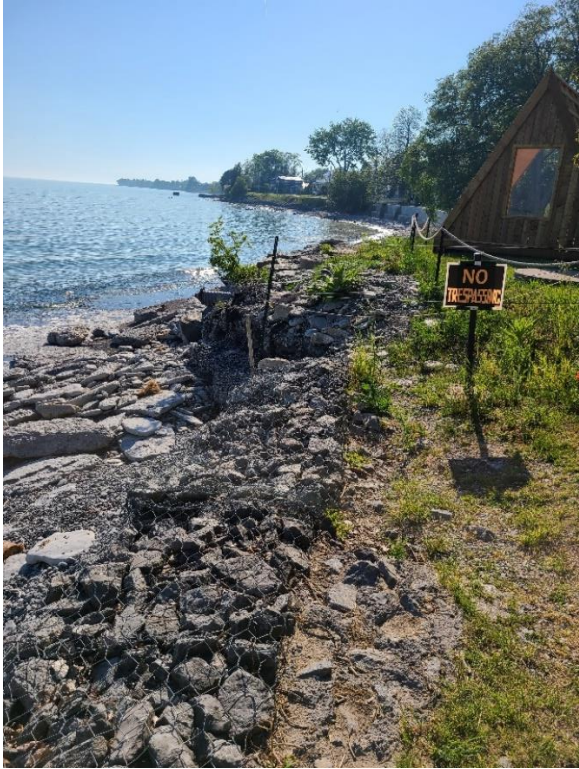
Figure C3 – Centre of gabion wall facing west.
