August 20, 2018

AG File No. 17546-1

**Ref: FINAL Slope Stability Investigation Report
The Reach Resort – 1315, 1329 and 1357 County Road 7
Prince Edward County**

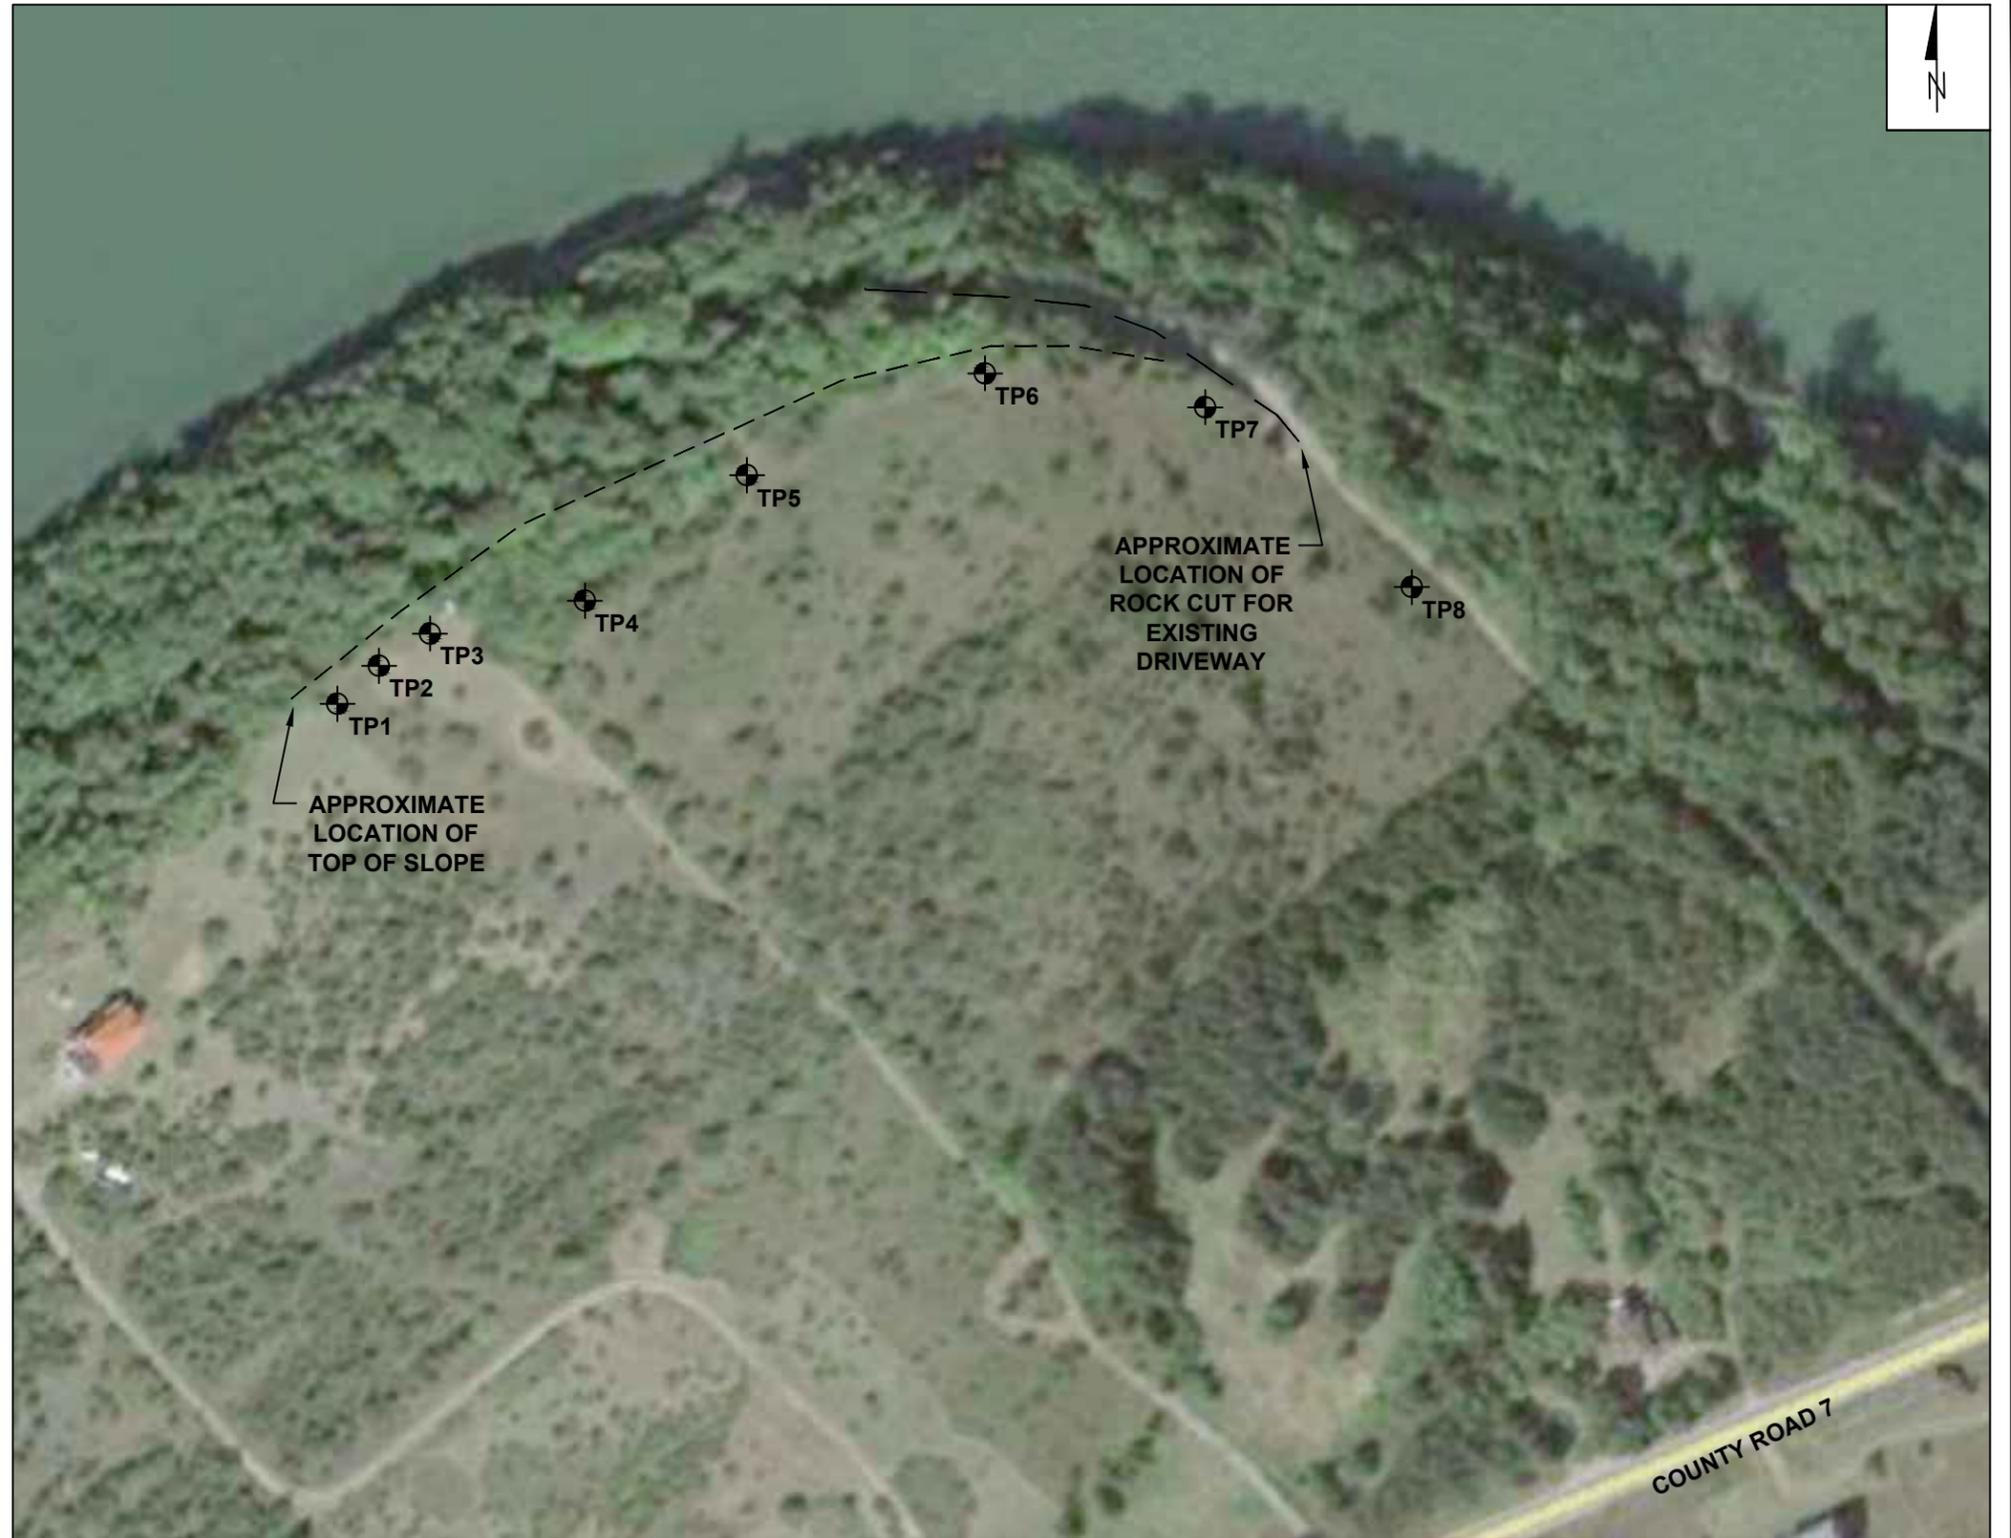
FIGURE NO. 1
SITE AND TEST PIT LOCATION PLAN

In general, the typical subsoil encountered in the test pit locations consisted of a surficial layer of topsoil overlying compact silty sand with gravel and cobbles (range 0.18 m to 0.4 m thickness) overlying limestone bedrock. The limestone bedrock was encountered at depths ranging between 0.25 m and 0.5 m below existing grade. The limestone bedrock was weathered (and excavated with the backhoe) for an average depth of 0.25 m.

Groundwater infiltration was not observed during the test pit investigation.

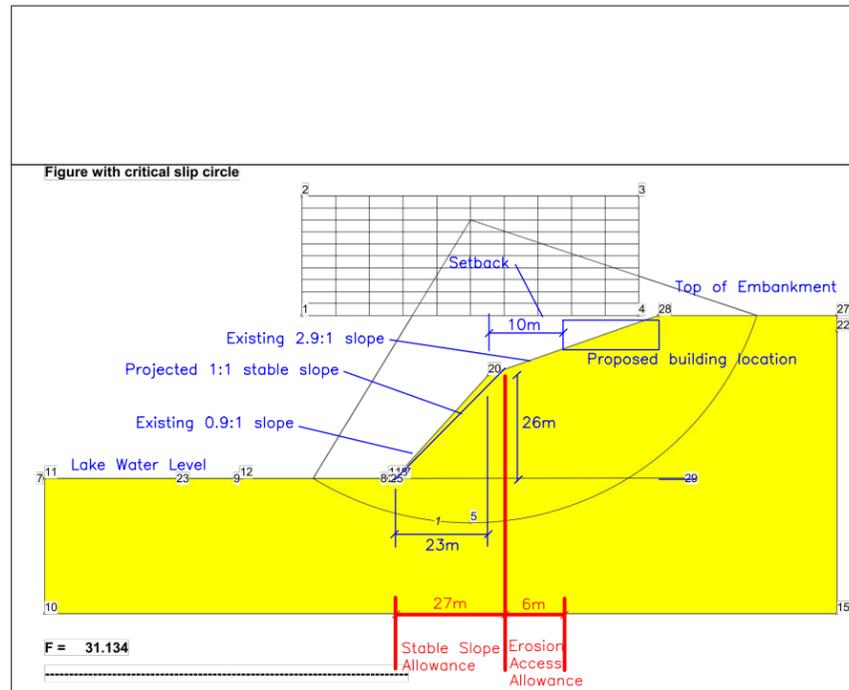
Section A-A
NTS

This section represents an area where buildings will be constructed on the embankment slope immediately beneath the top of the embankment. Entrance to the cabins will be from the upper level of the embankment and the structures will be founded on piles advanced into the bedrock slope.

The lowest Factor of Safety for this section was determined to be 31.3. For the purposes of this study, a Factor of Safety over 1.5 is considered to represent a slope with acceptable, long term stability.

Based on a projected 1H:1V stable slope (applicable for bedrock embankment) from the toe of slope at the water level to the first landward break of the embankment where the proposed structure is located, the stable slope allowance is determined as 27 m measured from the toe of slope at the lake level (or 4 m from the first landward break).

Based on a bedrock embankment, a minimum erosion allowance setback of 0 m is considered suitable. However, an erosion access allowance of 6 m is recommended measured from the edge of the stable slope allowance location (27 m from the toe of slope at the lake level) to the face of any structure (buildings). This setback will allow equipment access should any remedial repairs to the slope be necessary.

The recommended setback distance is determined to be 33 m measured from the toe of slope at the lake level (or 10 m from the edge of the first landward break) as depicted on **Figure No. 2**.

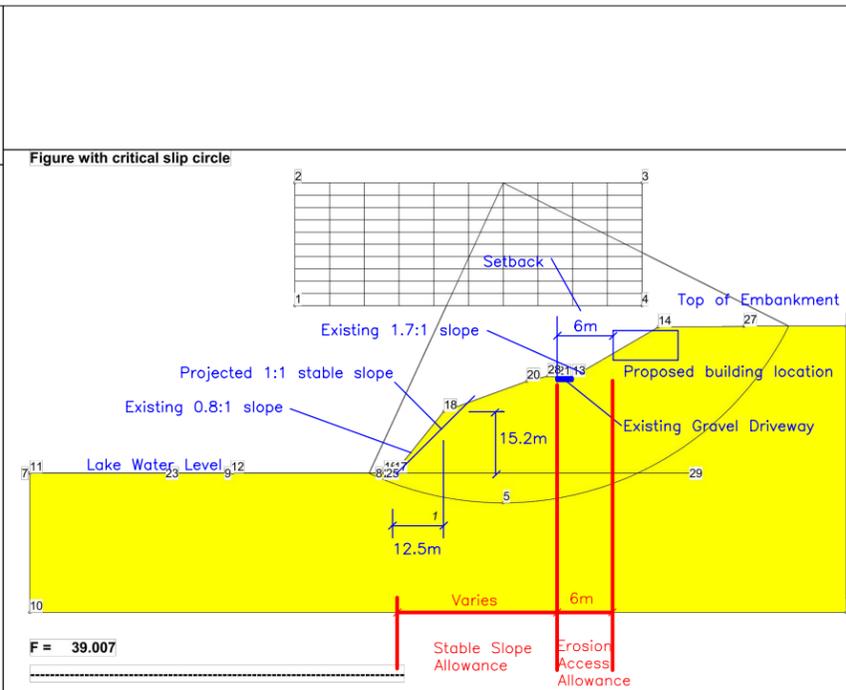
Section B-B
NTS

This section represents an area where buildings will be constructed on the embankment slope above and south of the existing gravel driveway. Entrance to the cabins will be from the most upper level of the embankment and the structures will be founded on piles advanced into the bedrock slope.

The lowest Factor of Safety for this section was determined to be 39.0. For the purposes of this study, a Factor of Safety over 1.5 is considered to represent a slope with acceptable, long term stability.

Based on a projected 1H:1V stable slope (applicable for bedrock embankment) from the toe of slope at the water level to the first landward break, the stable slope allowance is determined to be equal to the horizontal distance from the water level to a location within the first landward break of the embankment. Throughout this location, the distance varies due to the nature of the shoreline at the lake level. For ease of measurement, the north edge of the existing gravel driveway should be taken as the stable slope allowance distance from the toe of slope at the lake level.

Based on a bedrock embankment, a minimum erosion allowance setback of 0 m is considered suitable. However, an erosion access allowance of 6 m is recommended measured from the north edge of the existing gravel driveway to the face of any structure (buildings). This setback will allow equipment access should any remedial repairs to the slope be necessary.

The recommended setback distance is determined to be 6.0 m measured from the north edge of the existing driveway as depicted on **Figure No. 2**.

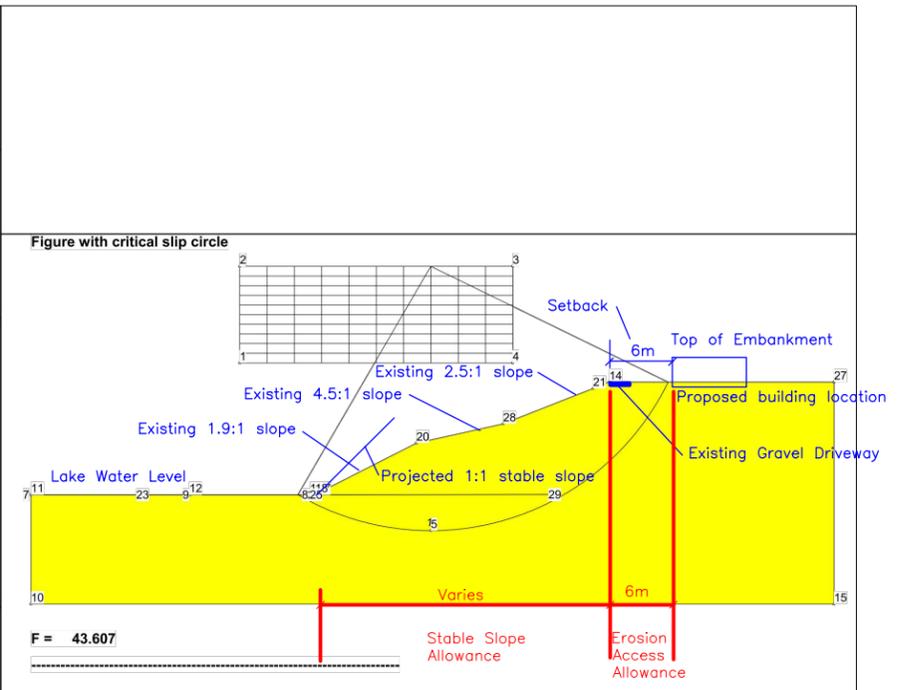
Section C-C
NTS

This section represents an area where buildings will be constructed along the west side of the existing gravel driveway on top of the existing embankment.

The lowest Factor of Safety for this section was determined to be 43.6. For the purposes of this study, a Factor of Safety over 1.5 is considered to represent a slope with acceptable, long term stability.

Based on a projected 1H:1V stable slope (applicable for bedrock embankment) from the toe of slope at the water level to the first landward break, the stable slope allowance is determined to be equal to the horizontal distance from the water level to a location within the first landward break of the embankment. Throughout this location, the distance varies due to the nature of the shoreline at the lake level. For ease of measurement, the east edge of the existing gravel driveway should be taken as the stable slope allowance distance from the toe of slope at the lake level.

Based on a bedrock embankment, a minimum erosion allowance setback of 0 m is considered suitable. However, an erosion access allowance of 6 m is recommended measured from the edge of the existing embankment to the face of any structure (buildings). This setback will allow equipment access should any remedial repairs to the slope be necessary.

The recommended setback distance is determined to be 6.0 m measured from the east edge of the existing driveway as depicted on **Figure No. 2**.
