## **Building Structural Assessments – Base 31 Properties, Prince Edward County – August 2023**

James Horne, P.Eng of James Horne Engineering was engaged to review and provide structural assessments on the buildings currently located on the former military base known variously as Picton Heights, Picton Airbase, Loch Sloy, or Base 31. The properties are located on the bluff overlooking the town of Picton in Prince Edward County, Ontario.

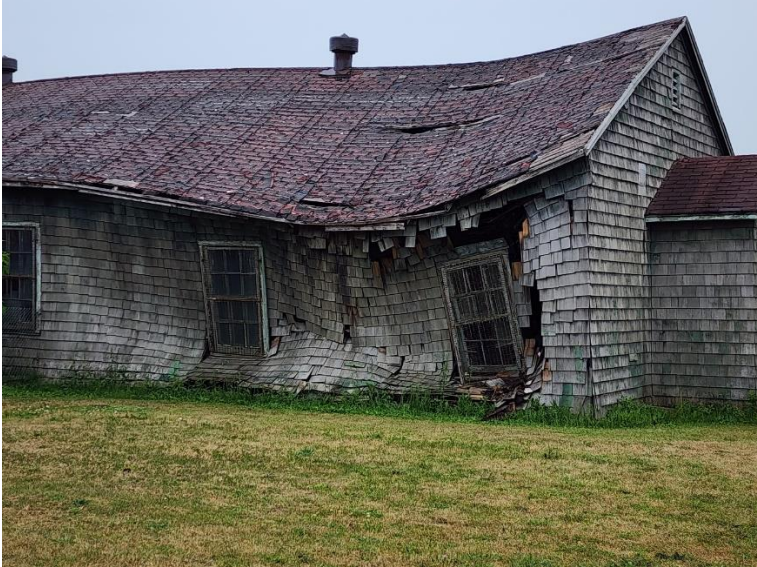
### **Building 13**

There has been significant loss of underlying support due to rot of the joists and rimboards of the whole structure. This has caused partial collapse of most of the main structure leading to more water ingress and accelerated decomposition of the structure. As of August 2023 the section shown below has collapsed.

At this point the whole building is unsafe and should be demolished.

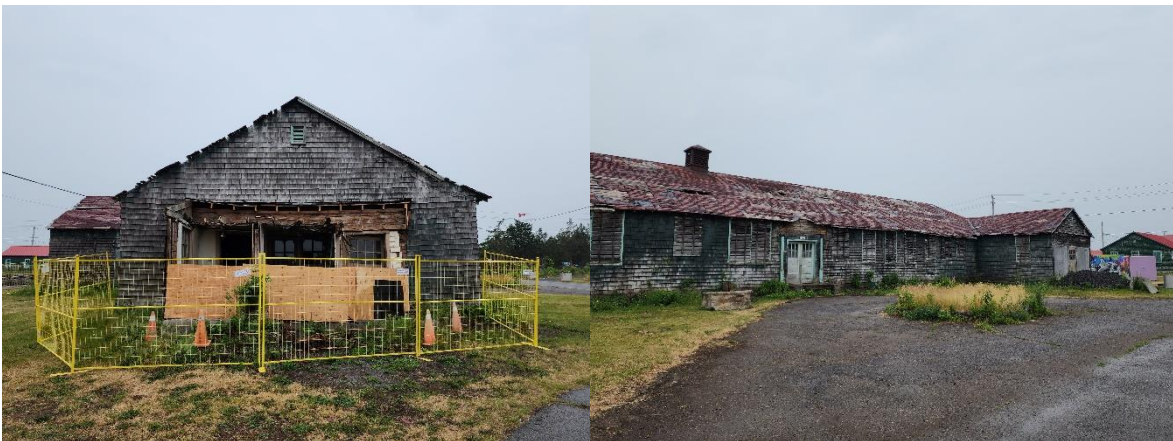
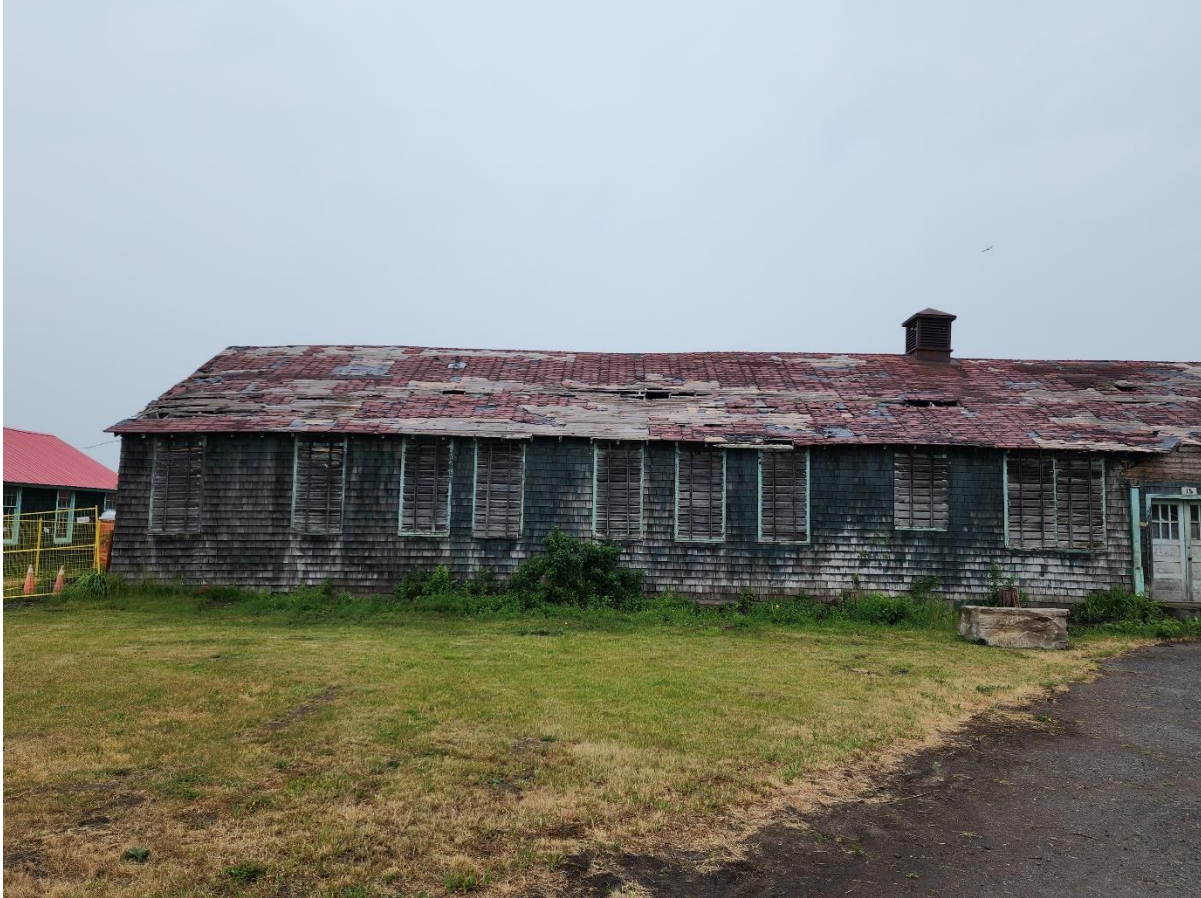
### **Building 15**

Building 15 is in very poor condition. Floors are largely rotted, but walls still sound, roof is in poor repair but doesn't yet show signs of significant rot of trusses. However there is a lot of internal damage as well as near total loss of roof making safe repair problematic. There is risk the building will hinge sideways as the roof is so compromised and the floors mainly gone. Should be demolished in the interest of safety.

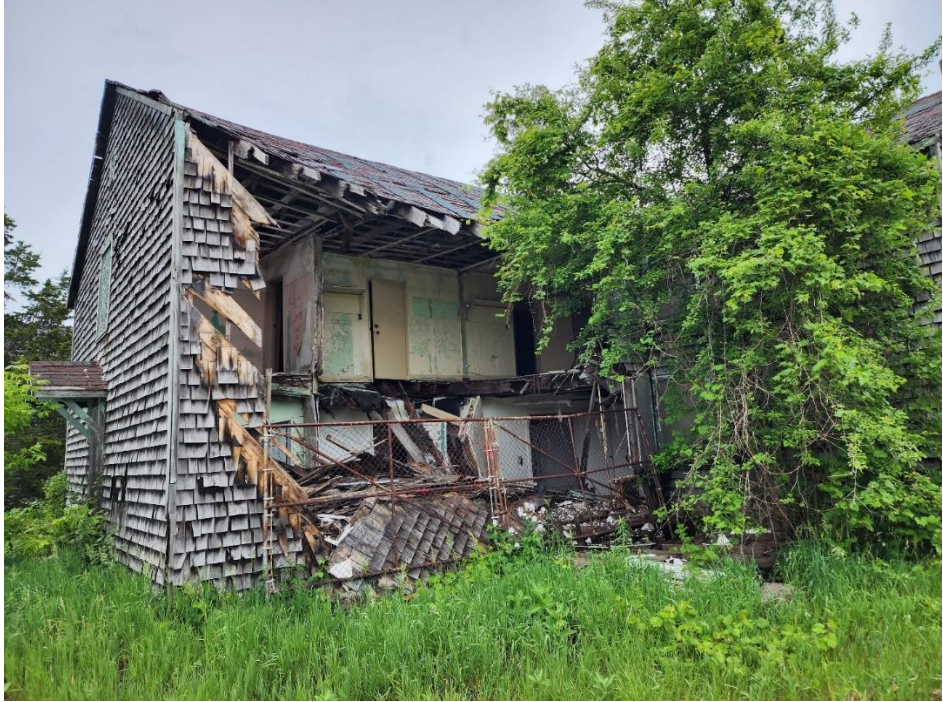
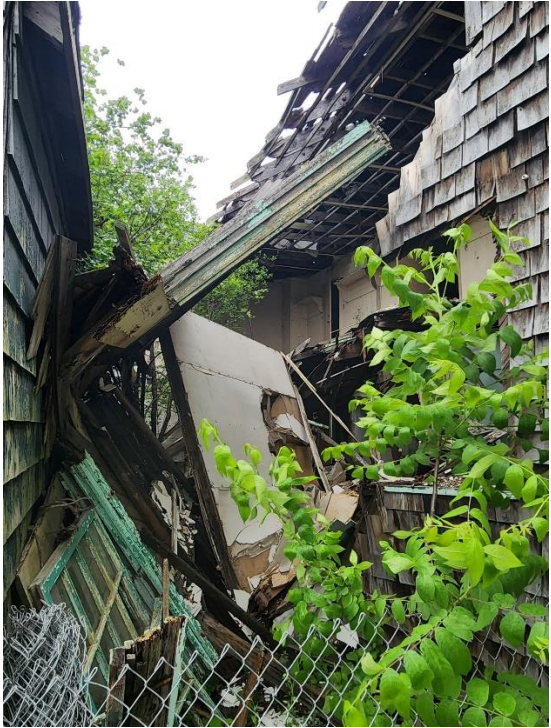
### **Building 49**

Hospital, south side walls have collapsed due to water ingress from roof and ensuing rot as a result of roof loss of shingles on south side. Significant deterioration in the last year. Lost south walls over the winter/spring. Building is unstable at this point, and should be demolished

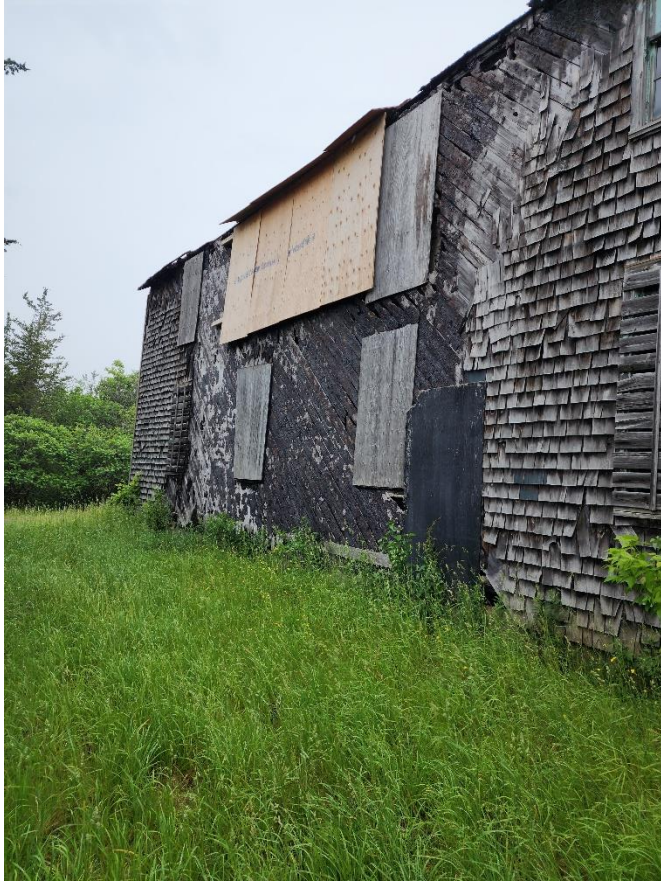
## **Building 50**

Hospital Wards in good condition with some damage due to fire, the fire damage has been closed up temporarily. Will need some work with repair due to areas of water damage from fire area and roof leakage. Building envelope maintenance will be needed to keep elements out.

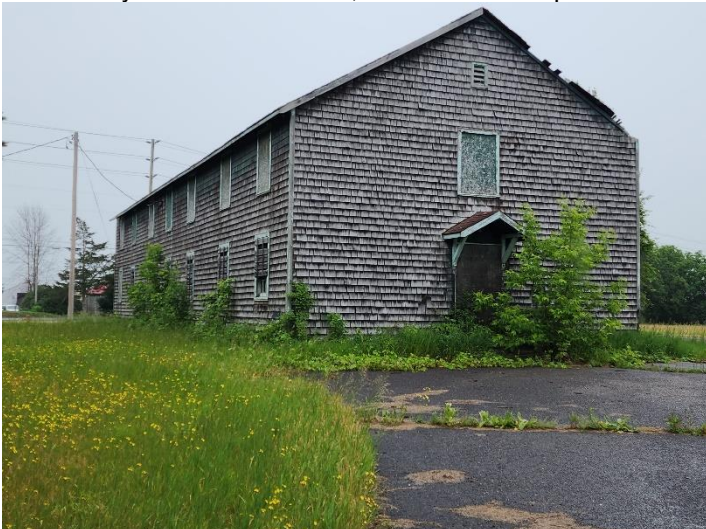
Structurally sound at this time, will need roof repair to maintain current condition.
