TREE PRESERVATION, PLANTING and MANAGEMENT REPORT

Address of Subject Property: South Big Island Road, Severed Lot 1 (Lot 22 & 23)
Prince Edward County

Report By: Gina Brouwer, ISA Certified Arborist ON-0937A,
Tree Risk Assessment Qualification, Butternut Health Assessor - BHA # 659

Date of Inventory: June 12, 2021 Report Date: June 18, 2021

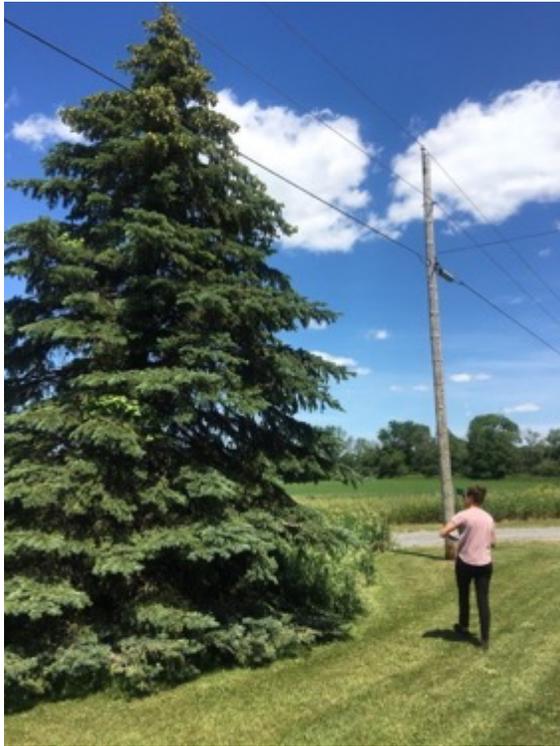
Tree No. 1

TREE NO.	SPECIES	SIZE	CONDITION	COMMENTS
House/ Lawn Area				
1	Colorado spruce (<i>Picea pungens</i>)	~25cm DBH	Good	Adjacent driveway and overhead wires, inner branch dieback
2	Colorado spruce (<i>Picea pungens</i>)	~35cm DBH	Fair	Adjacent overhead wires, top 30% dieback
3	Norway maple (<i>Acer platanoides</i>)	73cm DBH	Fair	Front yard, exposed buttress roots with mechanical damage, canker with decay to north at 1.5m ht, vertical seam and included bark, small dead branches with decay, 10% dieback
4	Colorado spruce (<i>Picea pungens</i>)	~45cm DBH	Fair	Yard, branches to ground, 20% dead branches towards north
5	white pine (<i>Pinus strobus</i>)	29cm DBH	Good	Yard
6	Poplar (<i>Populus spp.</i>)	~80cm DBH	Dead	Yard, dead
7	paper birch (<i>Betula papyrifera</i>)	23/27cm DBH	Good	Yard, 2 stems included from base, slight lean, 10% dieback
8	hybrid butternut (<i>Juglans spp.</i>)	49cm DBH	Good	Yard, cankers on trunk, data sheet for field identification of butternut hybrids completed (value = 6)

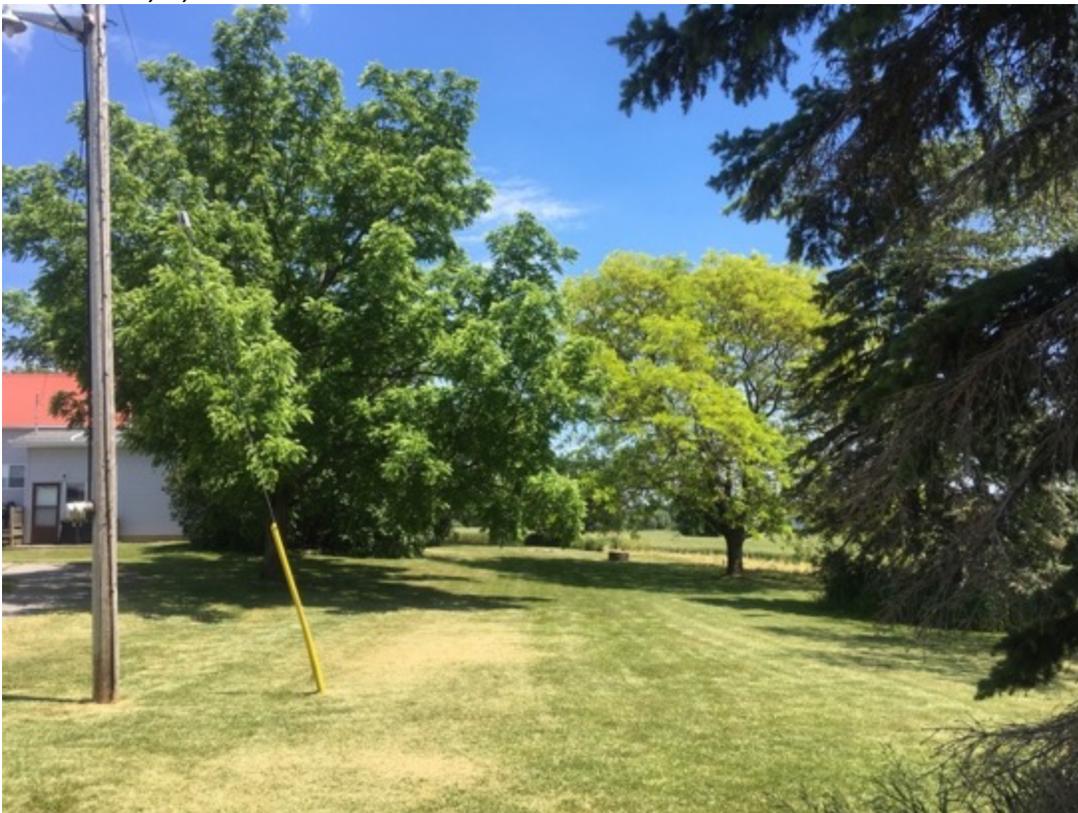
Trees No. 9, 10

9	Colorado spruce (<i>Picea pungens</i>)	50cm DBH	Good	Yard, 10% low branch dieback
10	honeylocust (<i>Gleditsia triacanthos</i>)	64cm DBH	Good	Yard, dead inner branches

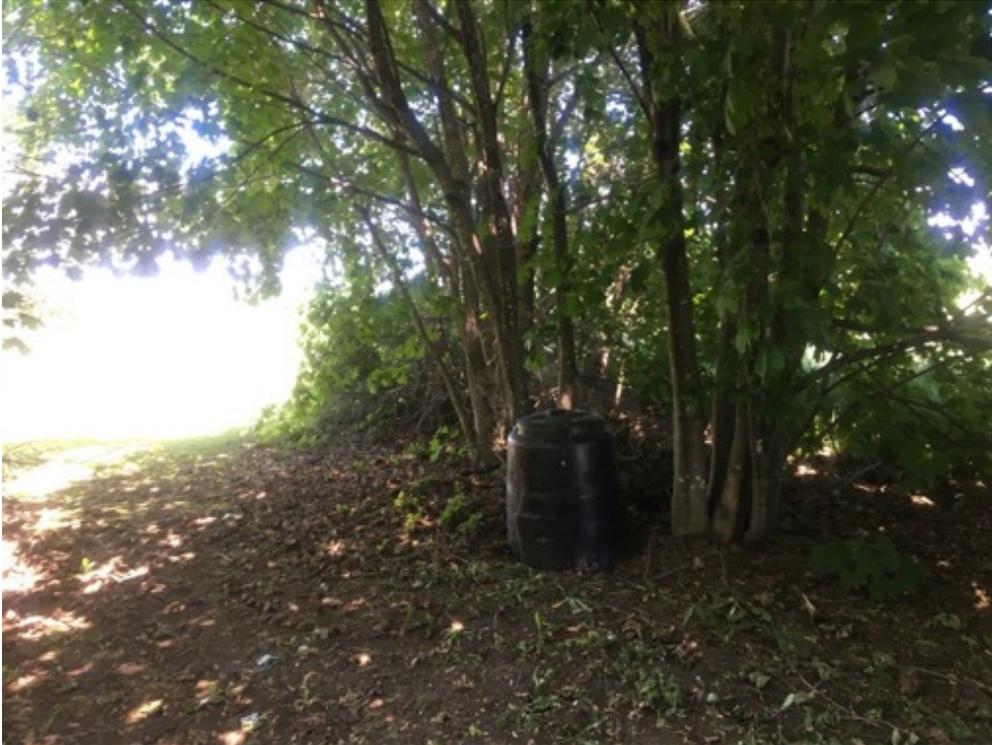
Tree No. 17

TREE NO.	SPECIES	SIZE	CONDITION	COMMENTS
11	common lilac (<i>Syringa vulgaris</i>)	multi-stems 5-10cm DBH	Good	Yard, multi-stems from base
12	Plum (<i>Prunus spp.</i>)	multi-stems 10-15cm DBH	Good	Yard, dense group with buckthorn throughout
13	hybrid butternut (<i>Juglans spp.</i>)	42cm DBH	Good	Yard, data sheet for field identification of butternut hybrids completed (value = 8)
14	buckthorn (<i>Rhamnus cathartica</i>)	3 stems @15cm DBH	Invasive	Southeast corner of yard, 3 stems from base, invasive
15	silver maple (<i>Acer saccharinum</i>)	>100cm DBH	Fair-Poor	East of house, co-dominant and included stems from base, two large stems pruned from branch union with decay, uneven canopy from house, exposed surface roots near foundation of house
16	eastern white cedar (<i>Thuja occidentalis</i>)	3 @ 15cm DBH	Dead	Dead - crowded out by Norway maples
17	Norway maple (<i>Acer platanoides</i>)	4 multi-stem groups 10- 20cm DBH	Good	4 groups of 5-7 stems each, co-dominant at base forming dense colony

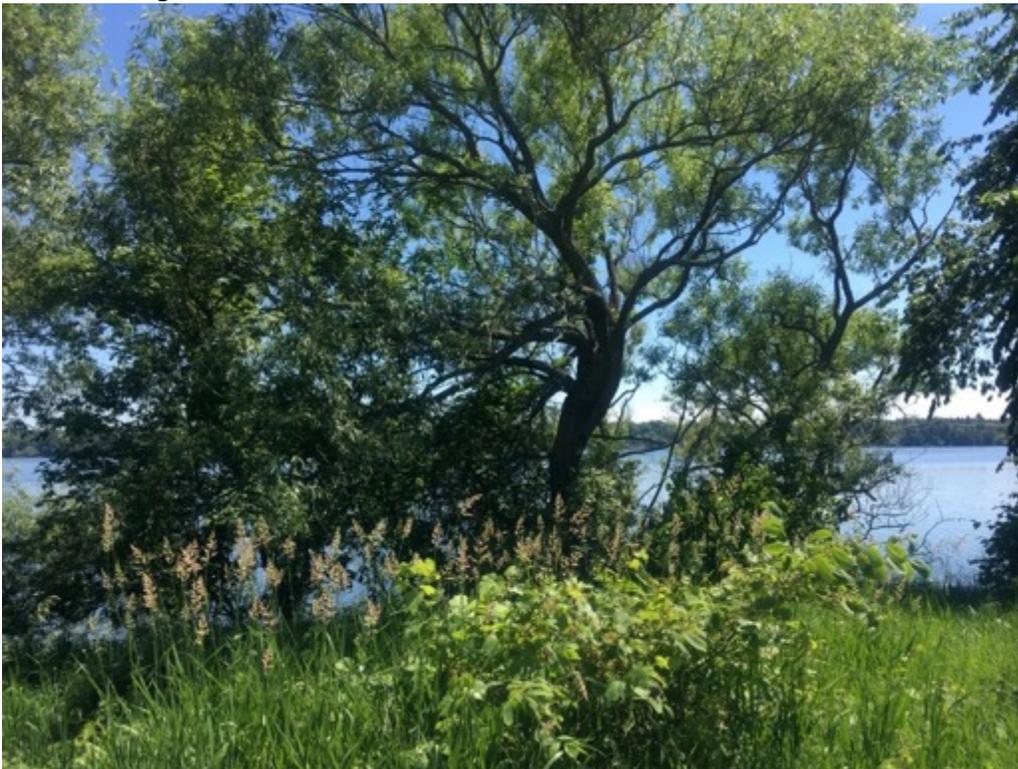
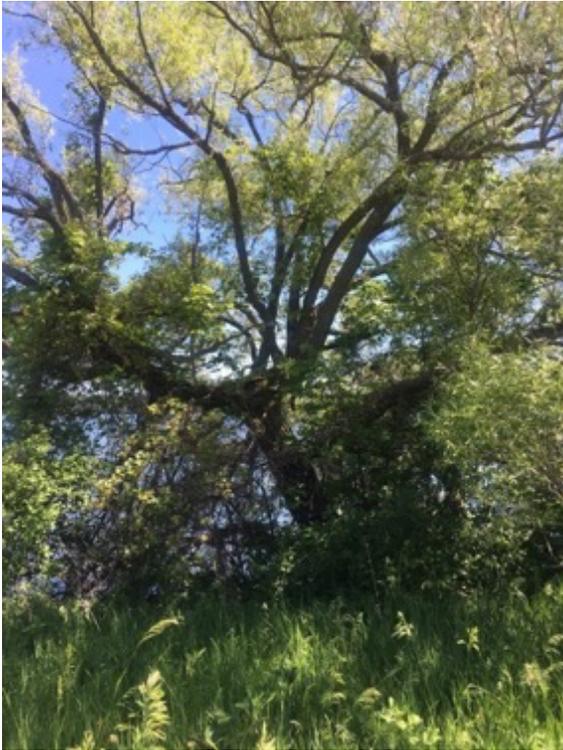
Non-native, naturalized, medium-sized trees named for their brittle branchlets. Hybrids with white willow occur commonly as naturalized populations along waterways. Site Occurrence: There are 17 very large willow trees along the Muscote Bay shoreline. Many have multiple large stems from the base and some have failed stems at base laying on the ground.

Shoreline willow

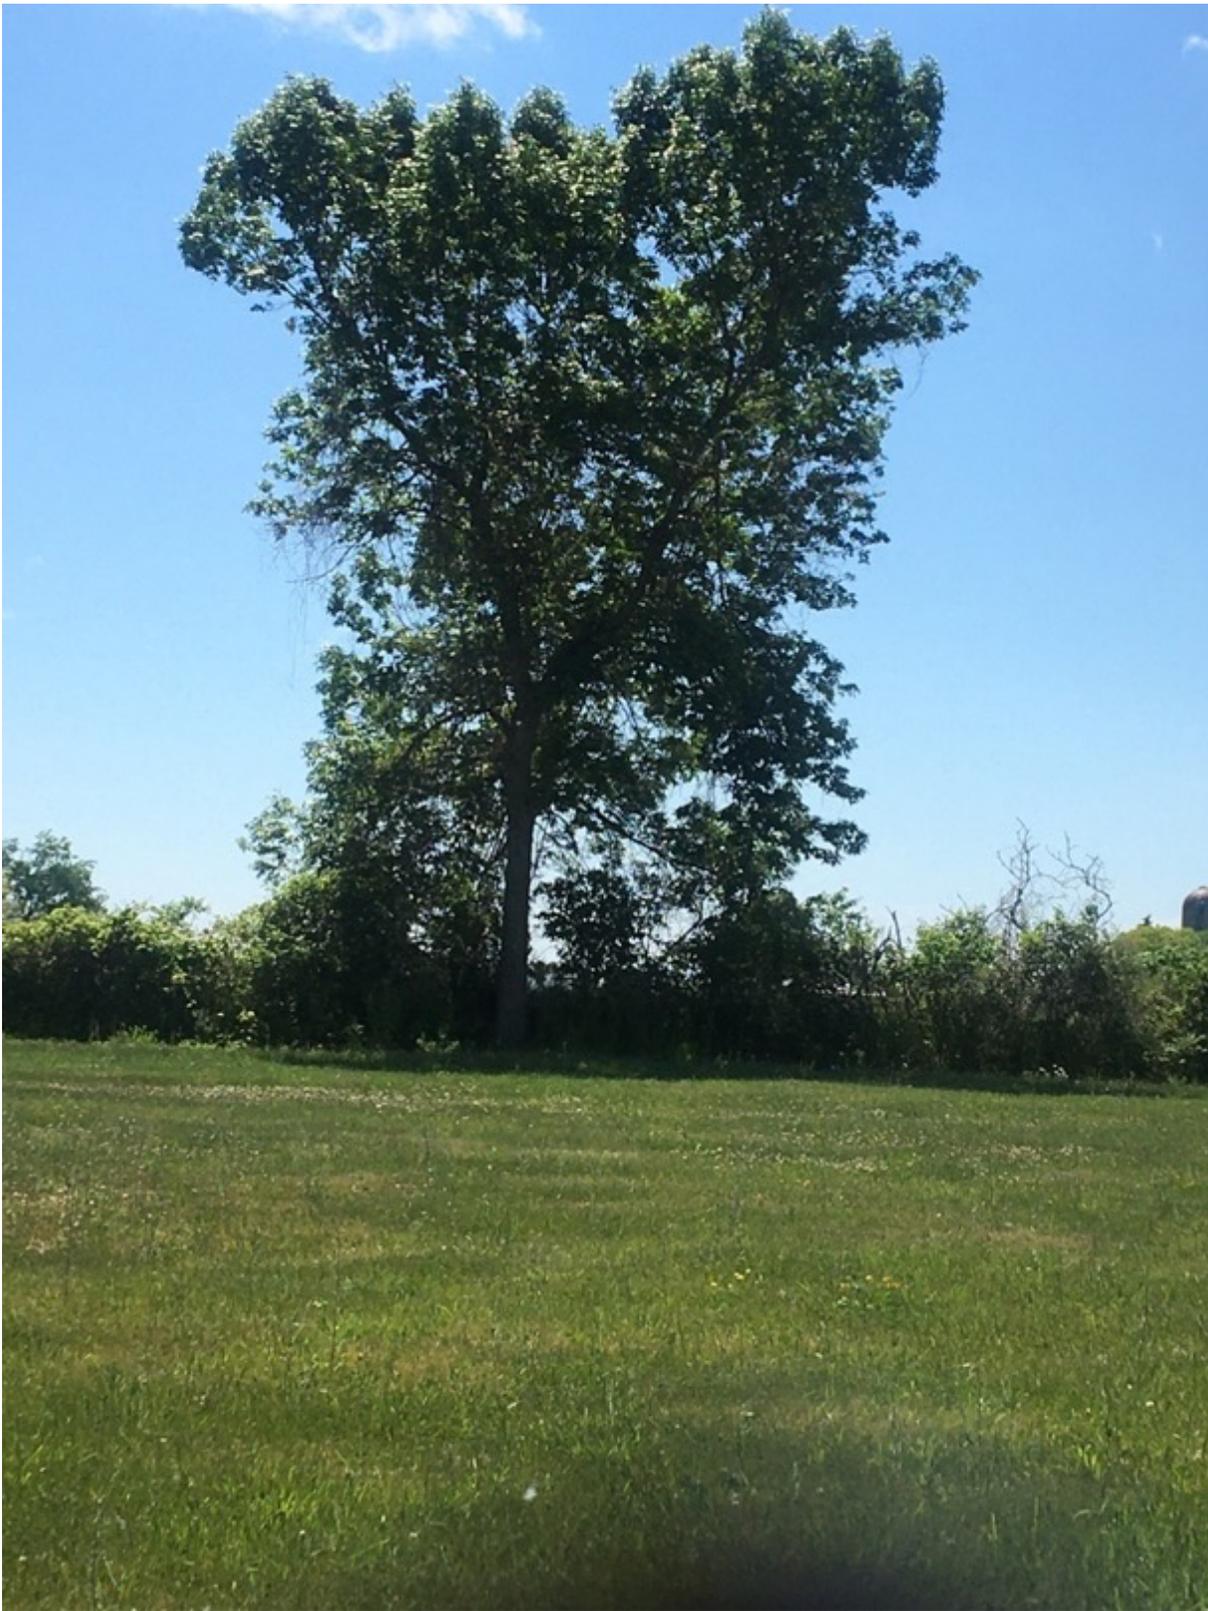
Tree No. 69 – green ash

Native and widely distributed medium-sized tree that propagate readily in disturbed areas. Emerald ash borer is an exotic, invasive insect pest that is present throughout southern Ontario and kills all ash (*Fraxinus spp.*) species. Pest control strategies are available with varying effectiveness. Site Occurrence: There one (1) semi-mature ash along the east property line hedgerow and smaller ash (10-20cm DBH) throughout the shoreline and along the South Big Island Road ditch east of the property.
