Phase One

Environmental Site Assessment

*12697 Loyalist Parkway
Picton, Ontario*

August 16, 2019
File: 1126-103.00

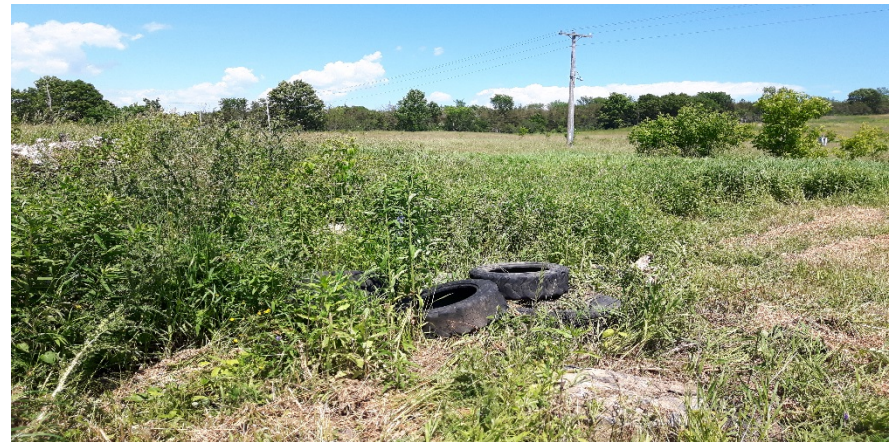
Photo 4: view of tires observed on the Phase One Property, approximately 100 m east of the Loyalist Parkway, along the access road

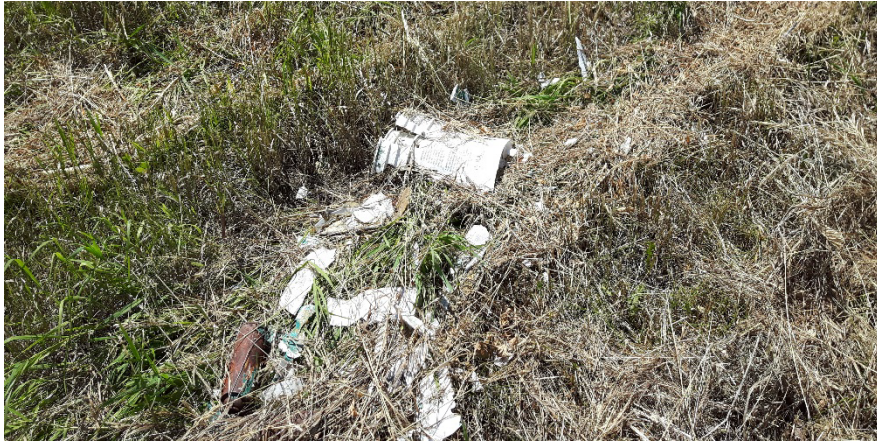
Photo 5: view of plastic and metal debris, observed in the northwestern portion of the Phase One Property

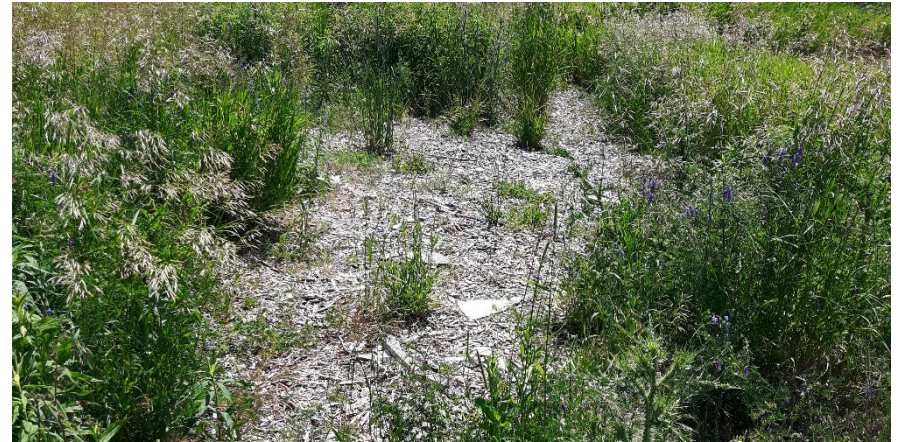
Photo 6: view of potential building material debris associated with a previous building, including wood and shingle fragments as well as wood mulch, observed at the Phase One Property, approximately 200 m east of Loyalist Parkway

Two buildings/structures were previously present in the northern area of the Phase One Property. A historical aerial photo from 2018 was the last to show the building. Buildings were not evident during the 2019 site visit. Trace amounts of fill materials indicative of a demolished building including asphalt shingles and wood fragments were observed on the ground surface during the 2019 site visit in the approximate area of the former buildings. Waste disposal tickets associated with the structure demolition were provided by the property owner (Appendix L).

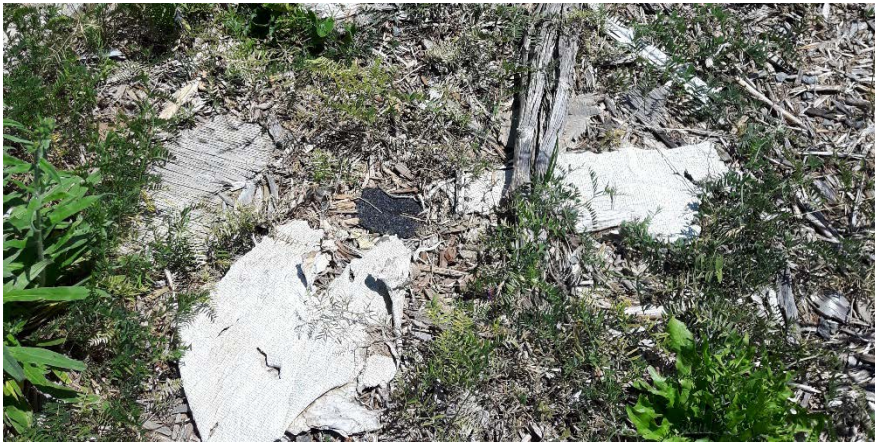
Photo 7: close-up view of materials described in photo 6

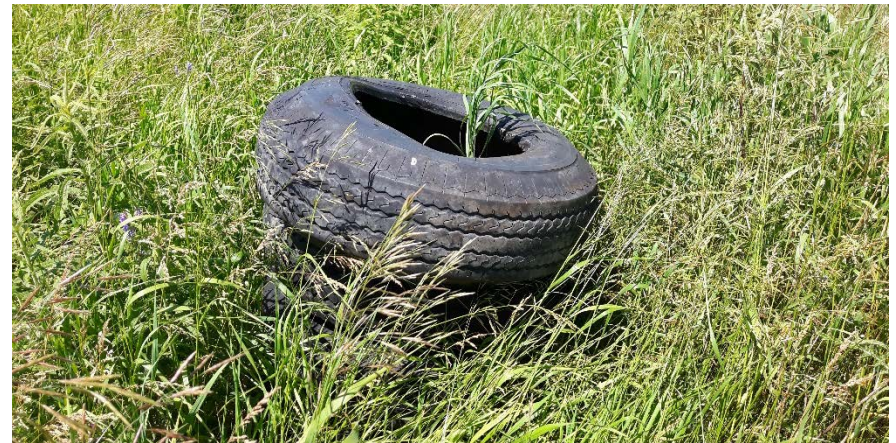
Photo 8: view of tires observed on the Phase One Property, approximately 200 m east of the Loyalist Parkway, along the access road

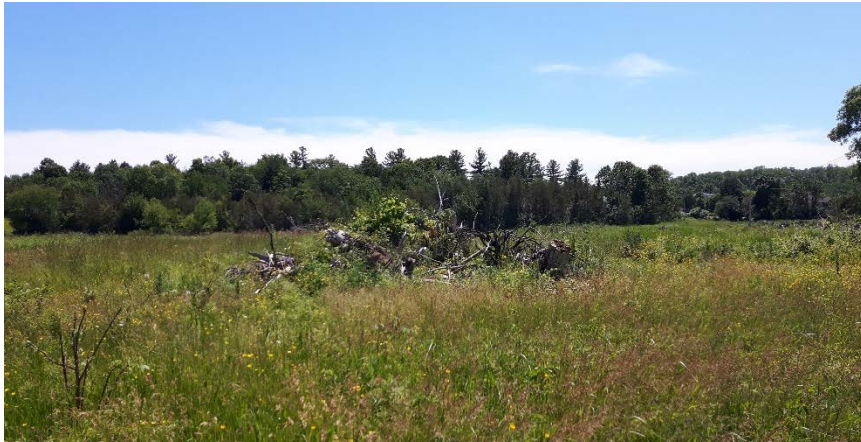
Photo 9: view of one of several piles of vegetation debris observed throughout the Phase One Property

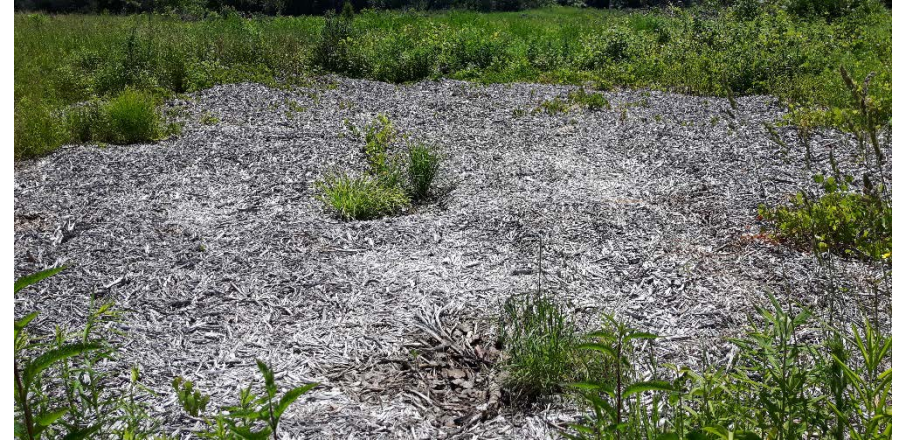
Photo 10: view of one of several of wood mulch piles observed throughout the Phase One Property

Significant amounts of wood chips/mulch were observed in piles throughout the property, especially in the south western portion of the property. The source of this material has is reported to be a product of vegetation clearing at the property in preparation of the proposed development.

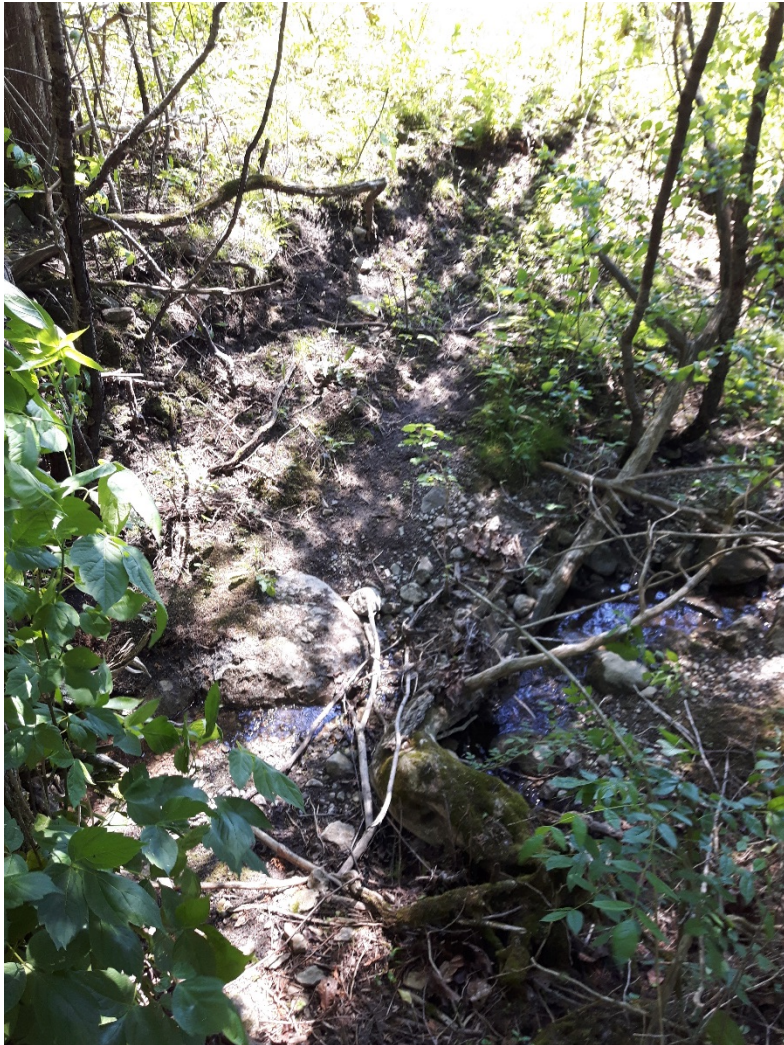
Photo 15: view of the west flowing drainage ditch observed along the north property limit of the Phase One Property, viewing west

A west flowing drainage ditch was observed along the northern perimeter of the phase one property. This eastern portion of the ditch was wet becoming dry approximately halfway down the slope.

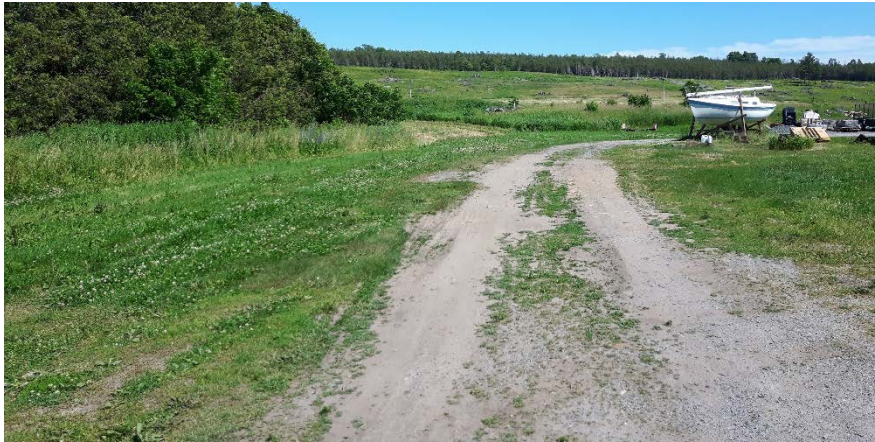
Photo 21: view of the access road located at north portion of Phase One Property, extending east from the Loyalist Parkway, looking east.

A partial gravel access road was observed at the Phase One Property during the site reconnaissance visit extending approximately 200 m east of the Loyalist Parkway. Significant quantities of wood mulch were observed across the Phase One Property during the site visit. This material is reported by Mr. DenOuden to be from tree clearing activities that occurred at the site in 2017-2018. Trace fragments of wood, plastic and metal were observed among wood mulch piles in the northwestern portion of the site.

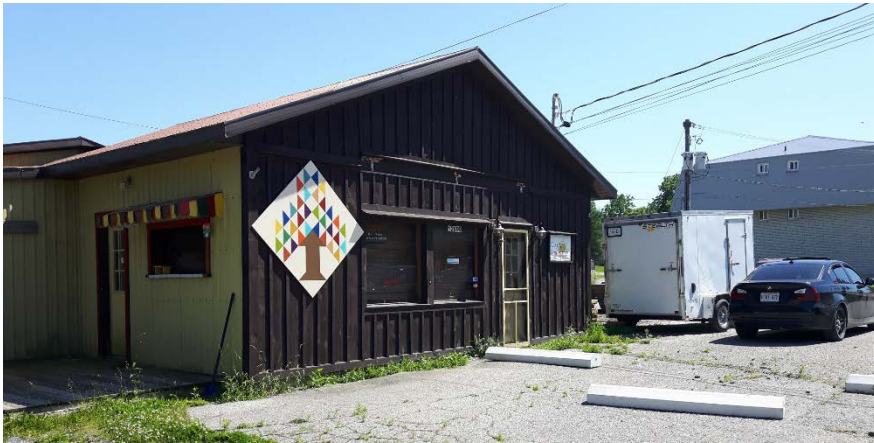
Photo 23: view of the west and north sides of the west adjacent property (12699 Loyalist Parkway), looking southeast.

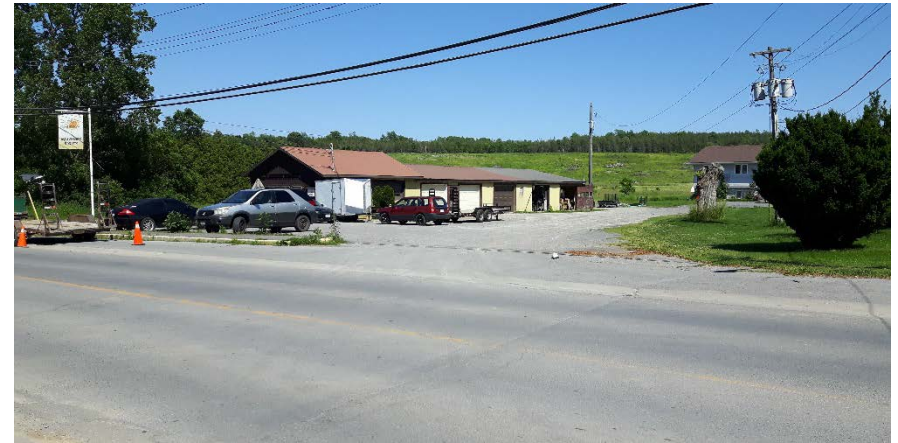
Photo 24: view of the south side of the west adjacent property (12699 Loyalist Parkway), looking northeast.
