RE: Results of Preliminary Soils Investigation: 2983 County Road 8.

Attachs.  
IPY:mrh  
Project No. 16-3486

**JOHN MURPHY FARM SOIL INVESTIGATIONS**

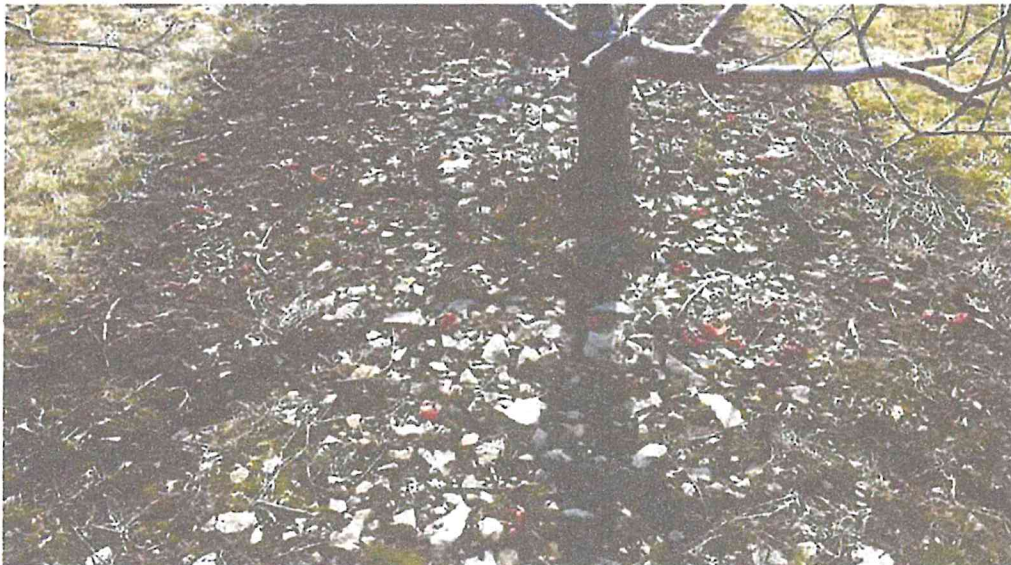
However, the soils in the orchard became extremely stony (**Photo 1**) as an increase in elevation towards the forest occurred. It was believed that this change in soil series (i.e., from Elmbrook to Ameliasburg) was due to the predominance of bedrock that was close to or at the soil surface. (**Photo 2**)

**Photo 1 – Condition of soil within apple row showing numerous stones. Soil depth to bedrock is less than 30 cm.**

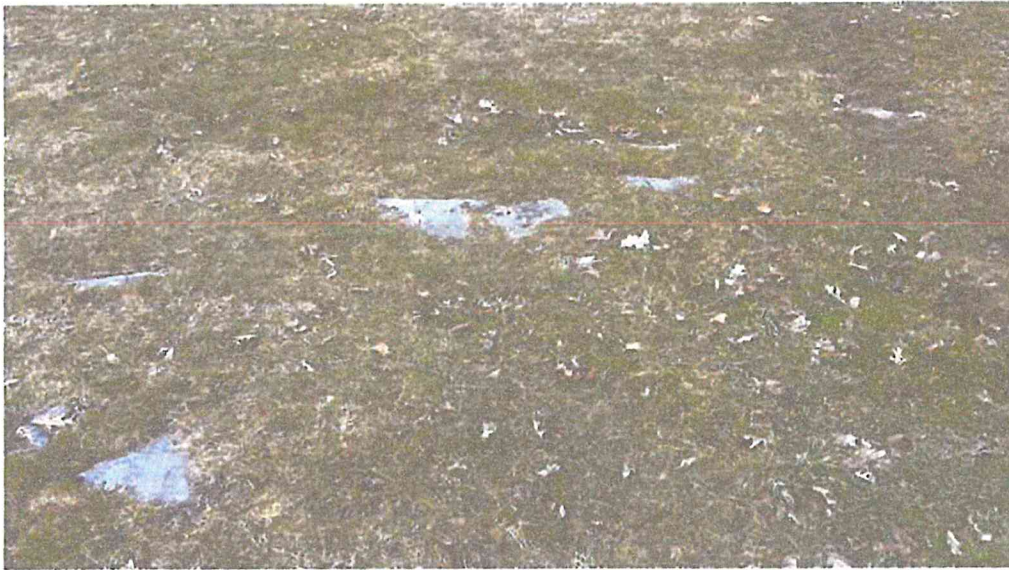
**Photo 2 – Example of bedrock at surface in grassy area. These outcrops are within 1.0 m to 2.0 m of each other with limited topsoil cover. This limitation would be Severe to Very Severe (see below for explanation).**

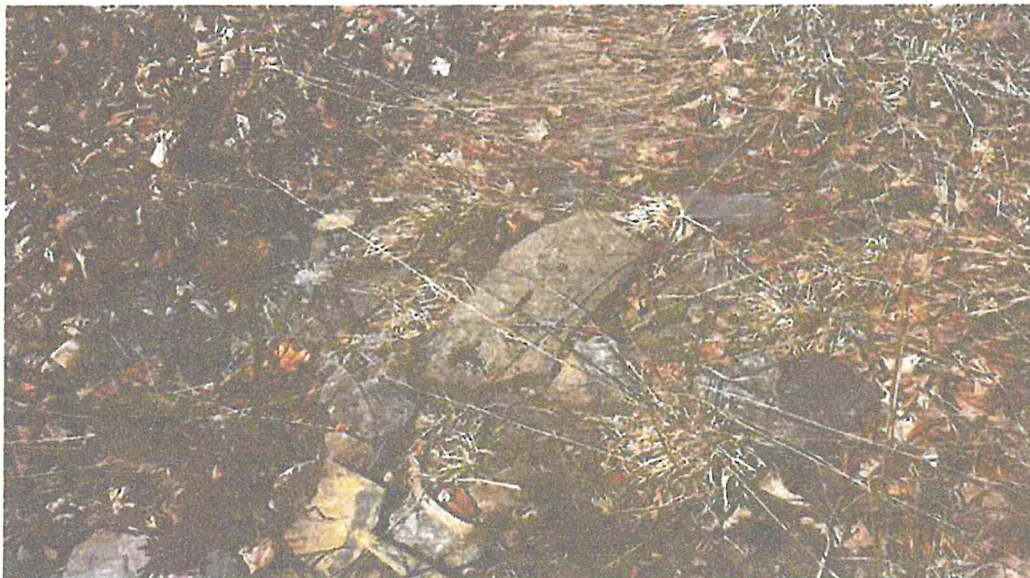
**Photo 3 – View of stones on surface of soil prior to pit excavation. Note: Compare shovel at bottom of photo (which is 20 cm wide) with large stones in centre of the photo.**

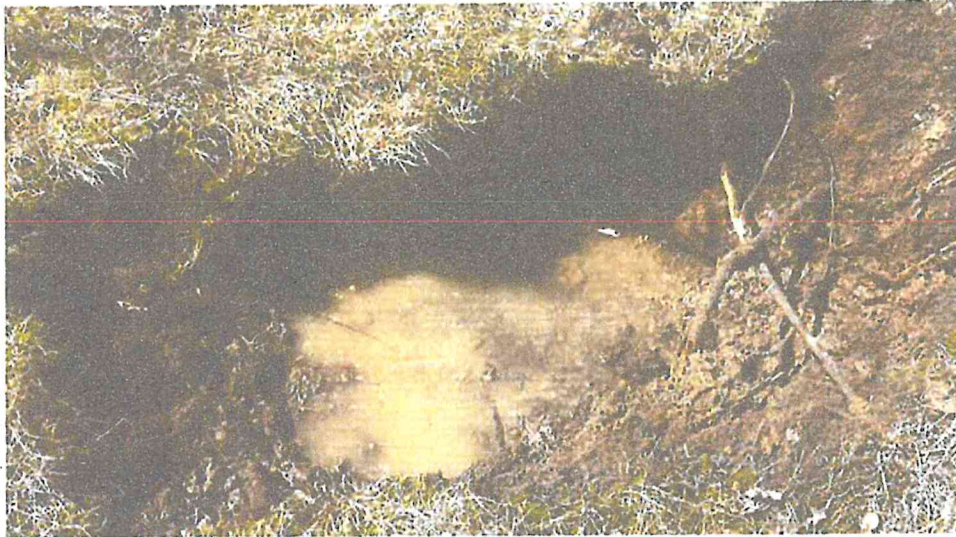
The excavation of all fourteen pits encountered bedrock within at least 70 cm of the soil surface. In some pits, large rocks were found (Photo 2) or seepage filled the pit shortly after it was excavated (Photo 3).

**Photo 4 – Example of seepage near ground level due to underlying bedrock.**

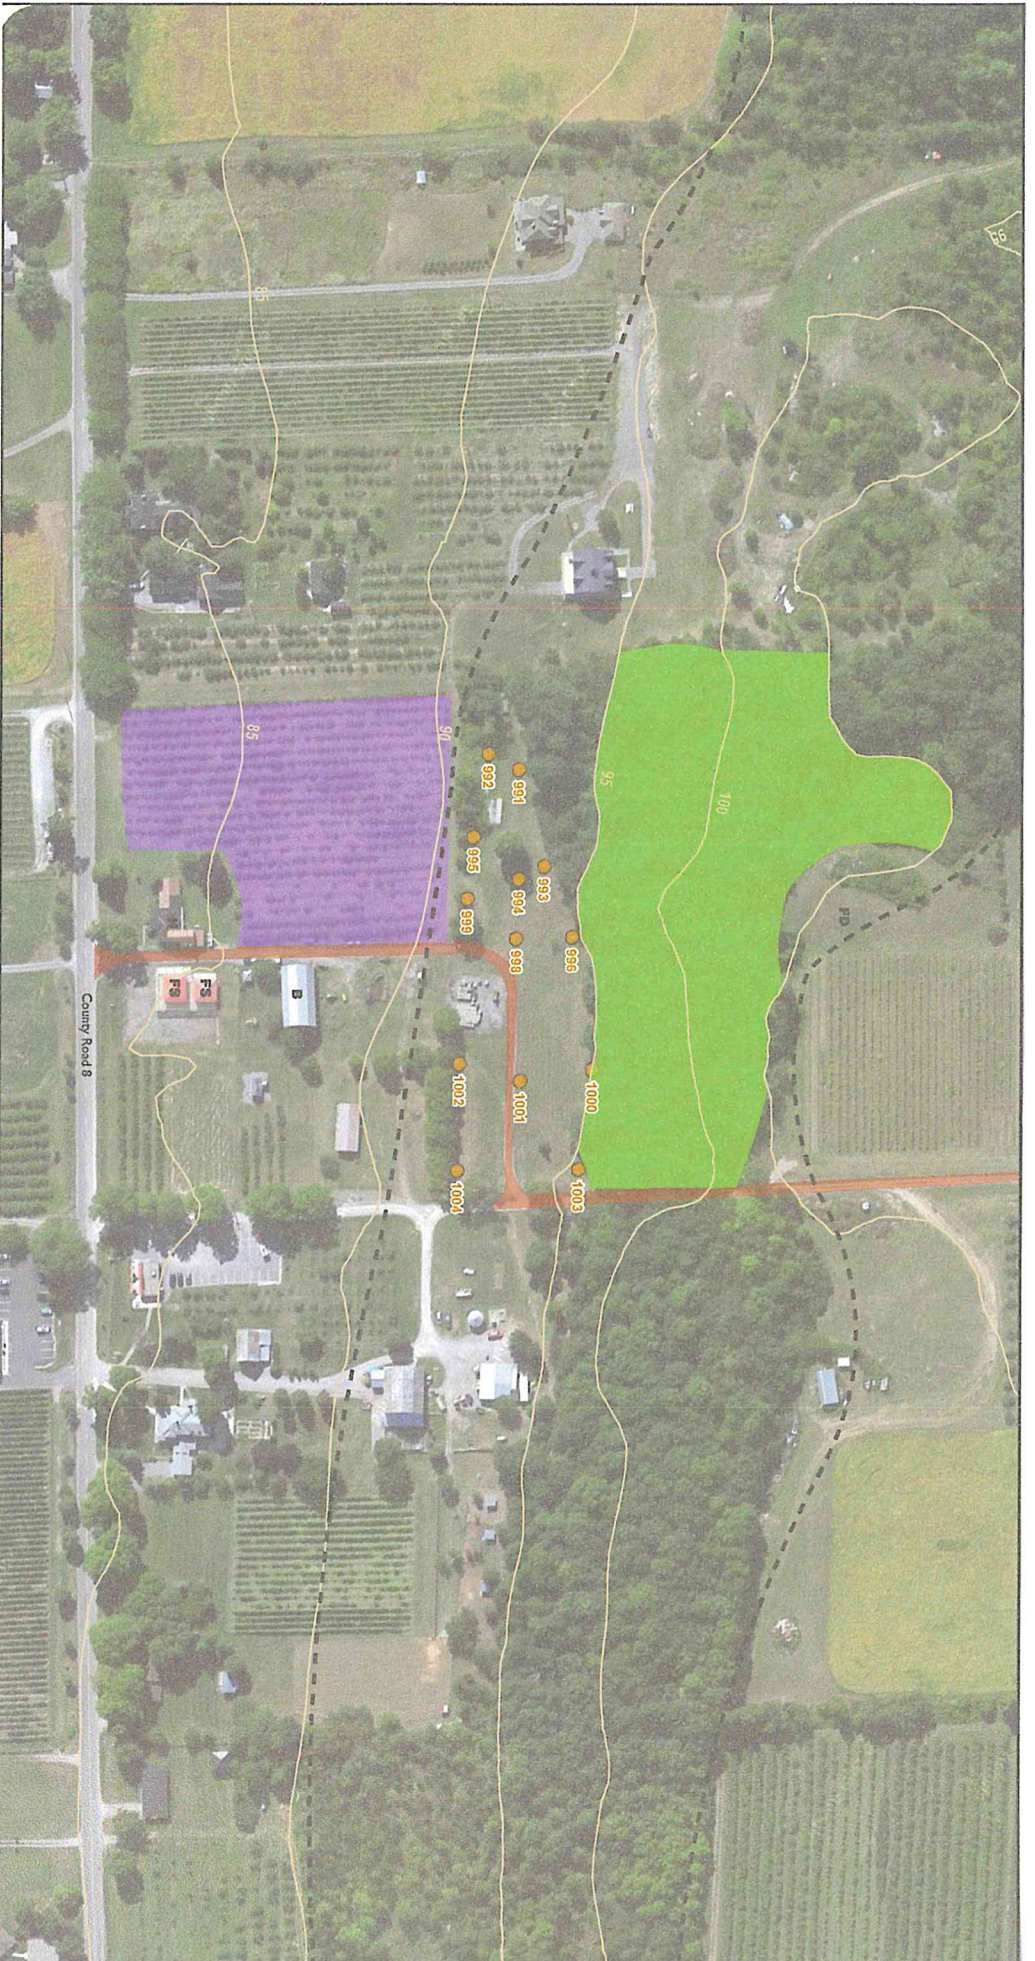
Location of Soil Pits  
Figure #1

To avoid damage to the existing orchard, these inspections occurred within an open, manicured grassy field situated north of the orchard (Figure 1). This allowed easier observation of bedrock outcrops from both Google earth images as well as field investigations. We have also added topographical contours to Figure 1 to show the relief of the property from south to north. We have also shown the approximate limits of the ridge across the Murphy farm as well as adjoining properties. ✓

A series of 14 pits were examined across the entire width of the property (Figure 1). The termination of each pit excavation occurred when solid bedrock was encountered OR the depth of the pit exceeded 1.0 metre. Table 1.0 provides the results of each pit.

Furthermore, the presence of forest and the underlying ridge (**Figure 1**) also creates a barrier between the orchards along County Road #8 and the fields and orchards north of this ridge.
