## **Hydrogeological Study**

519 Gore Road,  
Carrying Place, Ontario

**File: ASC-951 101r**  
**October 31, 2024**

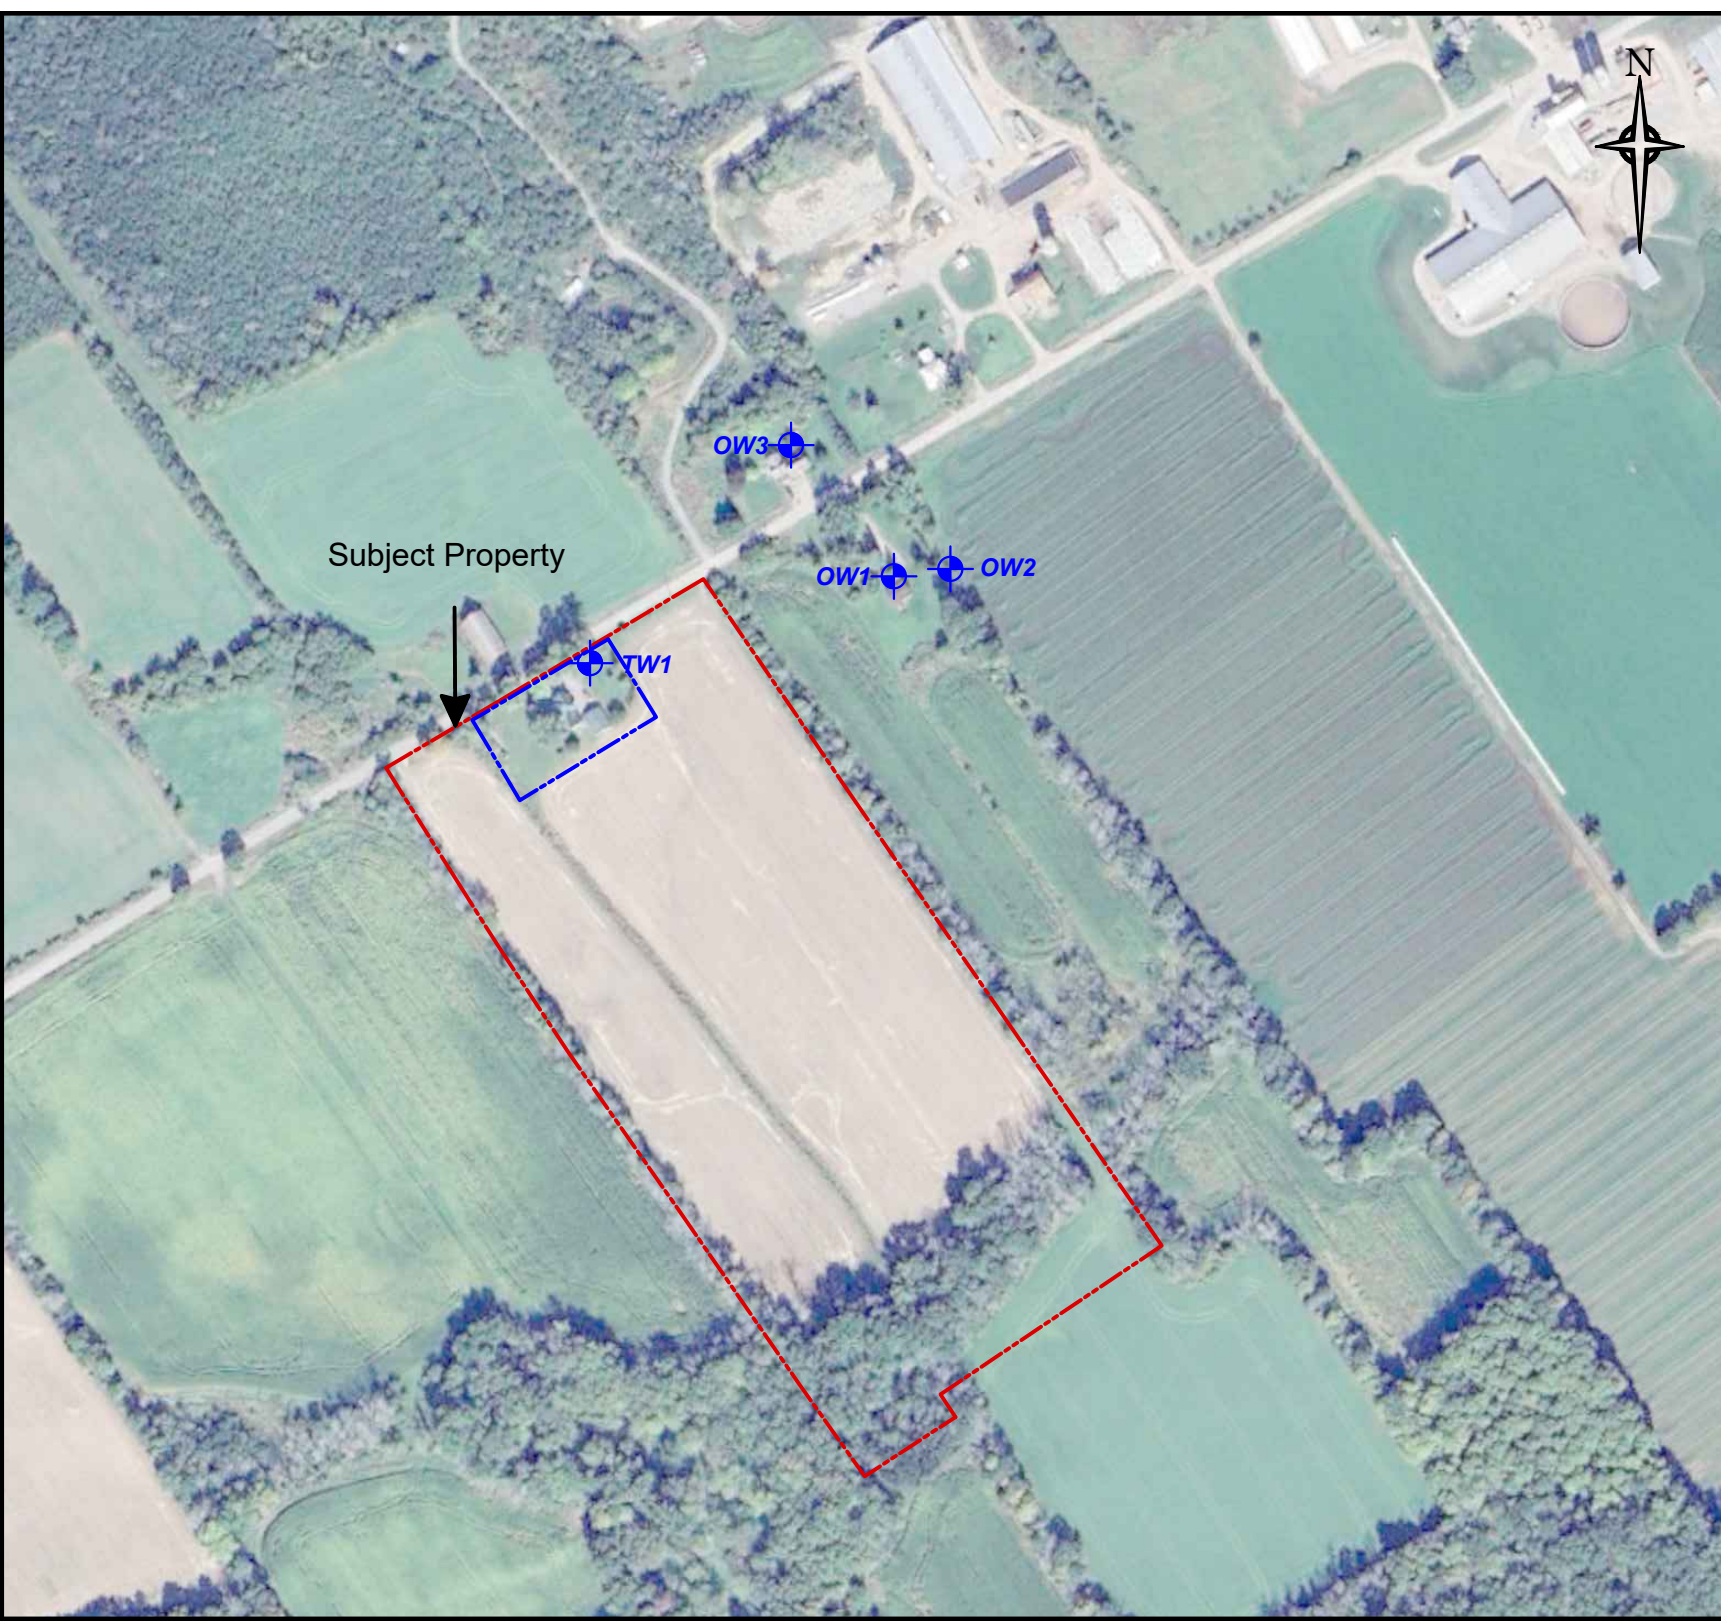
The date and method of construction for the test well is presently unknown. Visual observations for TW1 show that the test well is constructed with an interlocking stone casing that extends from surface to a depth of approximately 3.74 m. ASC is under the opinion that the test well is completed in the limestone bedrock based on information gathered from offsite well records and wells in the surrounding area. The well location is shown in Drawing No. 2 in Appendix A.

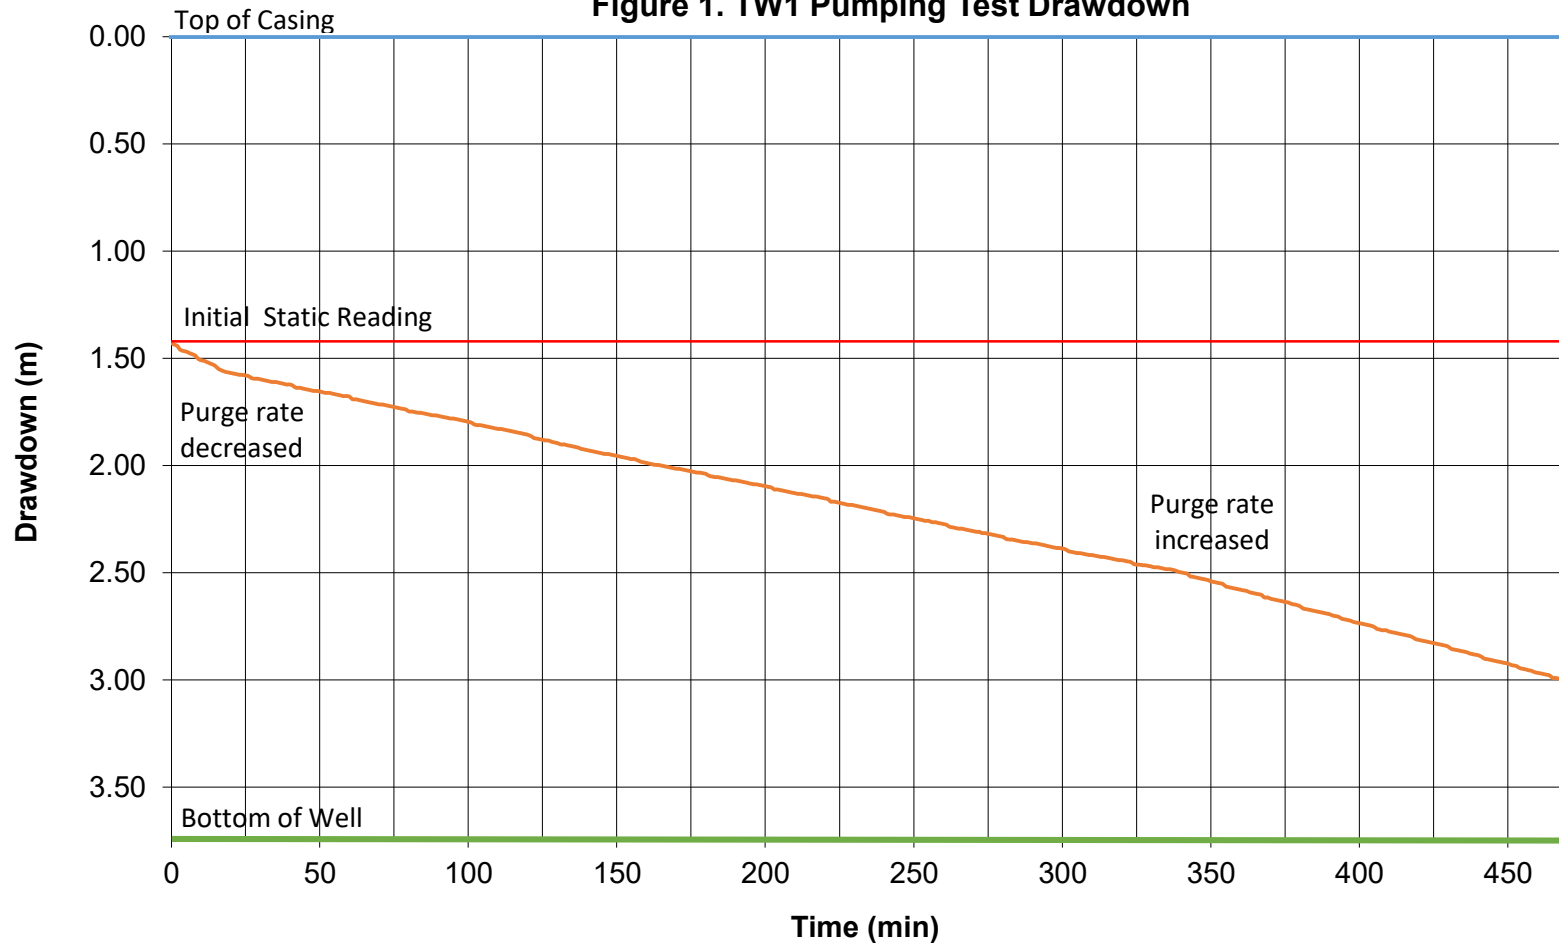
Figure 1. TW1 Pumping Test Drawdown

TW1 is approximately 3.74 metres deep, assumed to be completed in the limestone bedrock. Prior to the initiation of pumping, the static water level was measured to be approximately 1.41 m from the top of the casing. The water in the well was pumped at an initial rate of 40 L/min for a total of 15 minutes, yielding approximately 600 litres of water; the purge rate was decreased to 20 L/min for the 325 mins, yielding approximately 6,500 litres of water; the purge rate was increased to 26 L/min for 130 mins to remove residual chlorine, yielding approximately 3,380 litres of water. A total of approximately 10,480 litres of water was pumped from the well throughout the duration of the test. Maximum drawdown was measured at approximately 1.60 m over the duration of the test. At the completion of the pumping test, approximately 31% of the total well water supply was remaining. Specific capacity calculated over the final 170 minutes of the pumping test was found to be approximately 40.23 litres/minute/metre. A plot of drawdown versus time relationship is shown in Appendix D.

Drawdown and recovery measurements obtained during the pumping test are presented in Appendix D.
