Phase Two Environmental Site Assessment - 3401 County Road 13, Milford, Ontario

Prepared for:
71223 NB Ltd.

Cambium Reference: 13895-001

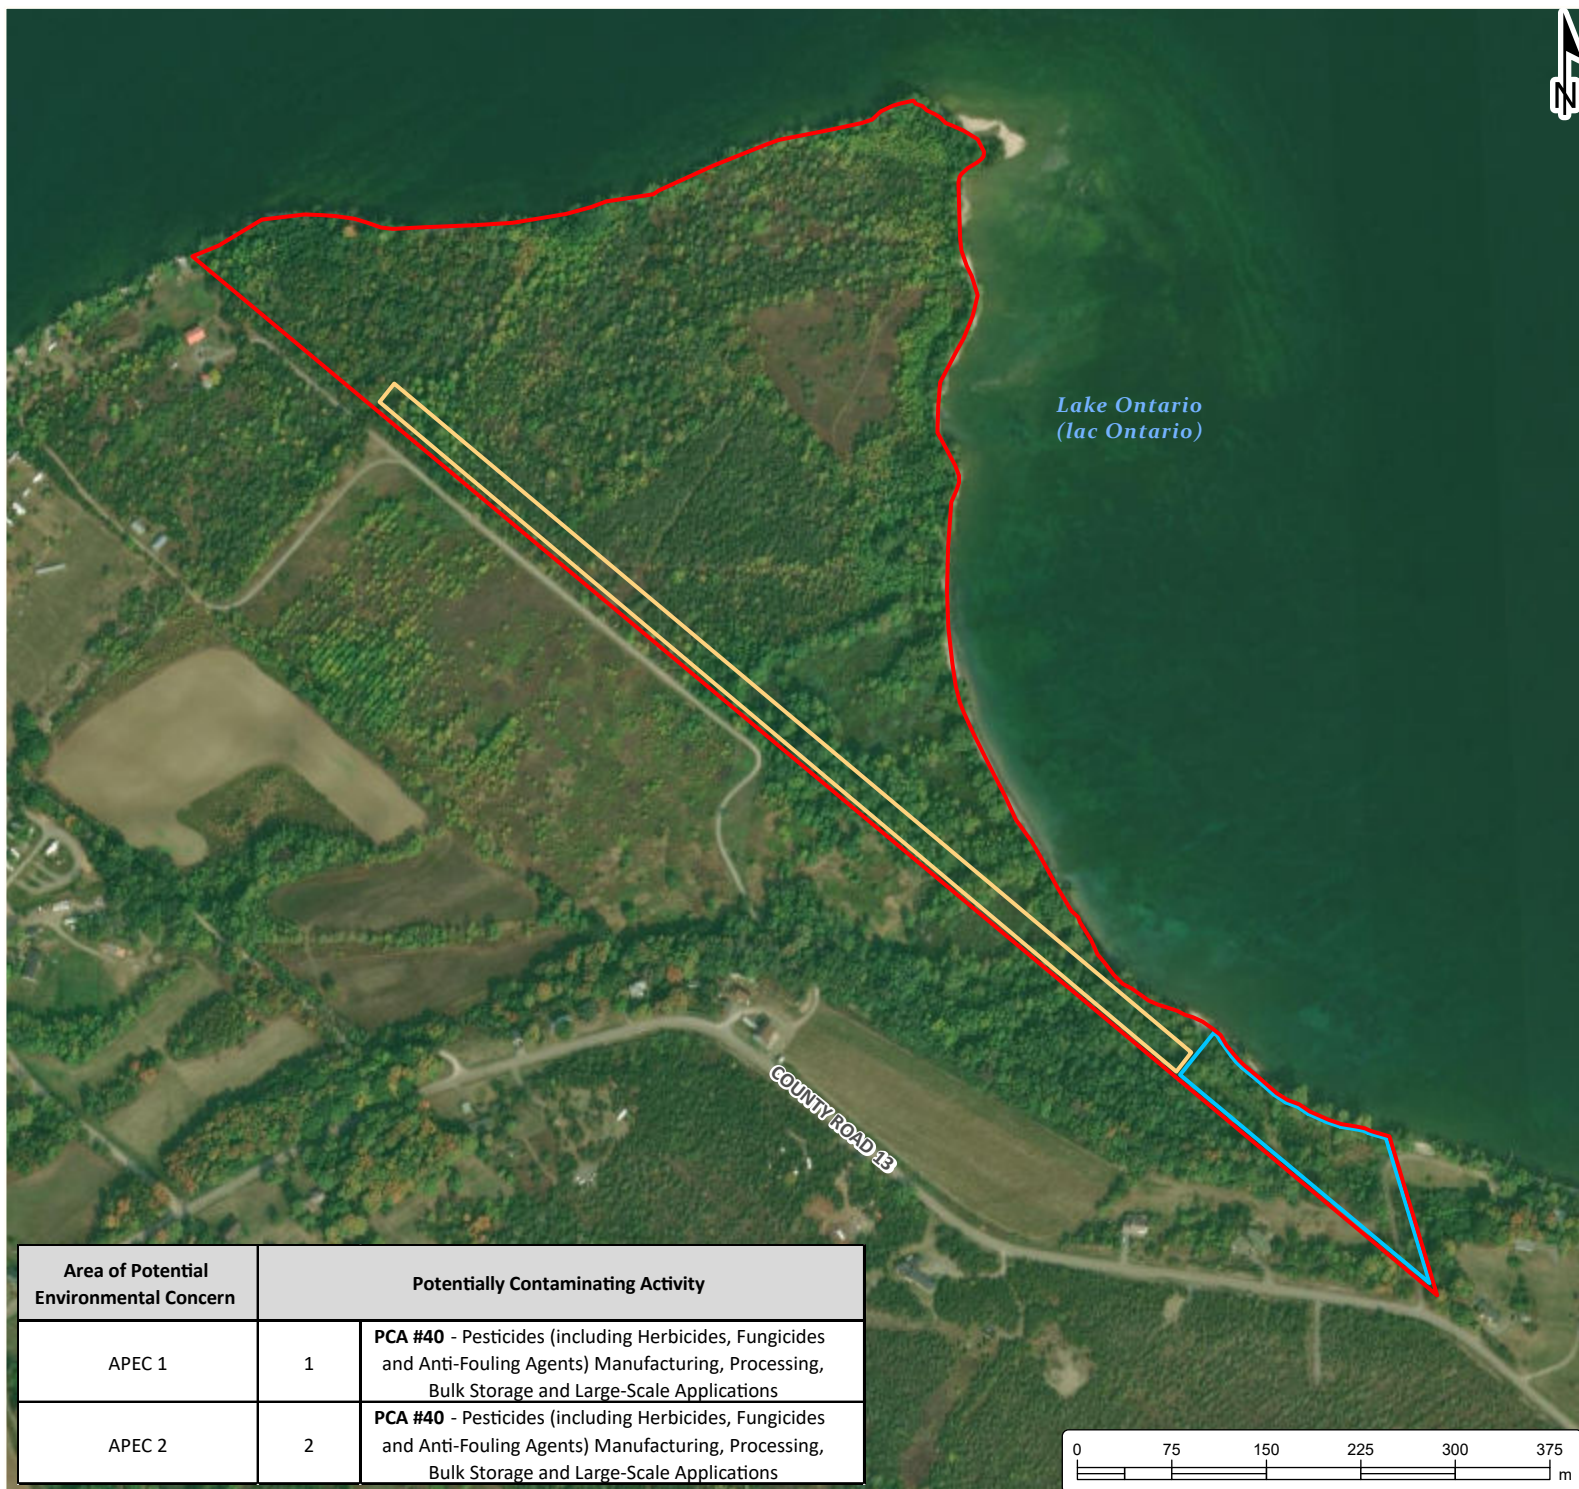
PCA ID #	Potentially Contaminating Activity (PCA)
1	PCA #40 - Pesticides (including Herbicides, Fungicides and Anti-Fouling Agents) Manufacturing, Processing, Bulk Storage and Large-Scale Applications
2	PCA #40 - Pesticides (including Herbicides, Fungicides and Anti-Fouling Agents) Manufacturing, Processing, Bulk Storage and Large-Scale Applications

**PHASE TWO
ENVIRONMENTAL SITE
ASSESSMENT**
71223 NB LTD.
3401 County Road 13
Prince Edward County, Ontario

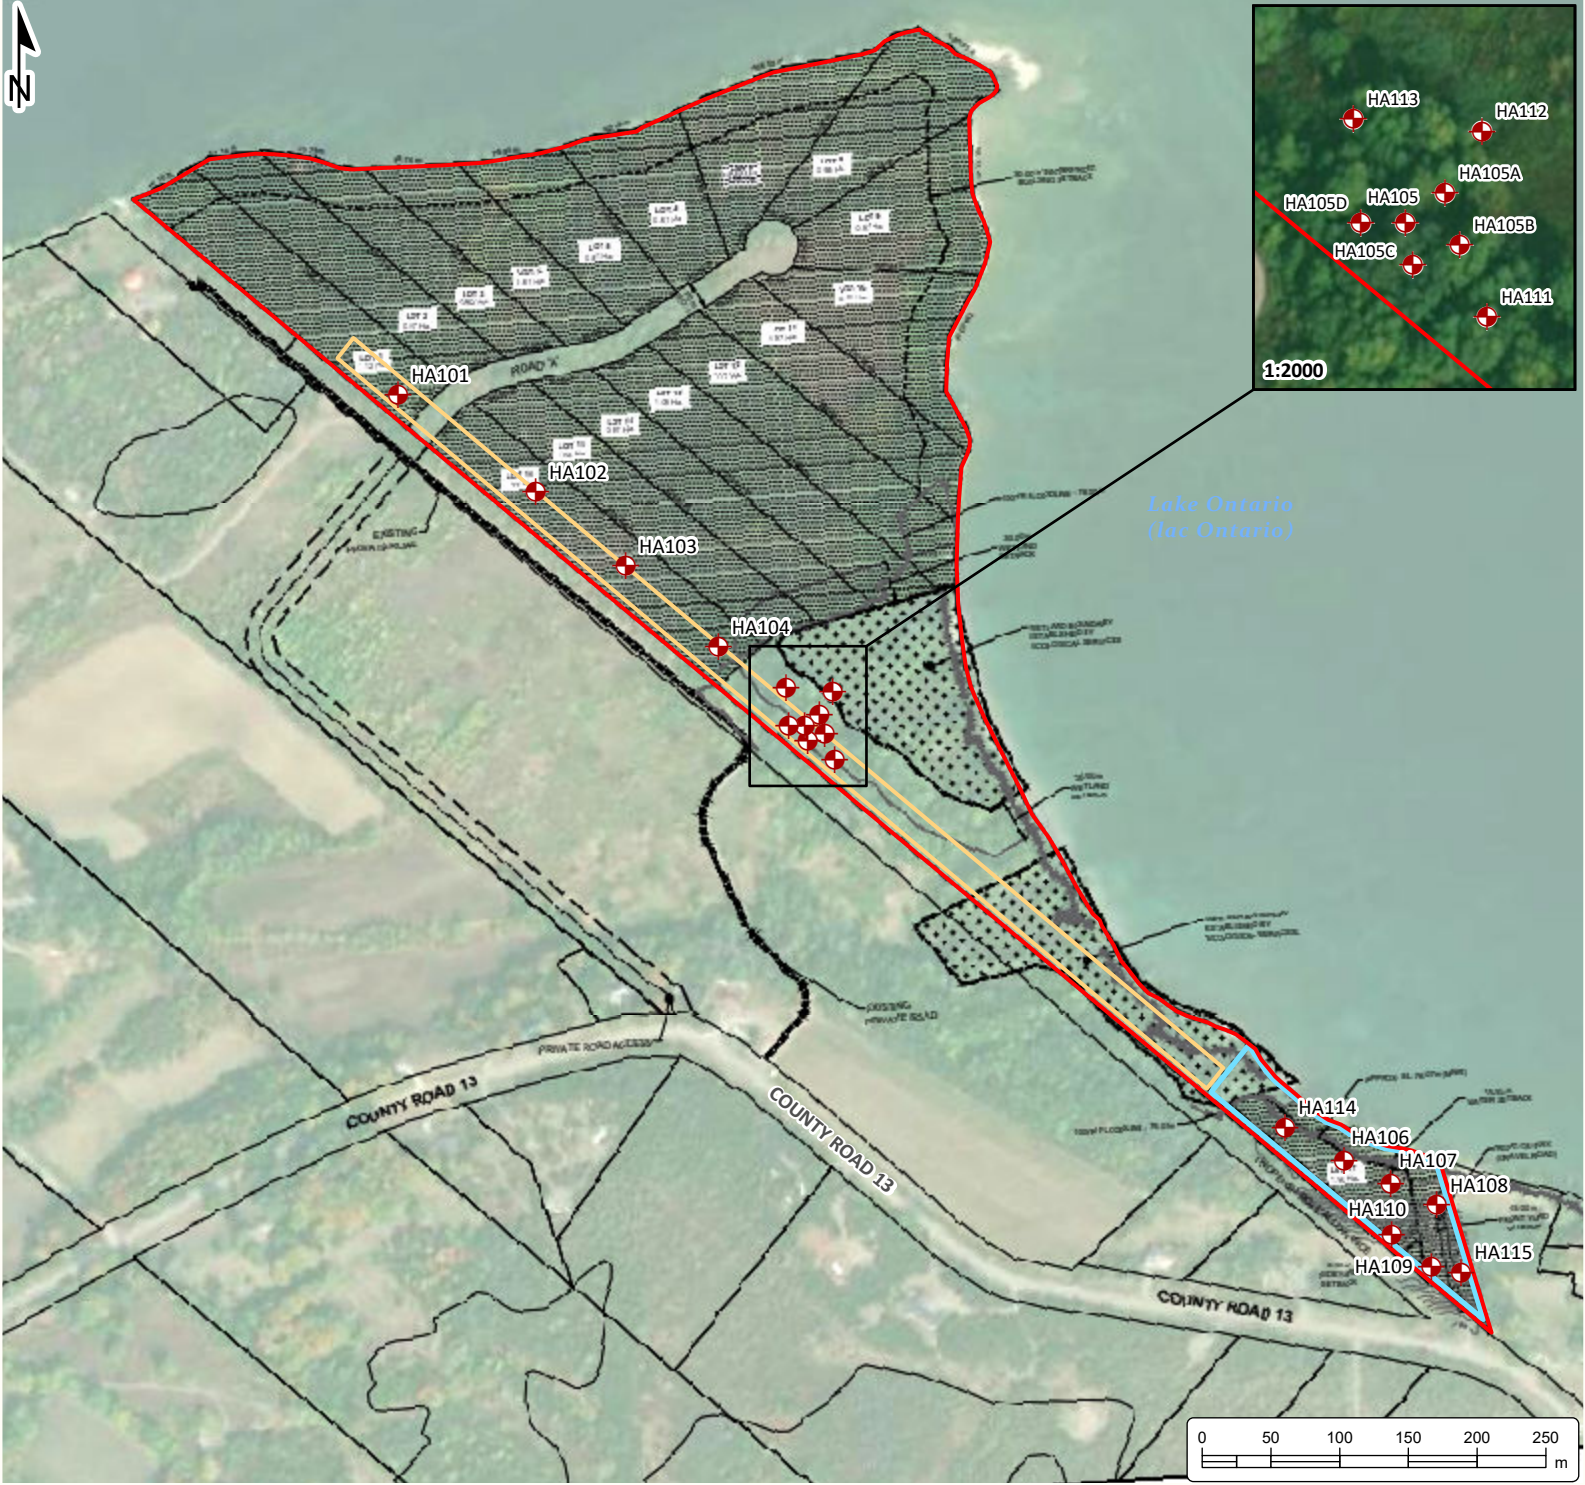
HA105	HA105A	HA105B	HA105C	HA105D	AVERAGE
Depth (m)	0.15 - 0.3					
Date	10-Apr-24	05-Jun-24	05-Jun-24	05-Jun-24	05-Jun-24	-
Antimony	<1.0	<1.0	<1.0	<1.0	<1.0	<1.0
Arsenic	4	24	12.8	46	7.4	19
Barium	225	152	195	137	123	166
Lead	12	66.6	77.6	144	21.2	64

HA105a	HA105b	HA105c	HA105d	AVERAGE
Depth (m)	1.0 - 1.2				
Date	05-Jun-24	05-Jun-24	05-Jun-24	05-Jun-24	-
Antimony	<1.0	<1.0	<1.0	<1.0	<1.0
Arsenic	7.2	5.8	8.0	4.9	6.5
Barium	178	297	258	39.3	193
Lead	17.2	13.1	15.7	8.6	14

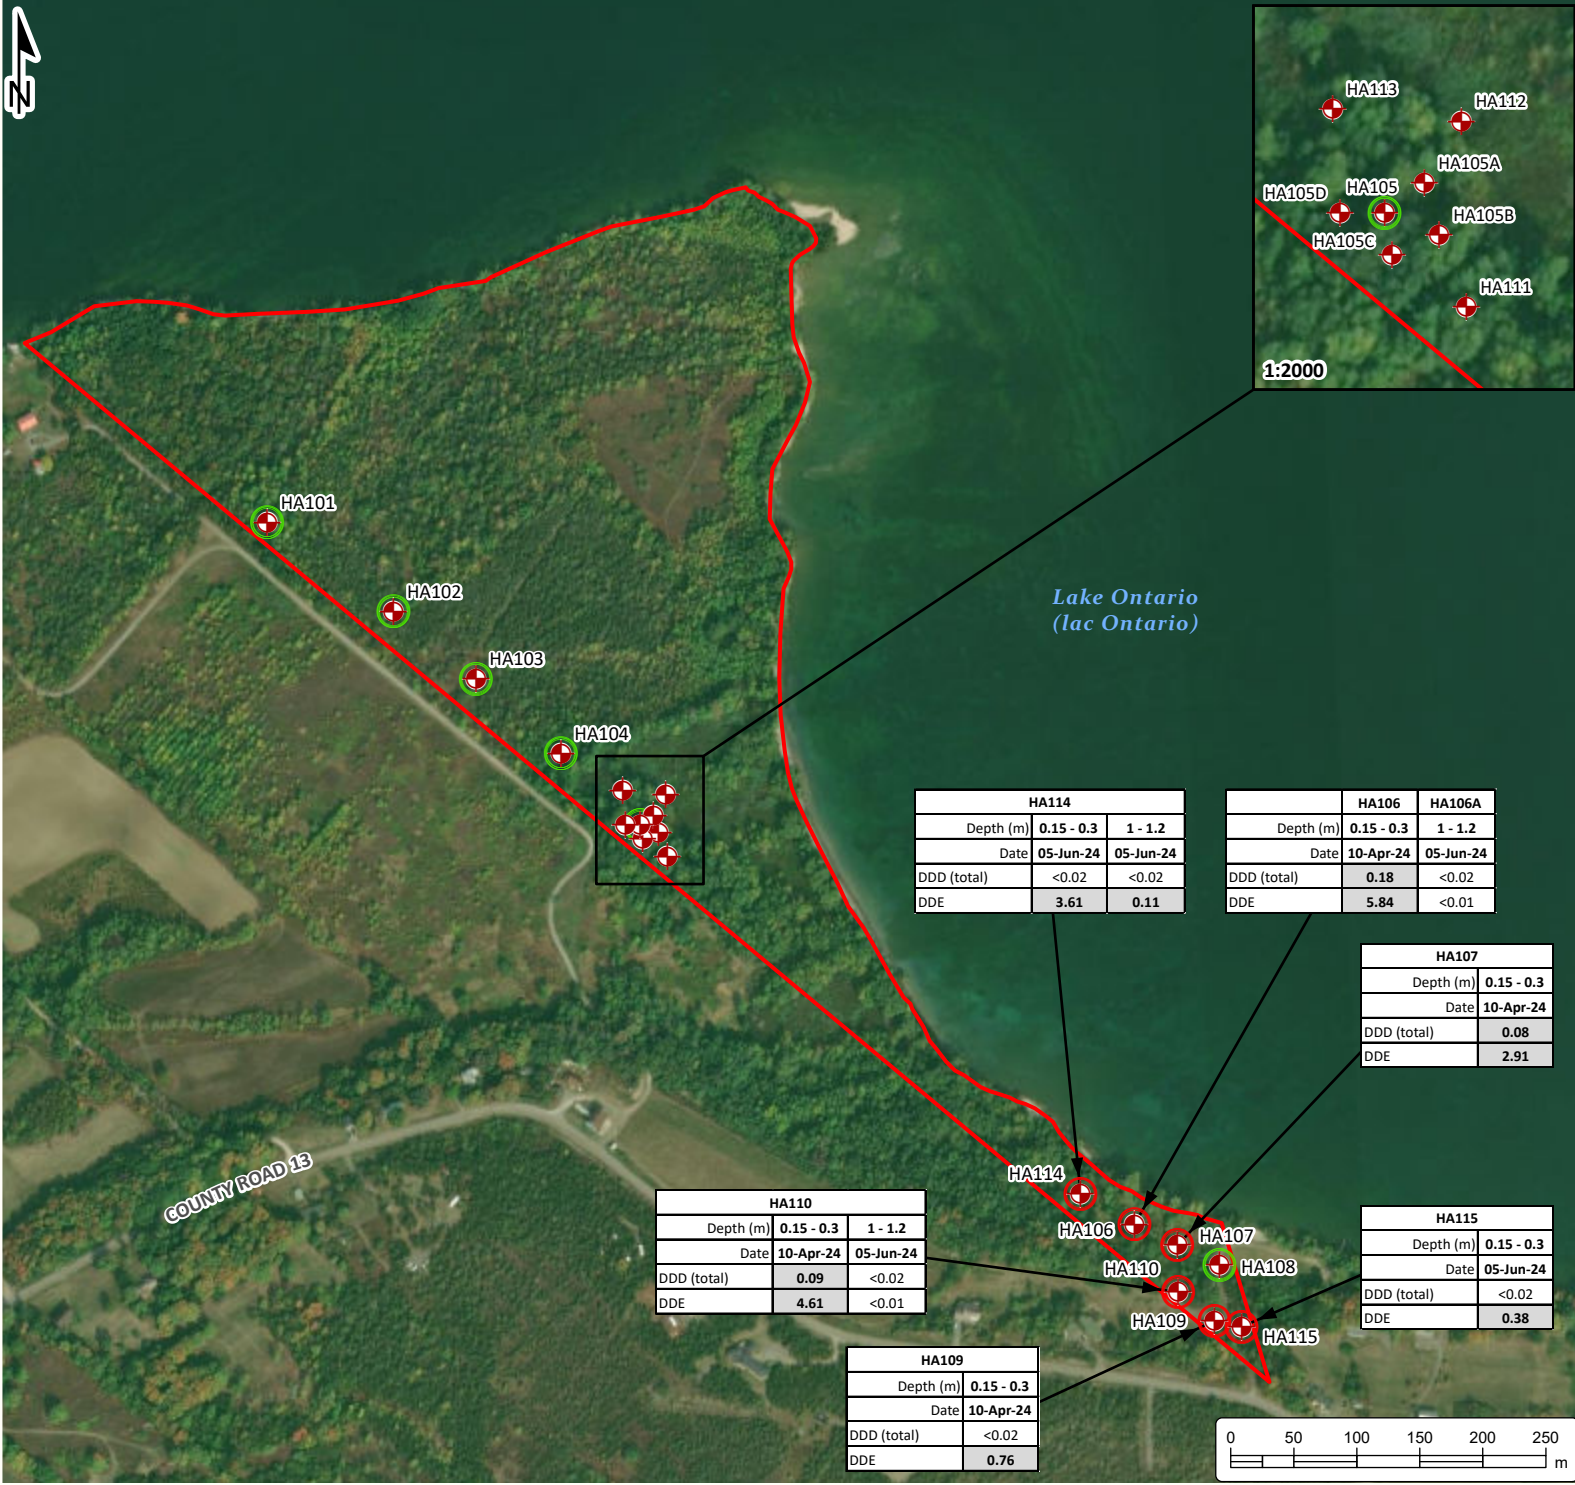
SOIL QUALITY OCs

Soil samples exceeding the Table 1 SCS for OCs, including DDD and DDE, were present within the southeastern portion of the Site. Vertical delineation of HA106 and HA110 was achieved at 1 to 1.2 m bgs; however vertical delineation was not achieved at HA107, HA108, HA109, HA111, HA114, and HA115. Inferred bedrock was encountered at 0.5 to 0.8 mbgs in HA107, HA108, HA109, HA111, and HA115. Horizontal delineation of the OC exceedances was not achieved and is inferred to be present across all of the proposed Lot 17 at the southeast portion of the Site. However, no OCs exceedances were observed in the proposed Lots 1-16.

Cambium notes that no exceedances were observed on the proposed residential subdivision on the north portion of the Site. The exceedances of OCs in the submitted soil sample is inferred to be encompass the entire proposed Lot 17 area. This area was the reported location of the historical on-site orchard/vineyard.

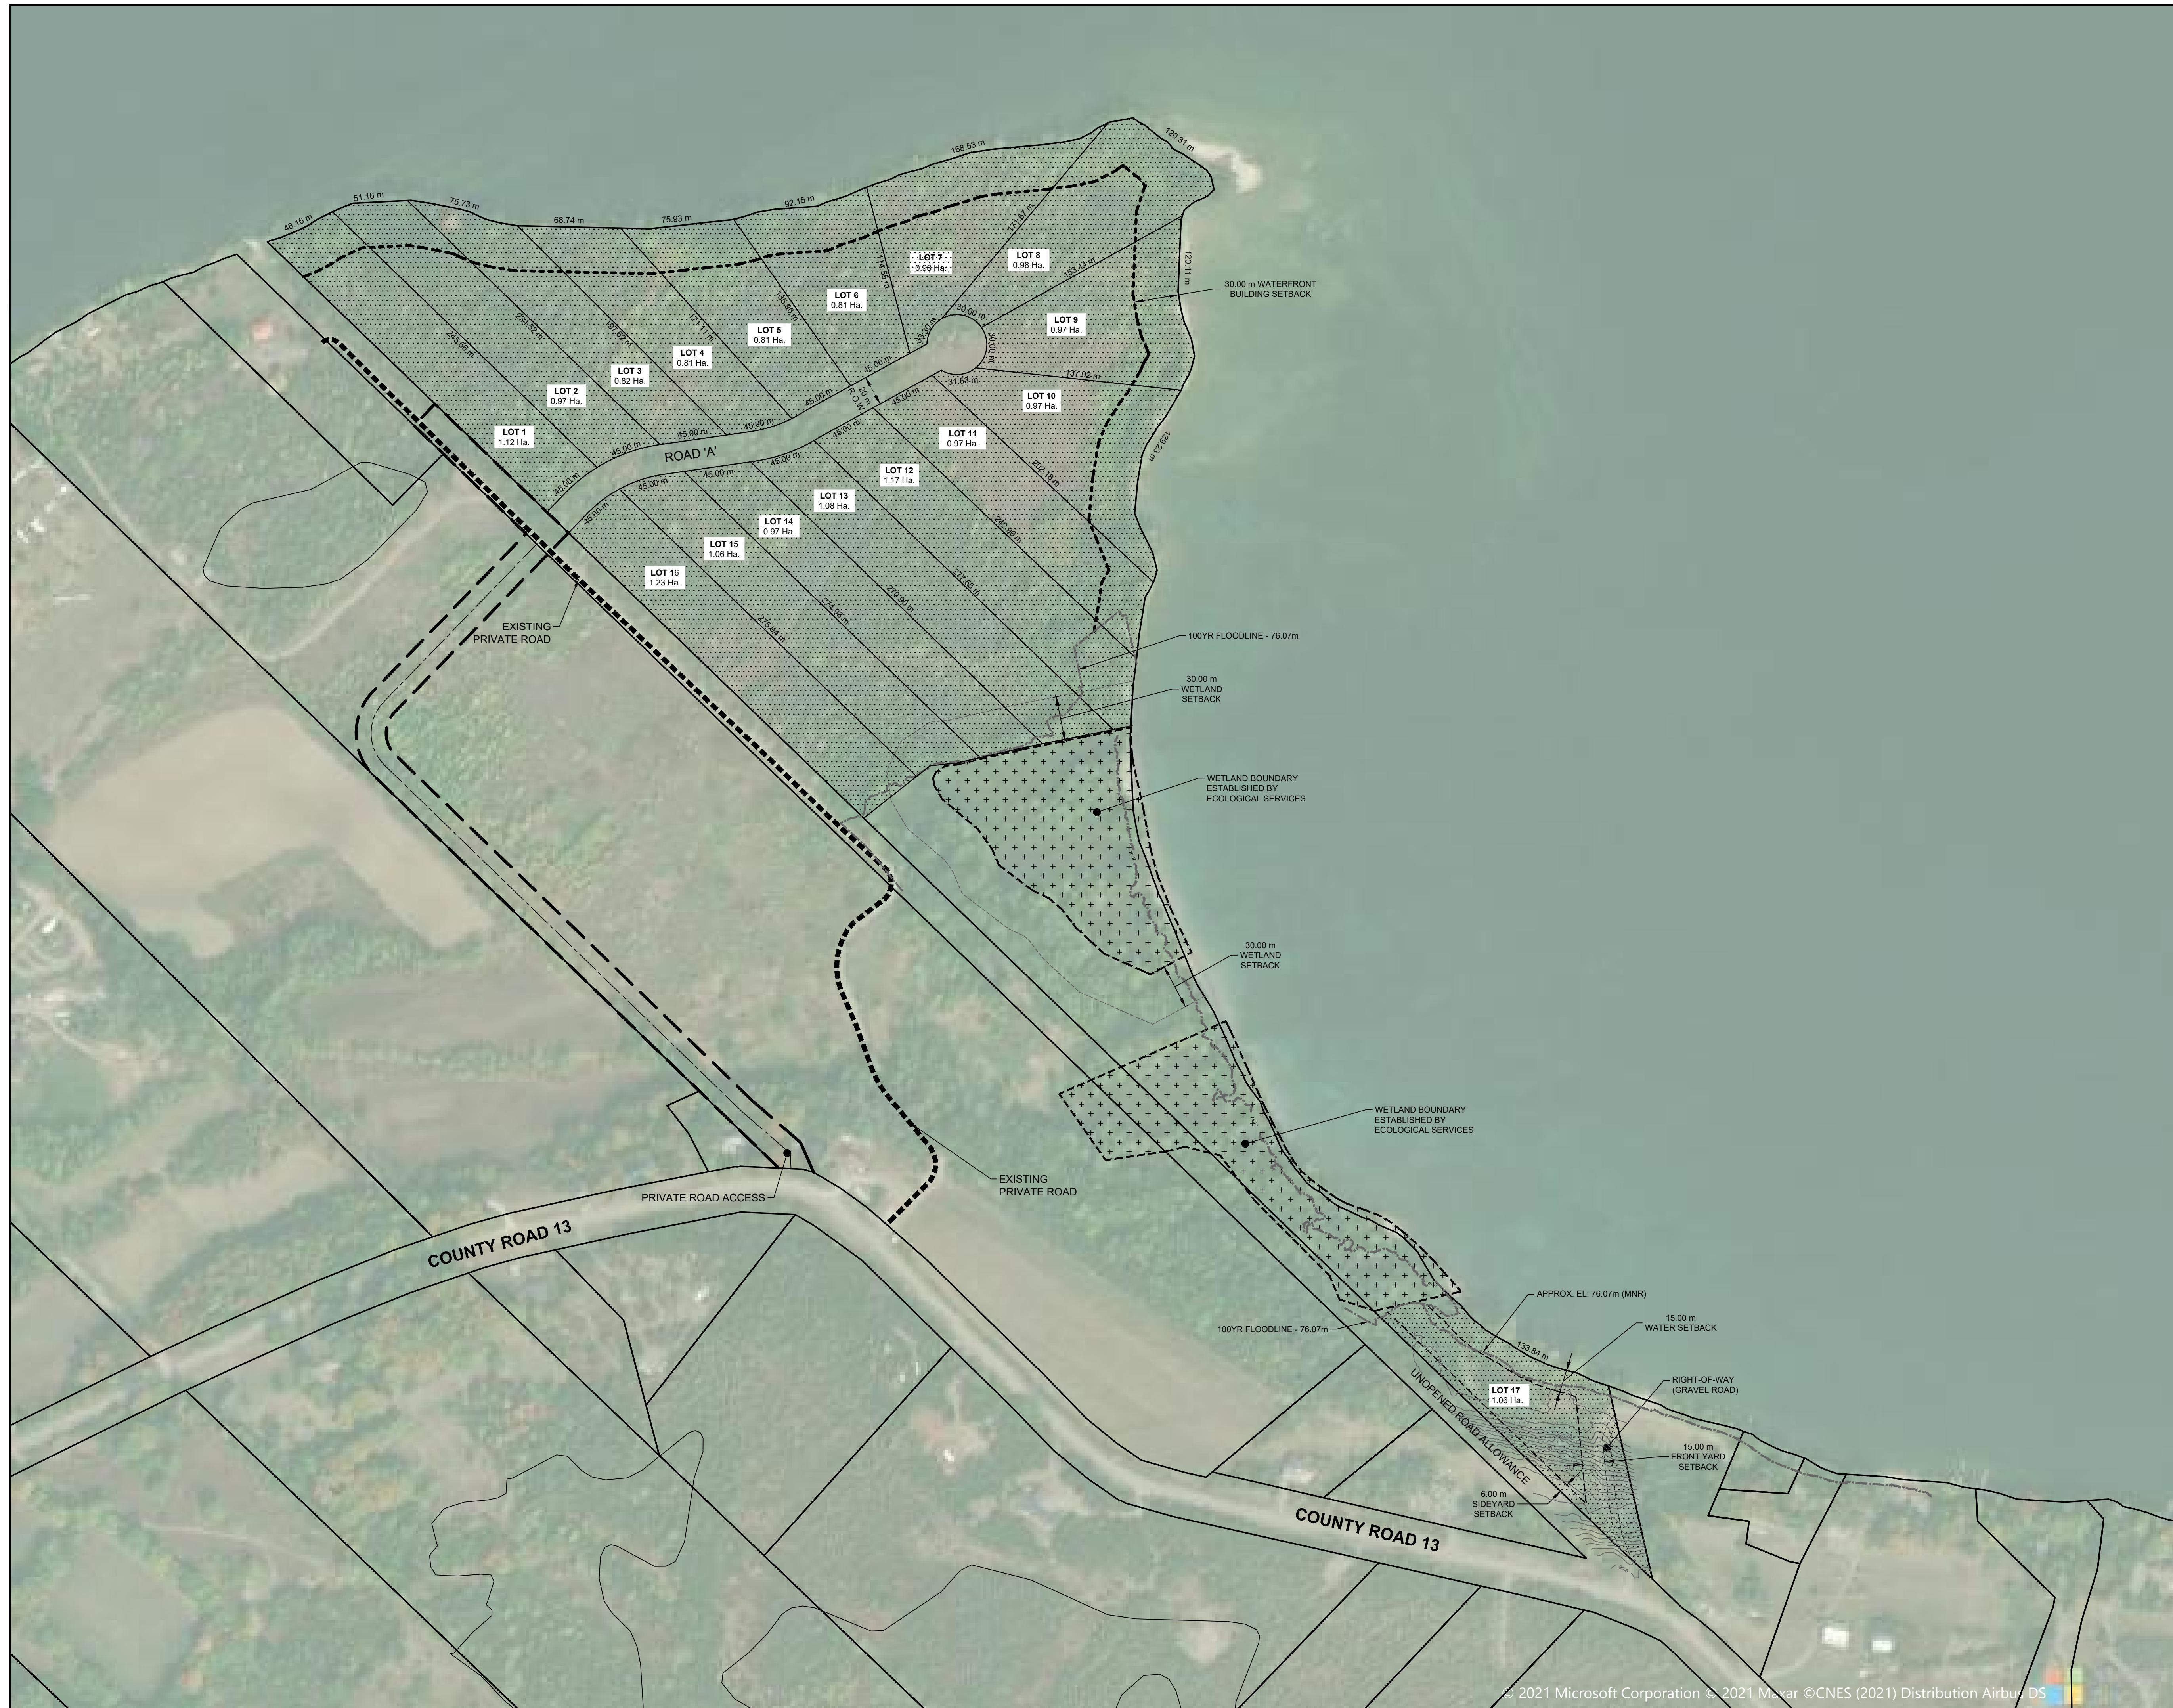
Appendix A
Concept Plan

PROJECT
FLATT POINT DEVELOPMENT
PRINCE EDWARD COUNTY
