Factual Hydrogeological Letter – 46 Eatonville Road, Prince Edward County

Prepared for:
Willowlee Sod Farms

Cambium Reference: 20382-001

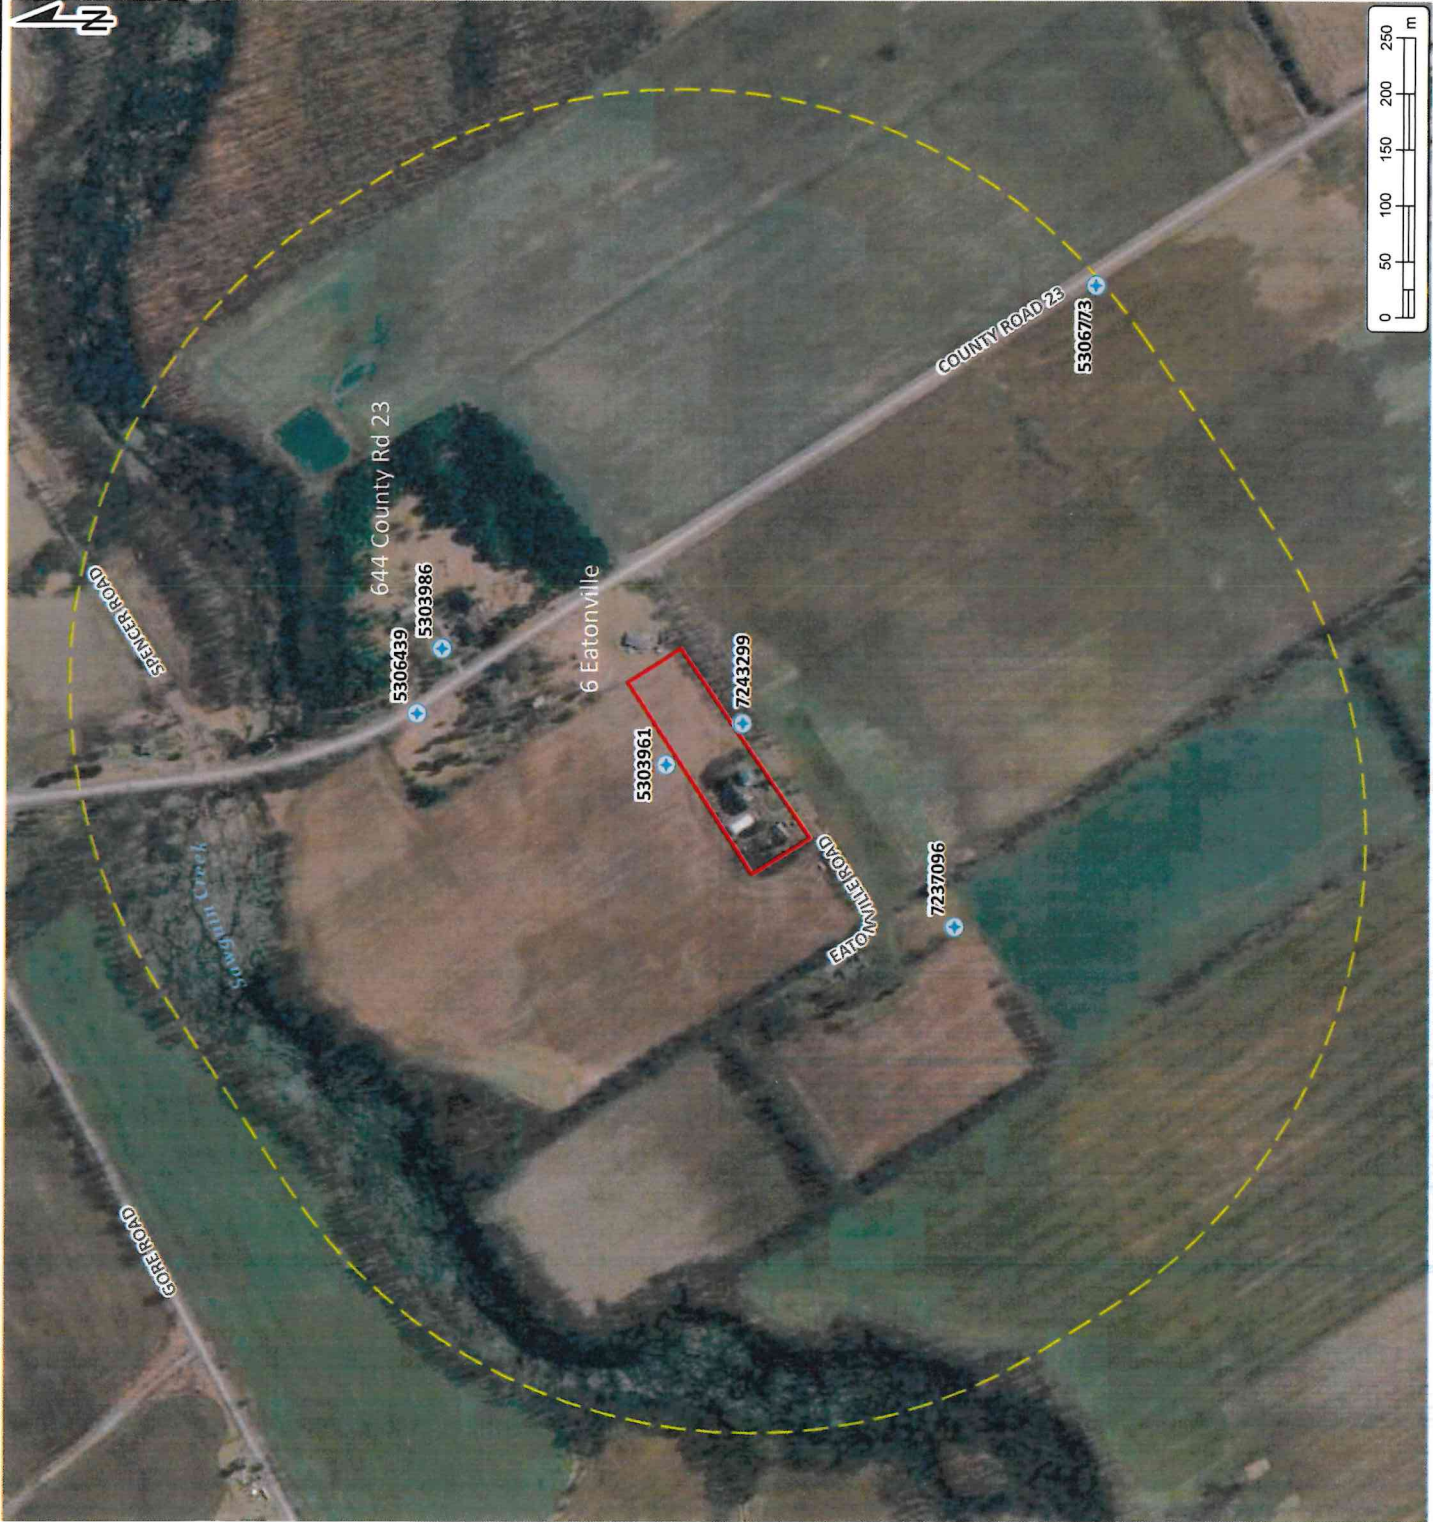
**MECP WELL
RECORDS WITHIN 500M**

Cambium accessed the MECP Water Well Information System (WWIS) to review water well records within 500 m of the Site (MECP, 2023b). A total of six records were identified, three of which describe wells installed into bedrock and three of which describe wells installed into overburden. The records identified one abandoned water supply well and the remaining wells were all water supply wells. The overburden lithology for all records was described as clay and gravel. The bedrock lithology for all records were described as limestone overlain by clay or gravel. The locations of wells records identified within 500 m of the Site are illustrated Figure 3. A summary of water well information, including total depth, static water level, and recommended pumping rate, is presented in Table 2. Further details are provided Appendix D.

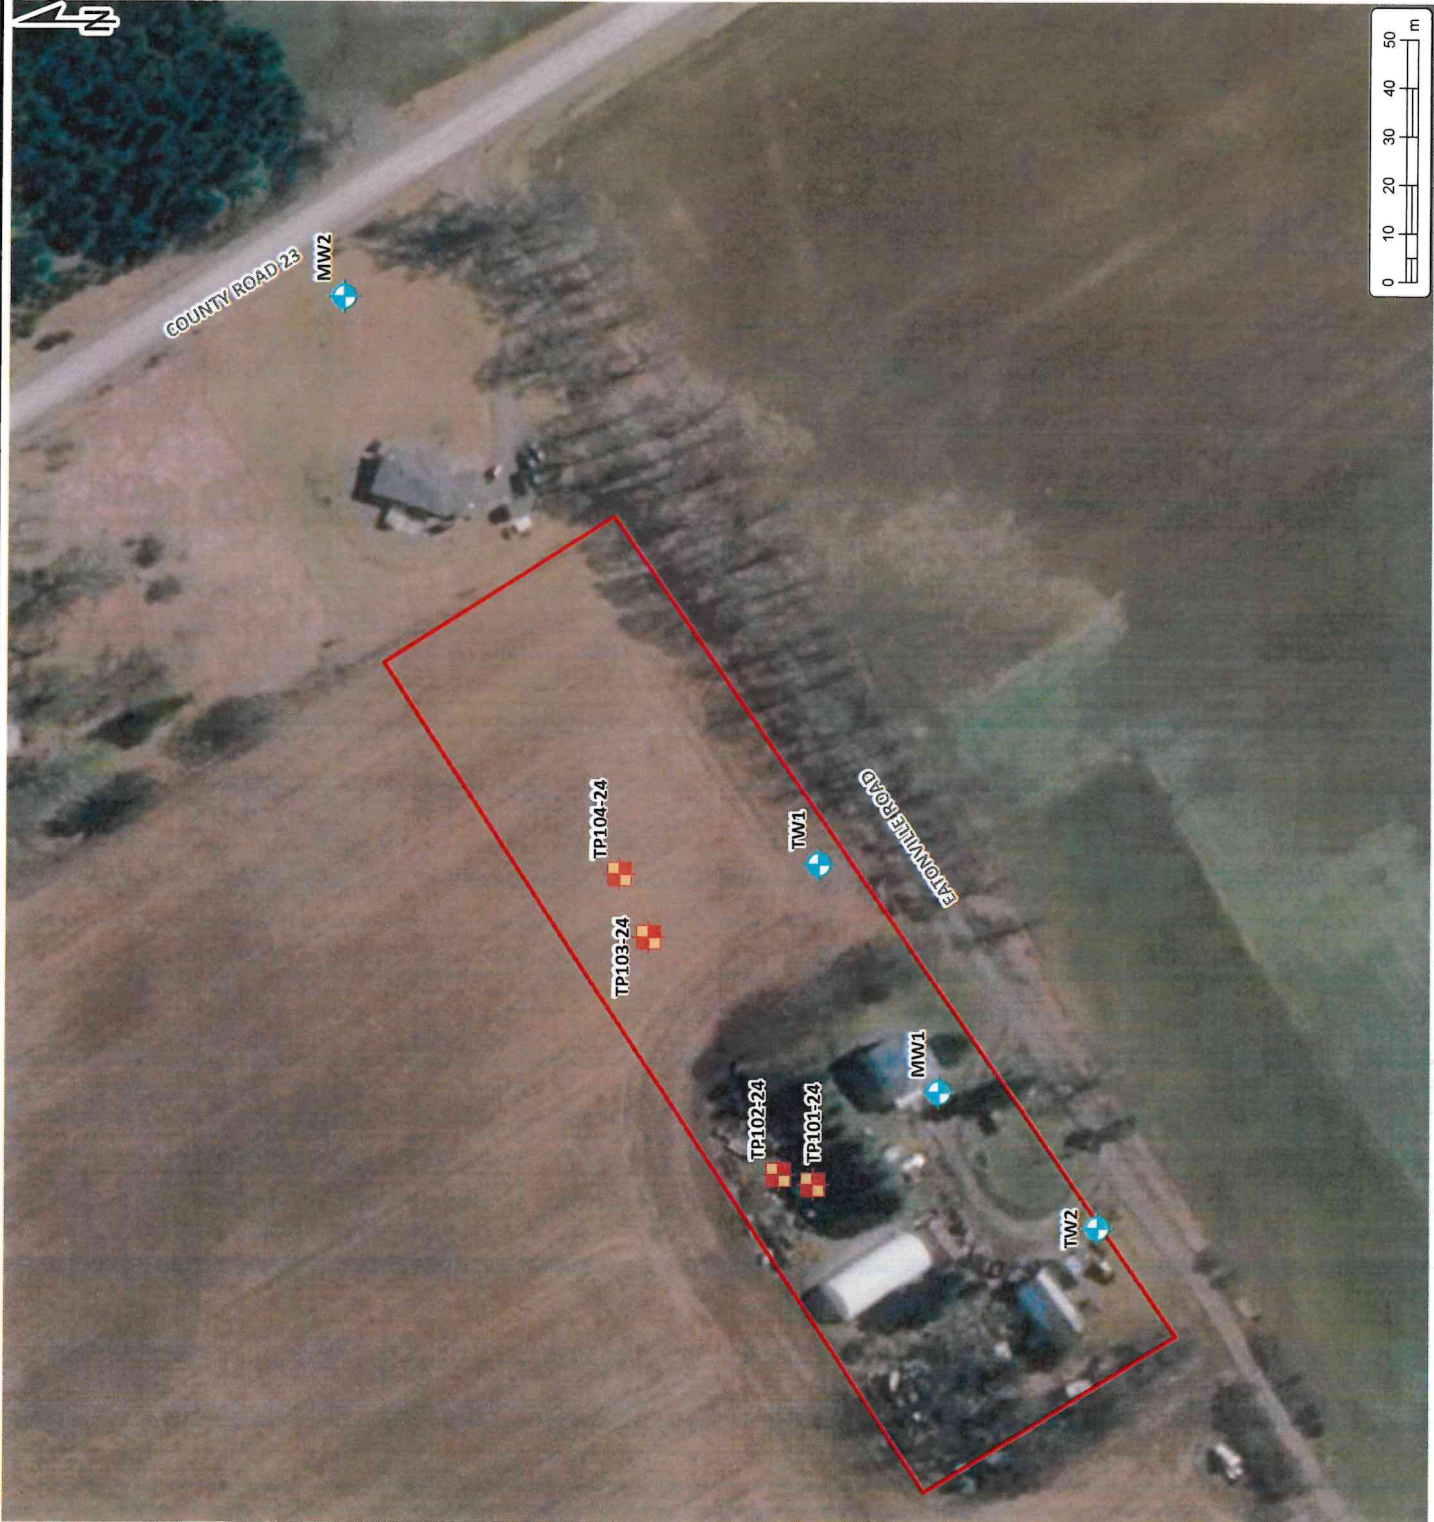
TEST PIT AND WELL LOCATION

Two dug wells were installed, one on the lot to be severed (TW2) and on the adjacent parcel (TW1). Pre-existing wells utilized for the monitoring network were located on the lot to be severed (MW1) and at 6 Eatonville Rd (MW2). Locations of the wells are provided in Figure 4.

Cambium staff completed a test pit investigation on May 31, 2024. The general lithology at the Site is characterized as 0.4 to 0.8 m sandy silt underlain by 1.1 to 1.5 m clayey silts and sand or clayey sand. Test pit practical refusal occurred at depths ranging from 1.58 to 1.85 mbgs. Based on the results of the MECP Well Records Assessment (discussed in more detail in Section 4.1.1), refusal is not expected to be associated with encountering the bedrock surface. Bedrock is expected to be located at depths in the range of 5 to 10 metres below ground surface. Test pit locations are shown in Figure 4 and test pit logs are included in Appendix B. Physical laboratory testing which included grain size distribution analysis, was completed on two soil samples to obtain percolation rate estimates and confirm textural classifications identified during field logging. Analysis results are based on the Unified Soil Classification System scale. A summary of results is provided in Table 1. Complete laboratory analysis reports are provided in Appendix C.

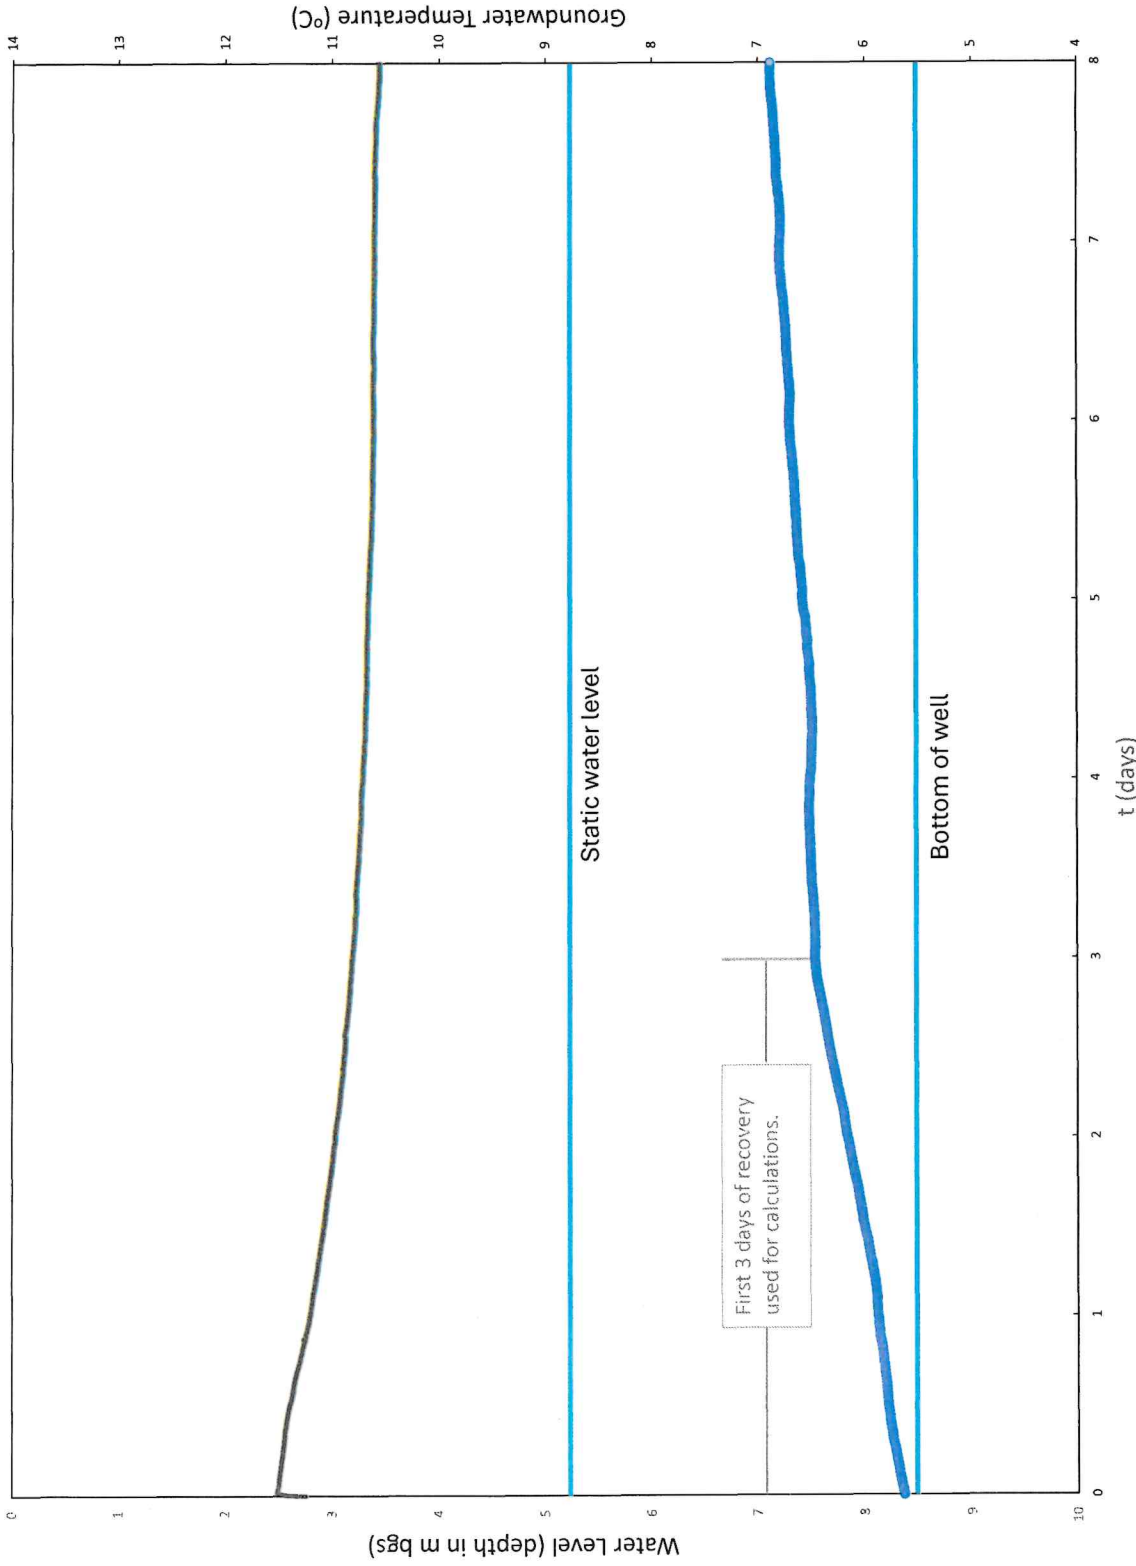
FIGURE 2:
RECOVERY HYDROGRAPH (TW2)
OCTOBER 6-14, 2025

The recovery of the well was monitored for 8 days. A plateau in the recovery curve was observed after 3 days, so the observed recovery up to this point was used for yield calculations. Over the three days, the well recovered from 8.38 m bgs to 7.55 m bgs, for a total of 0.83 m recovered.

Based on the water level recovery data, it was interpreted that the well can supply between 1,270 to 1,400 L/day. The memo notes that the pumping test was conducted under drought conditions, indicating that the well is likely to yield a greater supply during periods of higher groundwater recharge.
