**Hydrogeological Assessment**  
2188 County Road 1,  
Prince Edward County, ON

**File: ASC-1080 100r**  
**January 6, 2026**

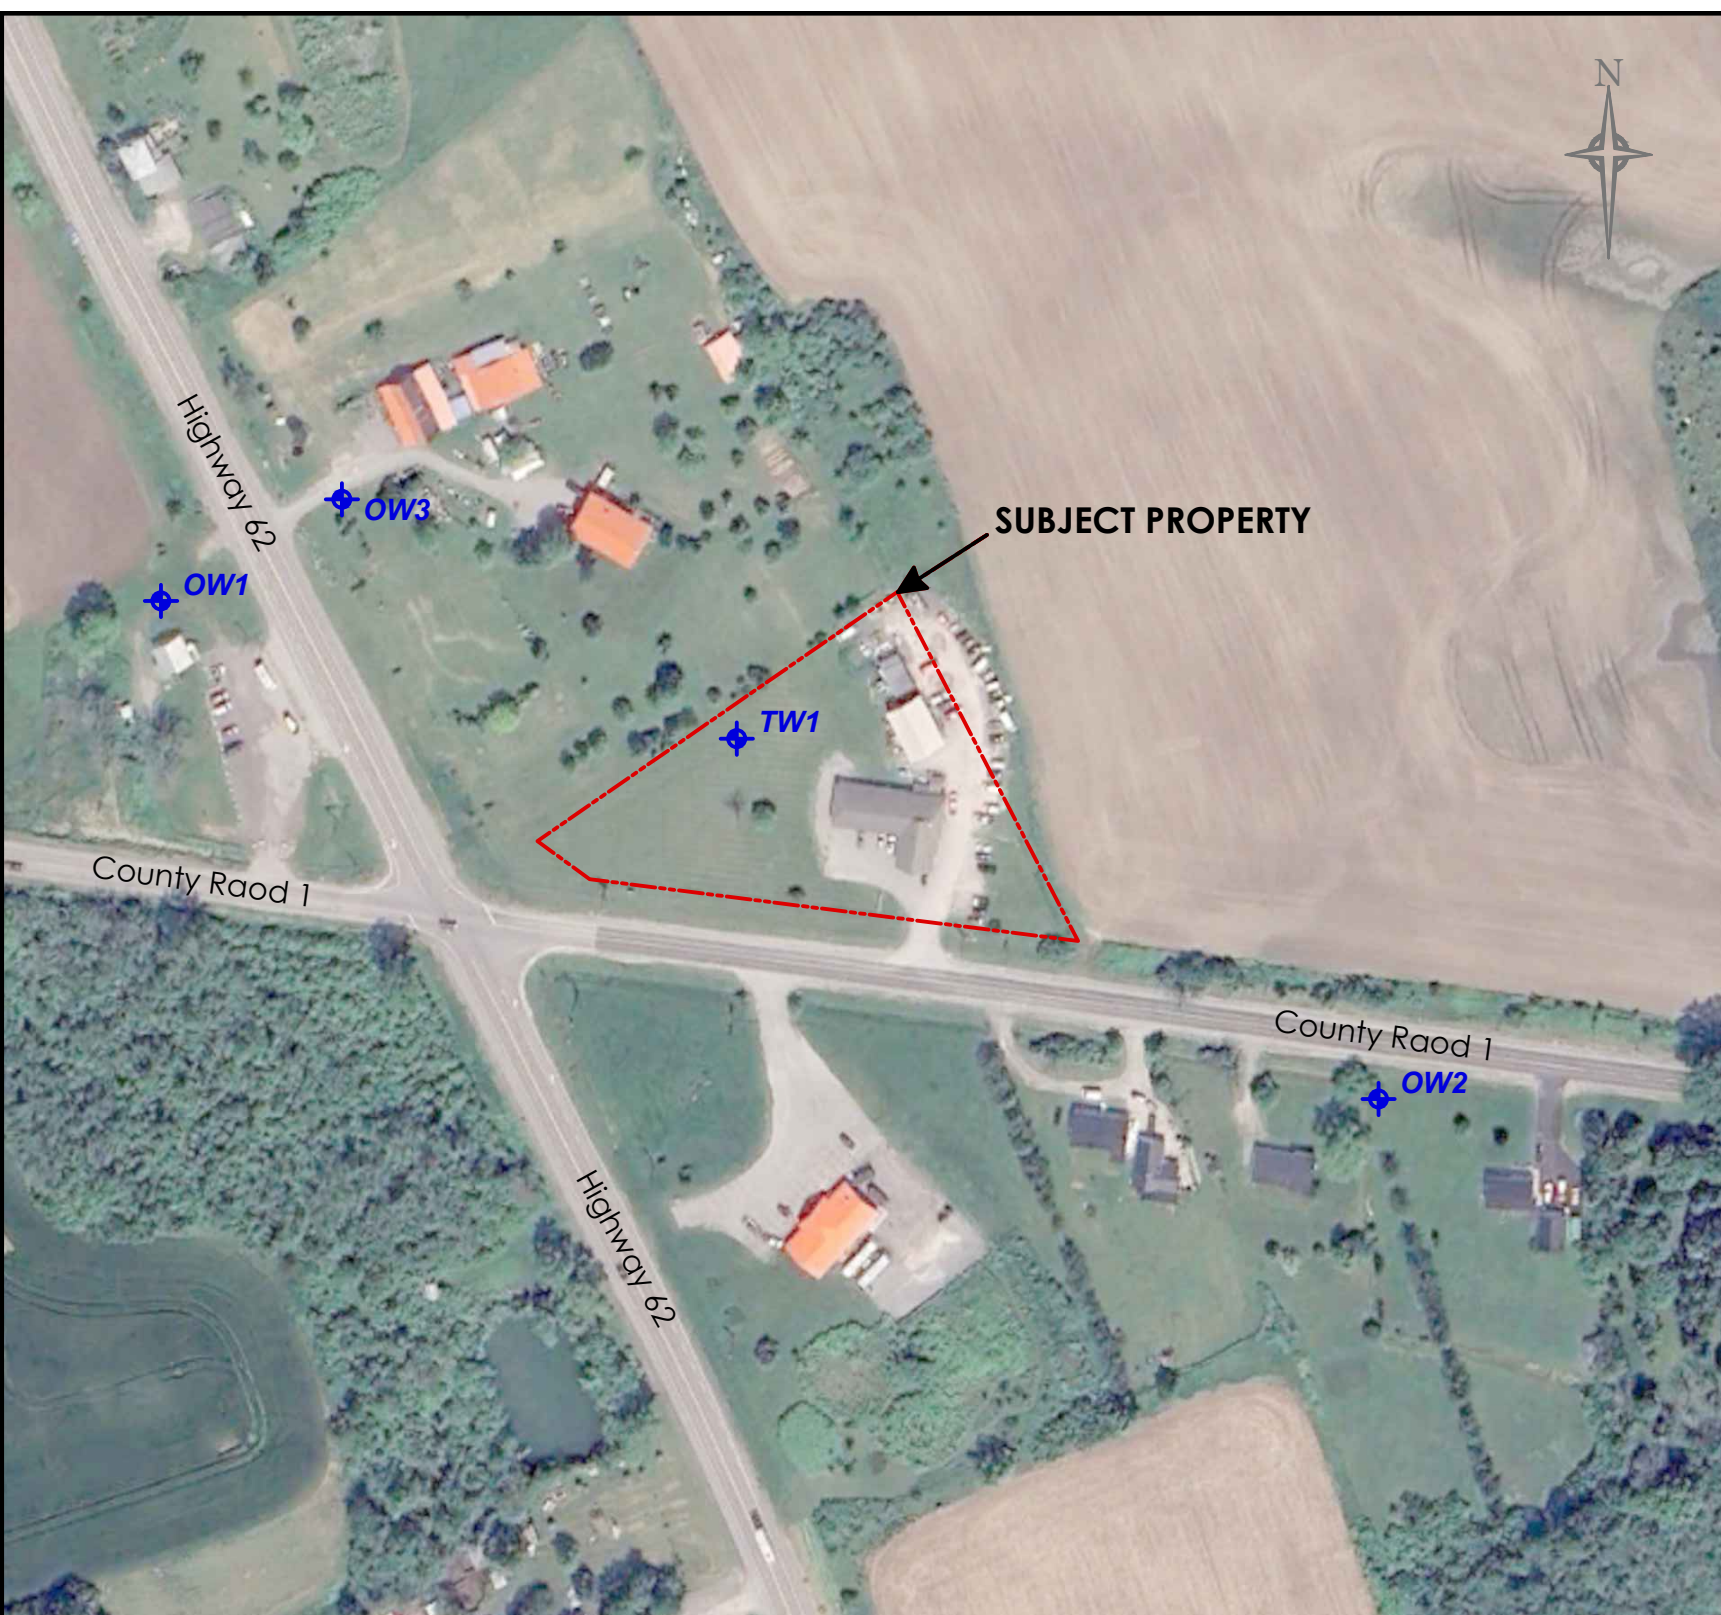
**DRAWING TITLE**  
Site Layout Plan

LEGEND	
	APPROXIMATE LOCATION OF SUBJECT PROPERTY
	APPROXIMATE LOCATION OF TEST WELL
	APPROXIMATE LOCATION OF OBSERVATION WELL

The subject property is an approximate 0.82-hectare parcel of land with approximately 166 metres of frontage along the north side of County Road 1 in Prince Edward County. The property is located approximately 5.0 kilometres northwest of the Village of Bloomfield. A site layout plan may be found in Drawing No. 2 in Appendix A.

Visual observations during field work indicated that the well was constructed and maintained to prevent surface water and other foreign materials from entering the well. The height of the casing above grade meets Ontario's Revised Regulation (RRO) 903, Wells, amended to Ontario Regulation (O Reg) 372/07, under the *Ontario Water Resources Act*. The test well location is shown on Drawing No. 2 in Appendix A.

The effects of interference were monitored during pumping of test well TW1. Neighbouring observation wells were utilized during pumping to assess potential interference. Observation well locations are shown on Drawing No. 2.

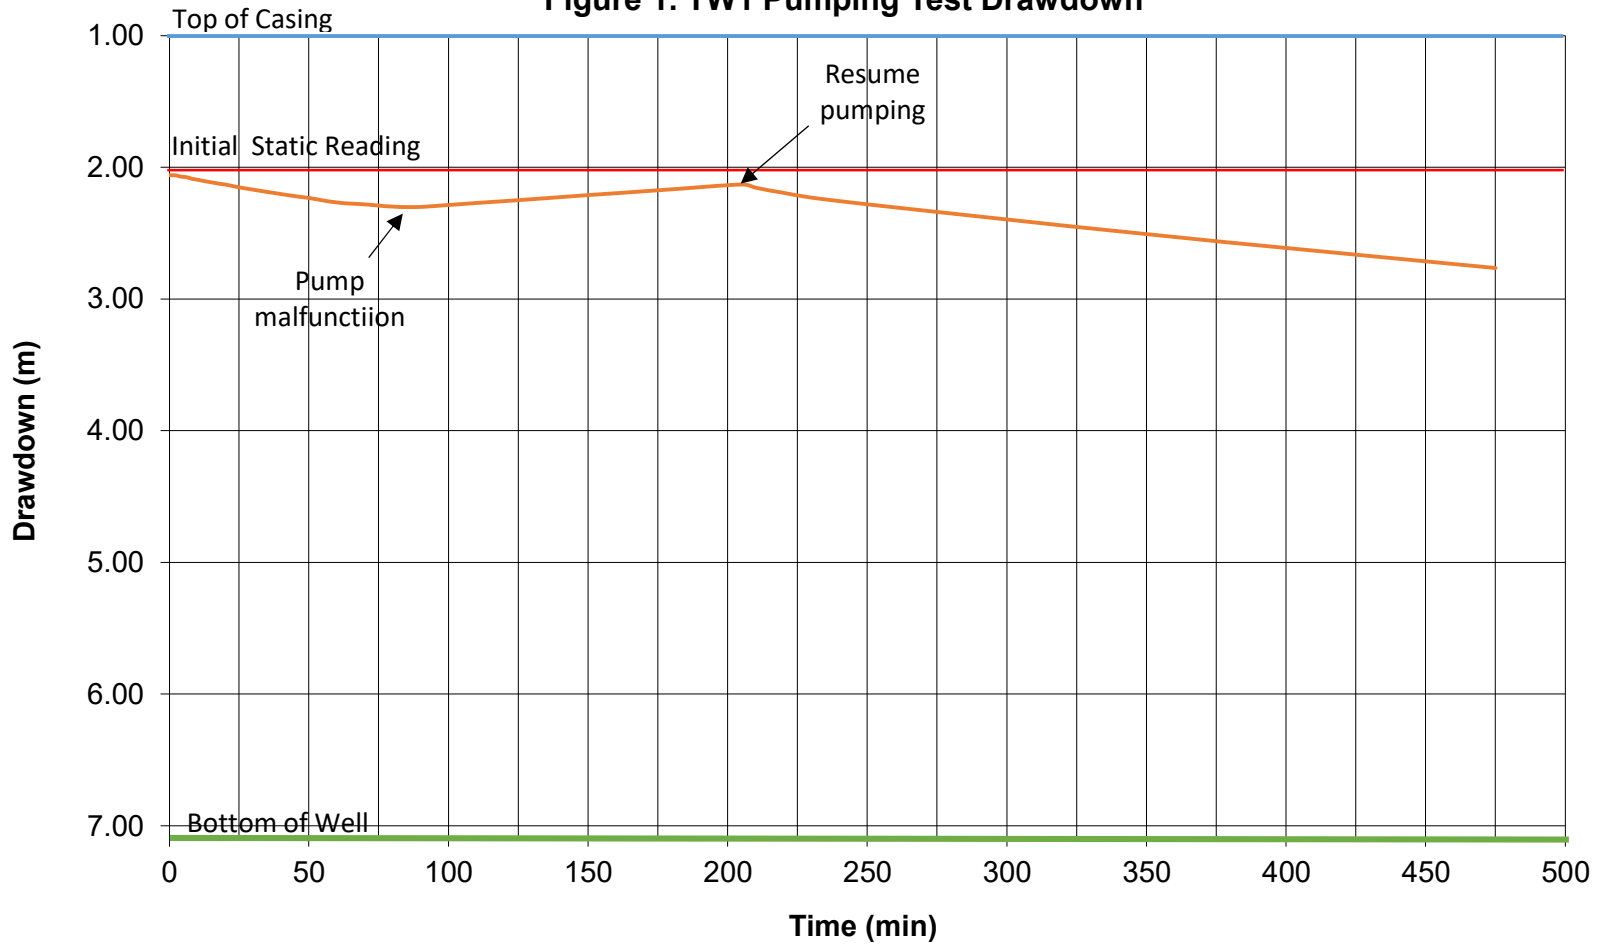
ASC Environmental Inc.  
ASC-1080, Chris Walcott, 2188 County Road 1,  
Prince Edward County, ON  
Figure 1. TW1 Pumping Test Drawdown

$\Delta S_{100-1000min}$	0.91	$Q_{100-1000min}$	40.00	57.6	
	m <sup>2</sup> /day	m <sup>2</sup> /s			
$T_{0-1min}$	6.14	7.11E-05			
$T_{1-10min}$	378.85	4.38E-03			
$T_{10-100min}$	46.96	5.43E-04			
$T_{100-1000min}$	11.63	1.35E-04			
Notes					
1			$\Delta s$	Drawdown over one Log Cycle based on Trend Line	
Q	Volumetric Flow Rate		L/min	Litres per Minute	
T	Coefficient of Transmissivity		gpm	Gallon per Minute

Maximum drawdown was manually measured at approximately 0.66 metres over the duration of the test. At the completion of the pumping test, approximately 87% of the total well supply was remaining. Specific capacity calculated over the final 60 minutes of the pumping test was found to be approximately 466 litres/minute/metre. A plot of drawdown versus time shows a logarithmic relationship (see Figure 1 in Appendix D).

The transmissivity (T) after approximately 100 minutes of pumping was calculated to be  $1.35 \times 10^{-4}$  m<sup>2</sup>/s. Hydraulic Conductivity (K = T/b), where b = 5.03 m (represents approximate aquifer thickness at time of pumping), was determined to be K =  $2.68 \times 10^{-5}$  m/s. The test well recovery and transmissivity data may be found in Appendix D.

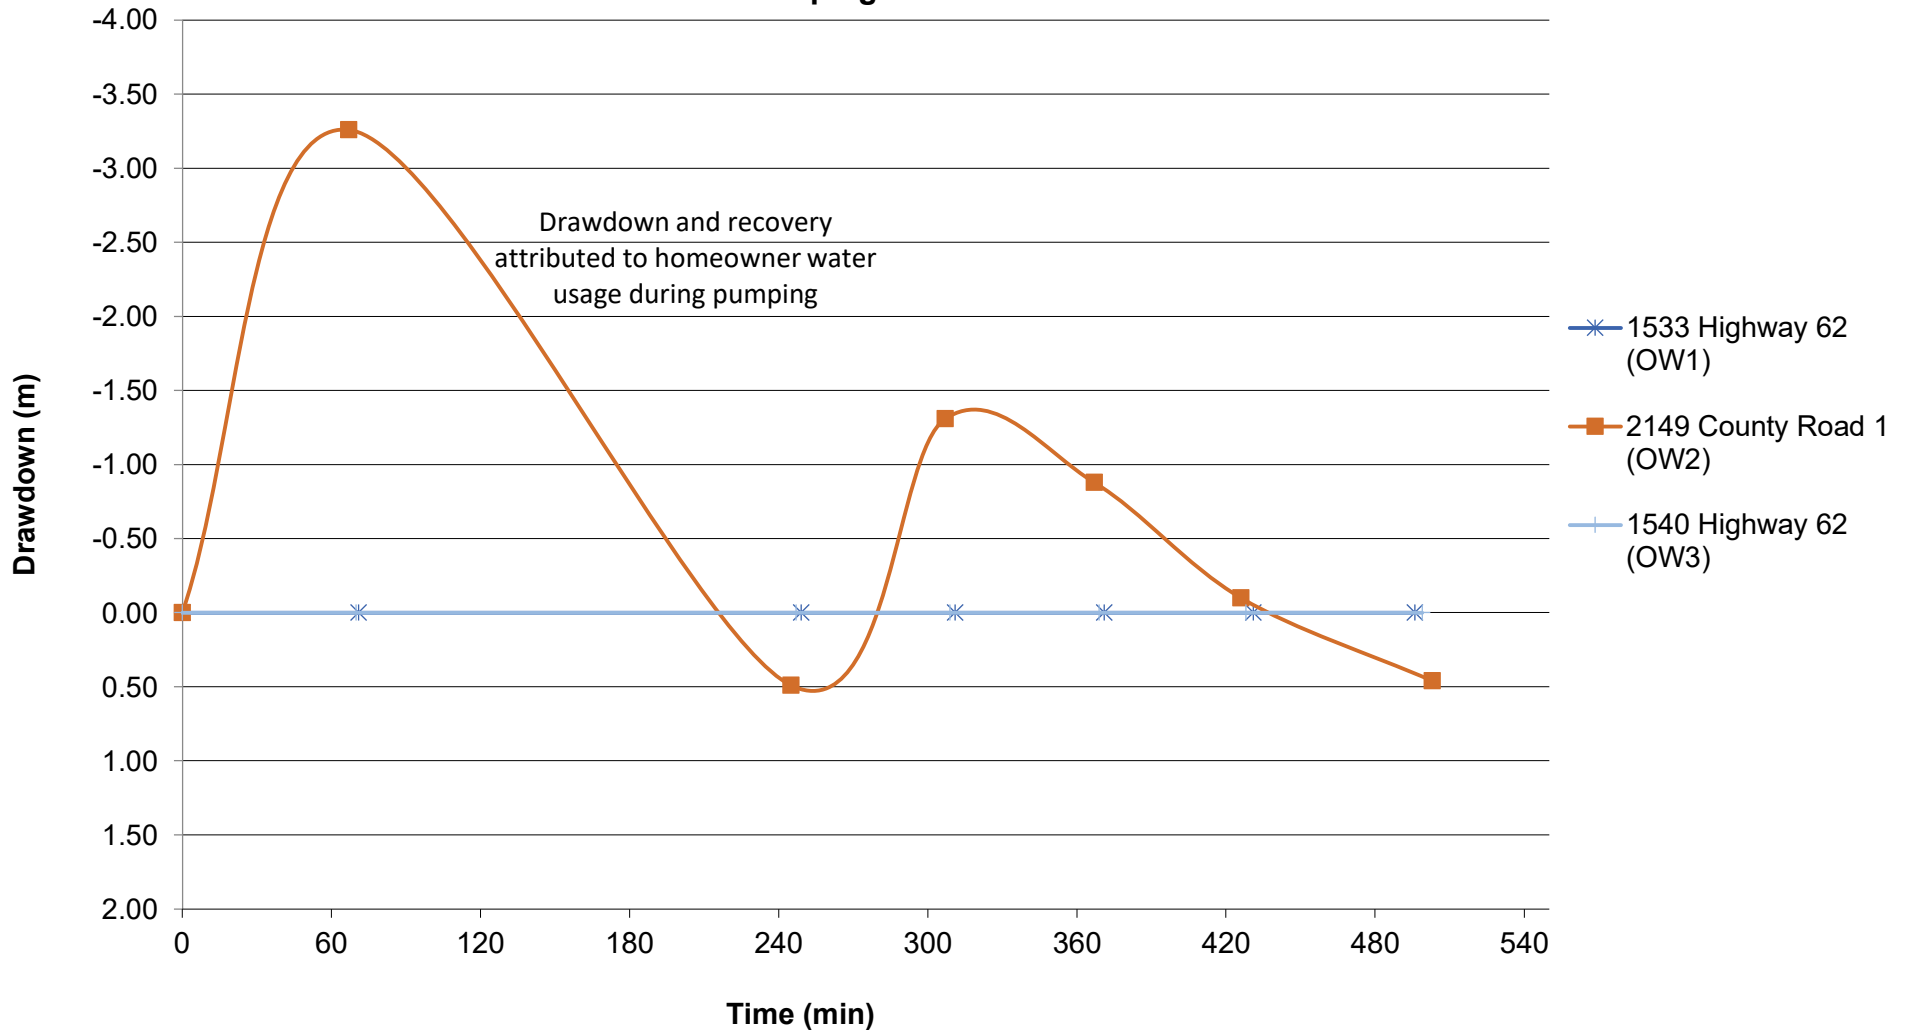
ASC Environmental Inc.  
ASC-1080, Chris Walcott, 2188 County Road 1,  
Prince Edward County, ON  
Figure 2. Pumping Test Influence on Neighbouring Wells  
TW1 Pumping Test Zone of Influence

Table 3. Observation well drawdown during pumping test.

No positive response was observed in the observation wells. A maximum drawdown of 0.49 m was measured in observation well OW2, located approximately 210 metres horizontal distance from the test well. ASC field staff consistently measured water level fluctuations during pumping in OW2. On this basis, ASC attributes the drawdown and recovery to homeowner water usage during pumping and potential water quantity problems resulting from mutual well interference are not expected for the test well TW1.

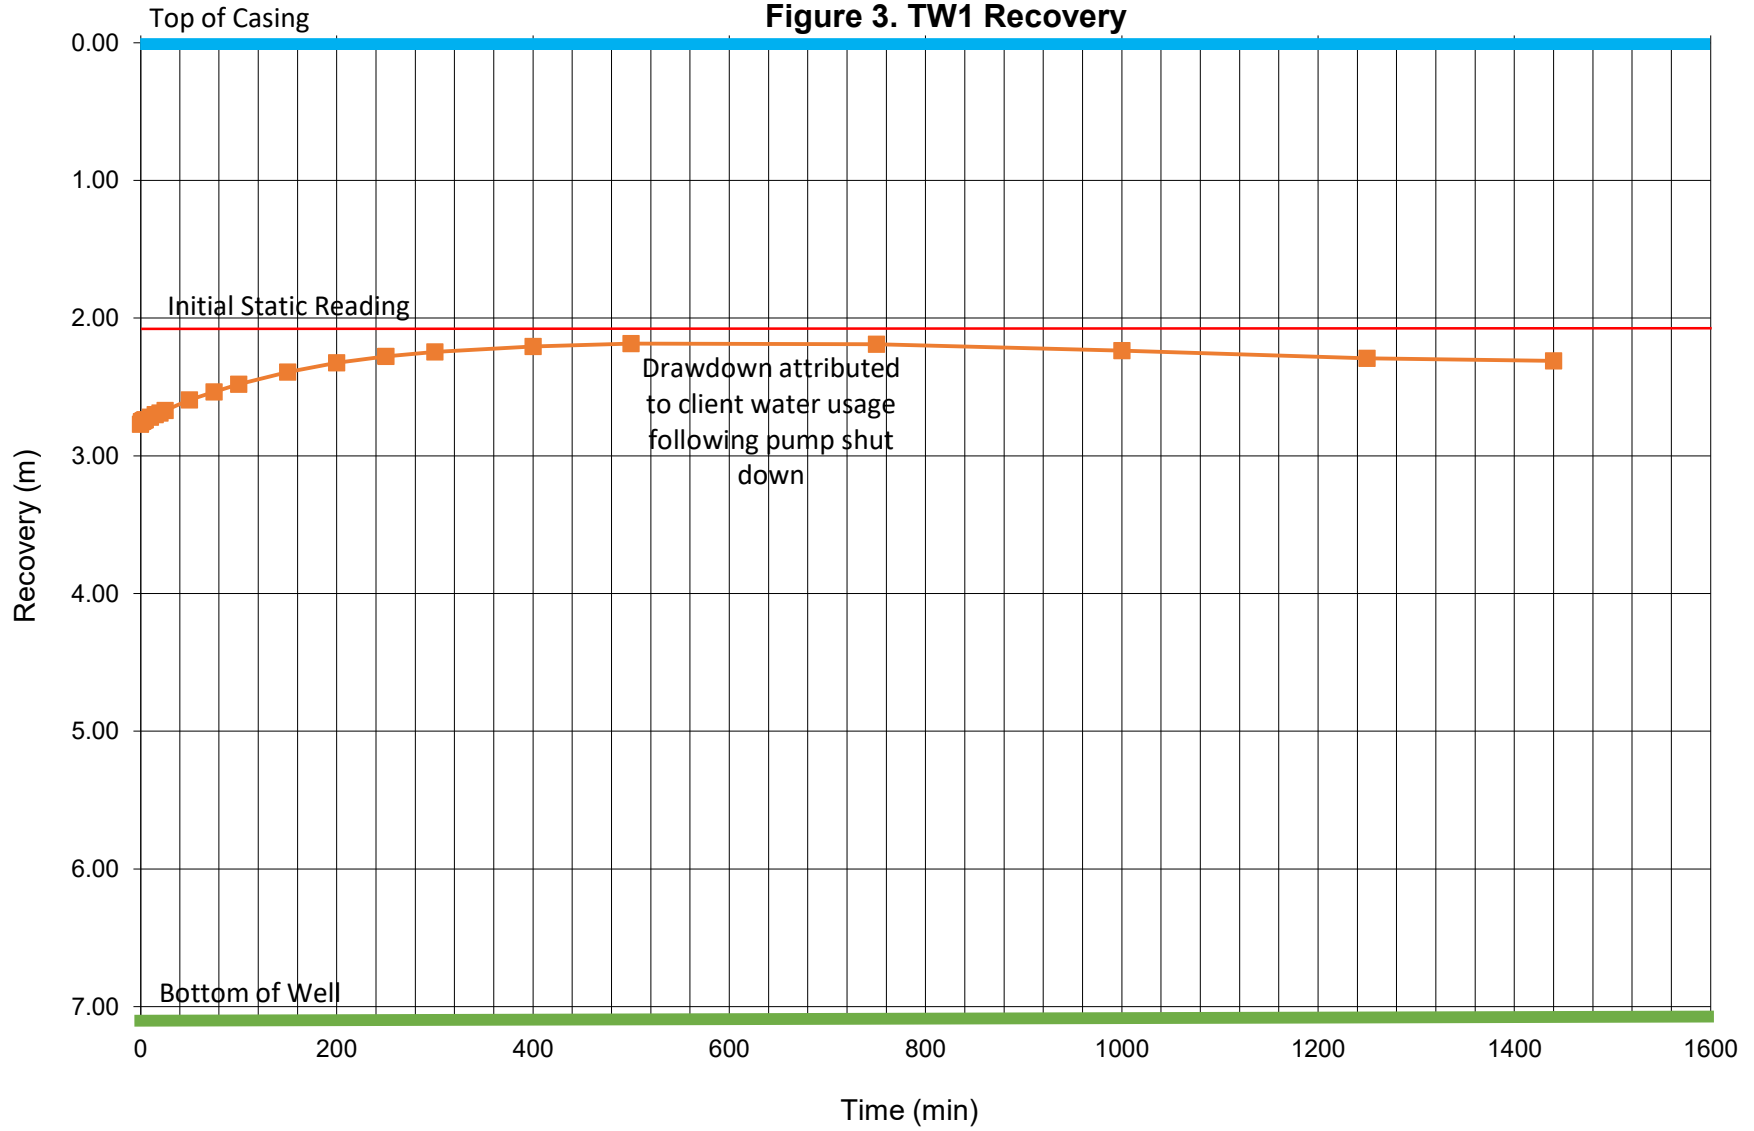
ASC Environmental Inc.  
ASC-1080, Chris Walcott, 2188 County Road 1,  
Prince Edward County, ON  
Figure 3. TW1 Recovery

<b>Pumping Test - Recovery</b>		<b>Test Well:</b>	<b>TW1</b>
	Project No.:	ASC-1080	Date:	9-Dec-25
	Client:	Chris Walcott	Recorded By: T.C	
	Location:	2188 County Road 1, Prince Edward County, ON		
	Test Well			
Pumping	Elapsed Time (min)	Well Level (WL) (m)	Drawdown (m)	
0	0	2.77	0.71	
0	1	2.75	0.69	
0	2	2.75	0.69	
0	3	2.75	0.69	
0	4	2.74	0.68	
0	5	2.74	0.68	
0	10	2.72	0.66	
0	15	2.70	0.64	
0	20	2.69	0.63	
0	25	2.67	0.61	
0	50	2.60	0.54	
0	75	2.54	0.48	
0	100	2.48	0.42	
0	150	2.39	0.33	
0	200	2.32	0.26	
0	250	2.28	0.22	
0	300	2.25	0.19	
0	400	2.21	0.15	
0	500	2.18	0.12	
0	750	2.19	0.13	
0	1000	2.24	0.18	
0	1250	2.29	0.23	
0	1440	2.31	0.25	
WL at 95% Recovery =		2.09		
Notes		Well in-use following the completion of the pumping test, maximum observed recovery within 24 hrs (83%)

Section 4.3.1 of the Ministry of Environment, Conservation and Parks (MECP) (*previously known as the Ministry of Environment*) D-5-5 Procedure, Technical Guideline for Private Wells: Water Supply Assessment requires that water level recovery must be monitored in the test well for the lesser of 95% recovery or 24 hours. Total drawdown over the period of pumping was manually measured at approximately 0.66 m. Maximum observed recovery within the 24-hour period following pump shutdown was 83%. The test well presently supplies water to the on-site commercial structure. Following completion of the pumping test, TW1 was in-use and skewed the recovery data. Based on the minimal measured drawdown (0.66 m), well supply remaining following pump shut down (87%), and TW1's ability to recover to 83% while in-use following pump shutdown, the well is determined to be sufficiently able to meet the peak usage periods, recover and meet the daily requirement design flows for the proposed Zoning By-Law Amendment application and proposed future commercial development.
