PUBLIC INFORMATION CENTRE

OUTLET BRIDGE REHABILITATION

Welcome to the Public Information Centre for the rehabilitation of Outlet Bridge within the County of Prince Edward.

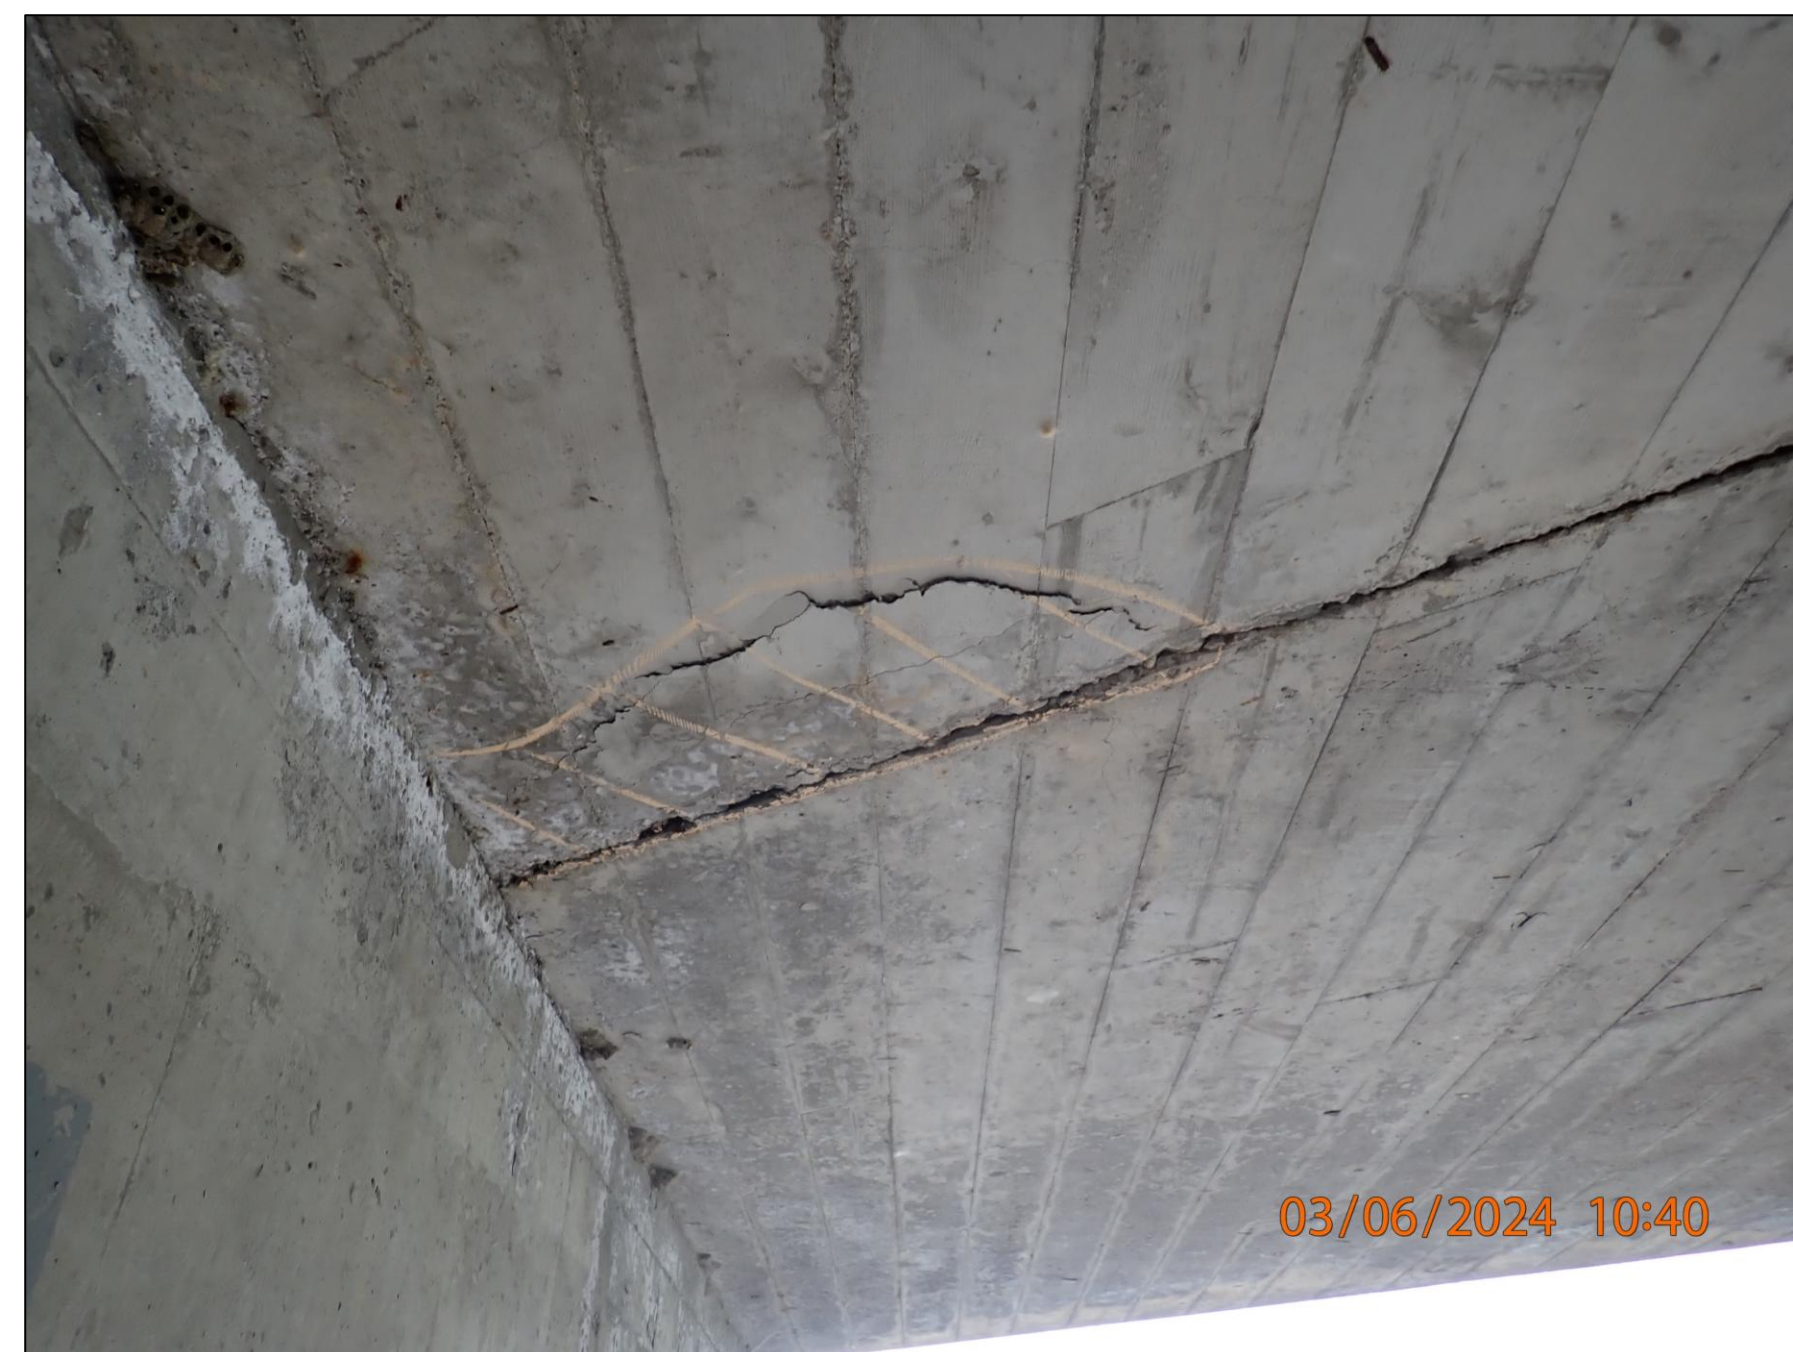
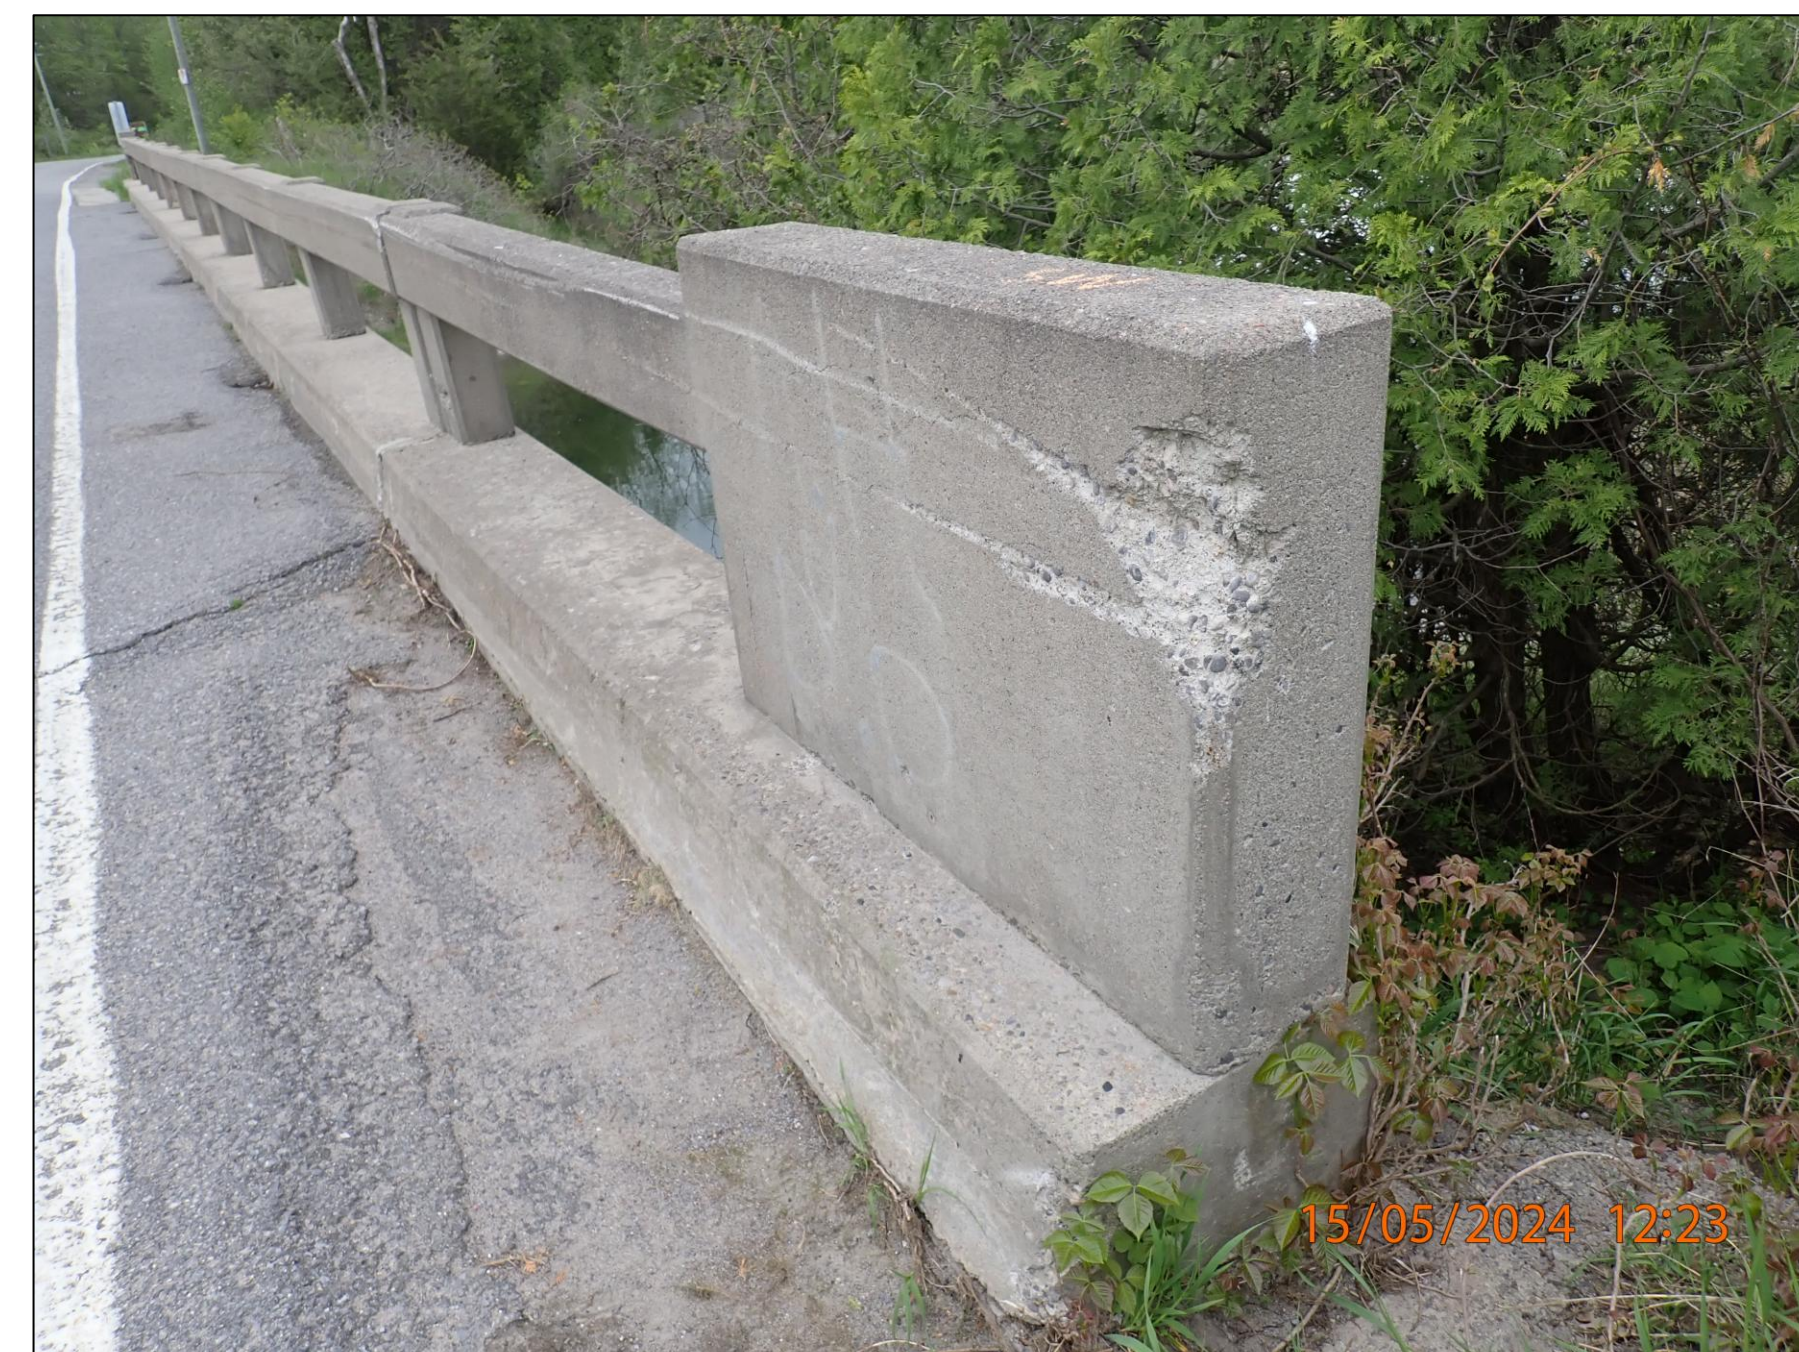
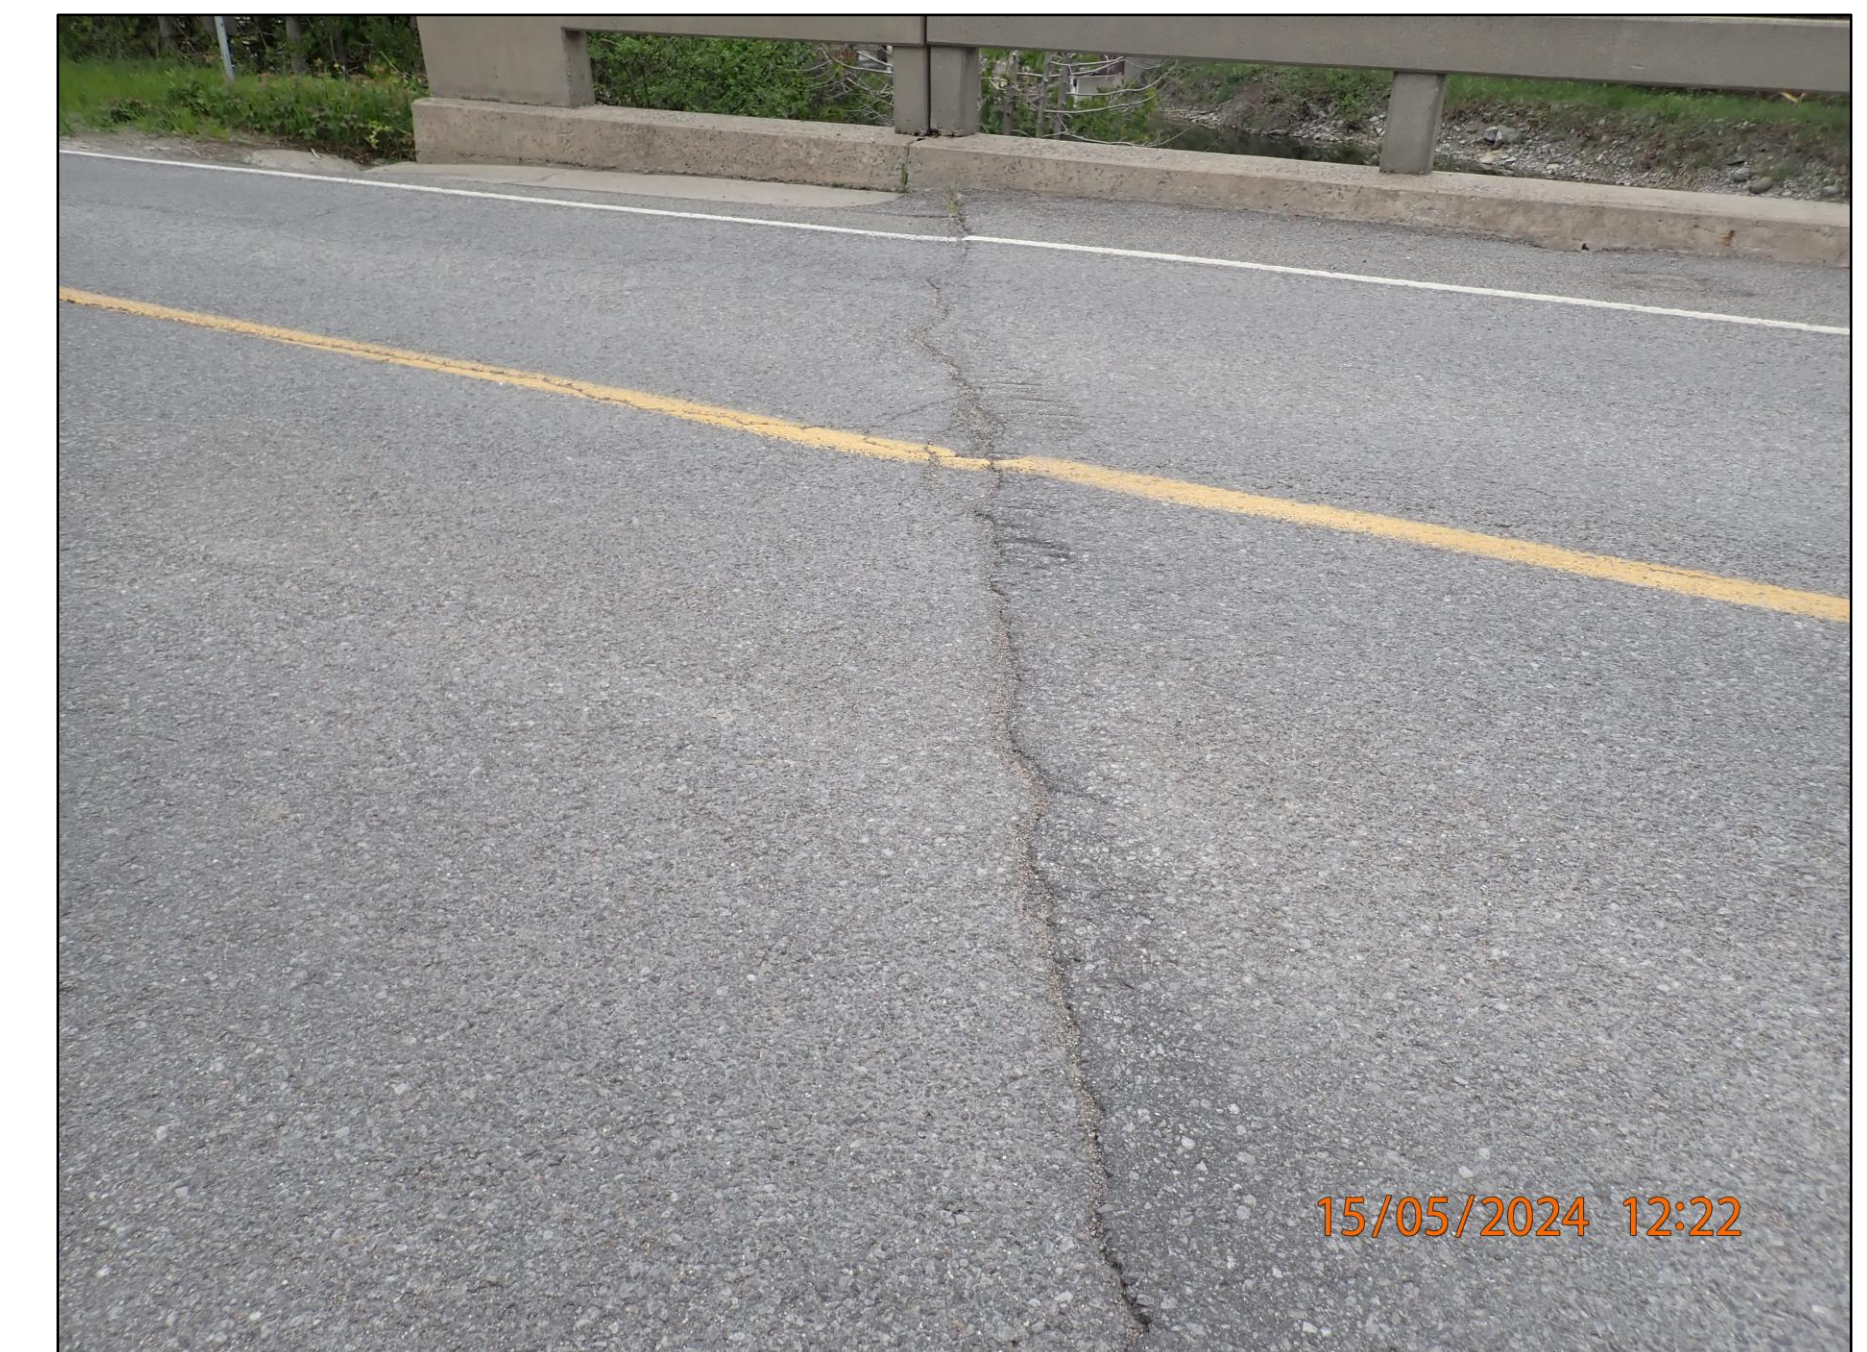
- Outlet Bridge is a three span structure originally constructed in 1958.
- The three span structure is a continuous thick concrete deck slab supported on reinforced concrete abutments and two piers.
- The structure has a total deck length of 25.7 m with an asphalt wearing surface, and overall width of 9.8m. It carries 1 lane of traffic each direction running west and east.
- The OSIM report dated July 2022, noted several defects on the superstructure and concrete defects on the abutment walls.

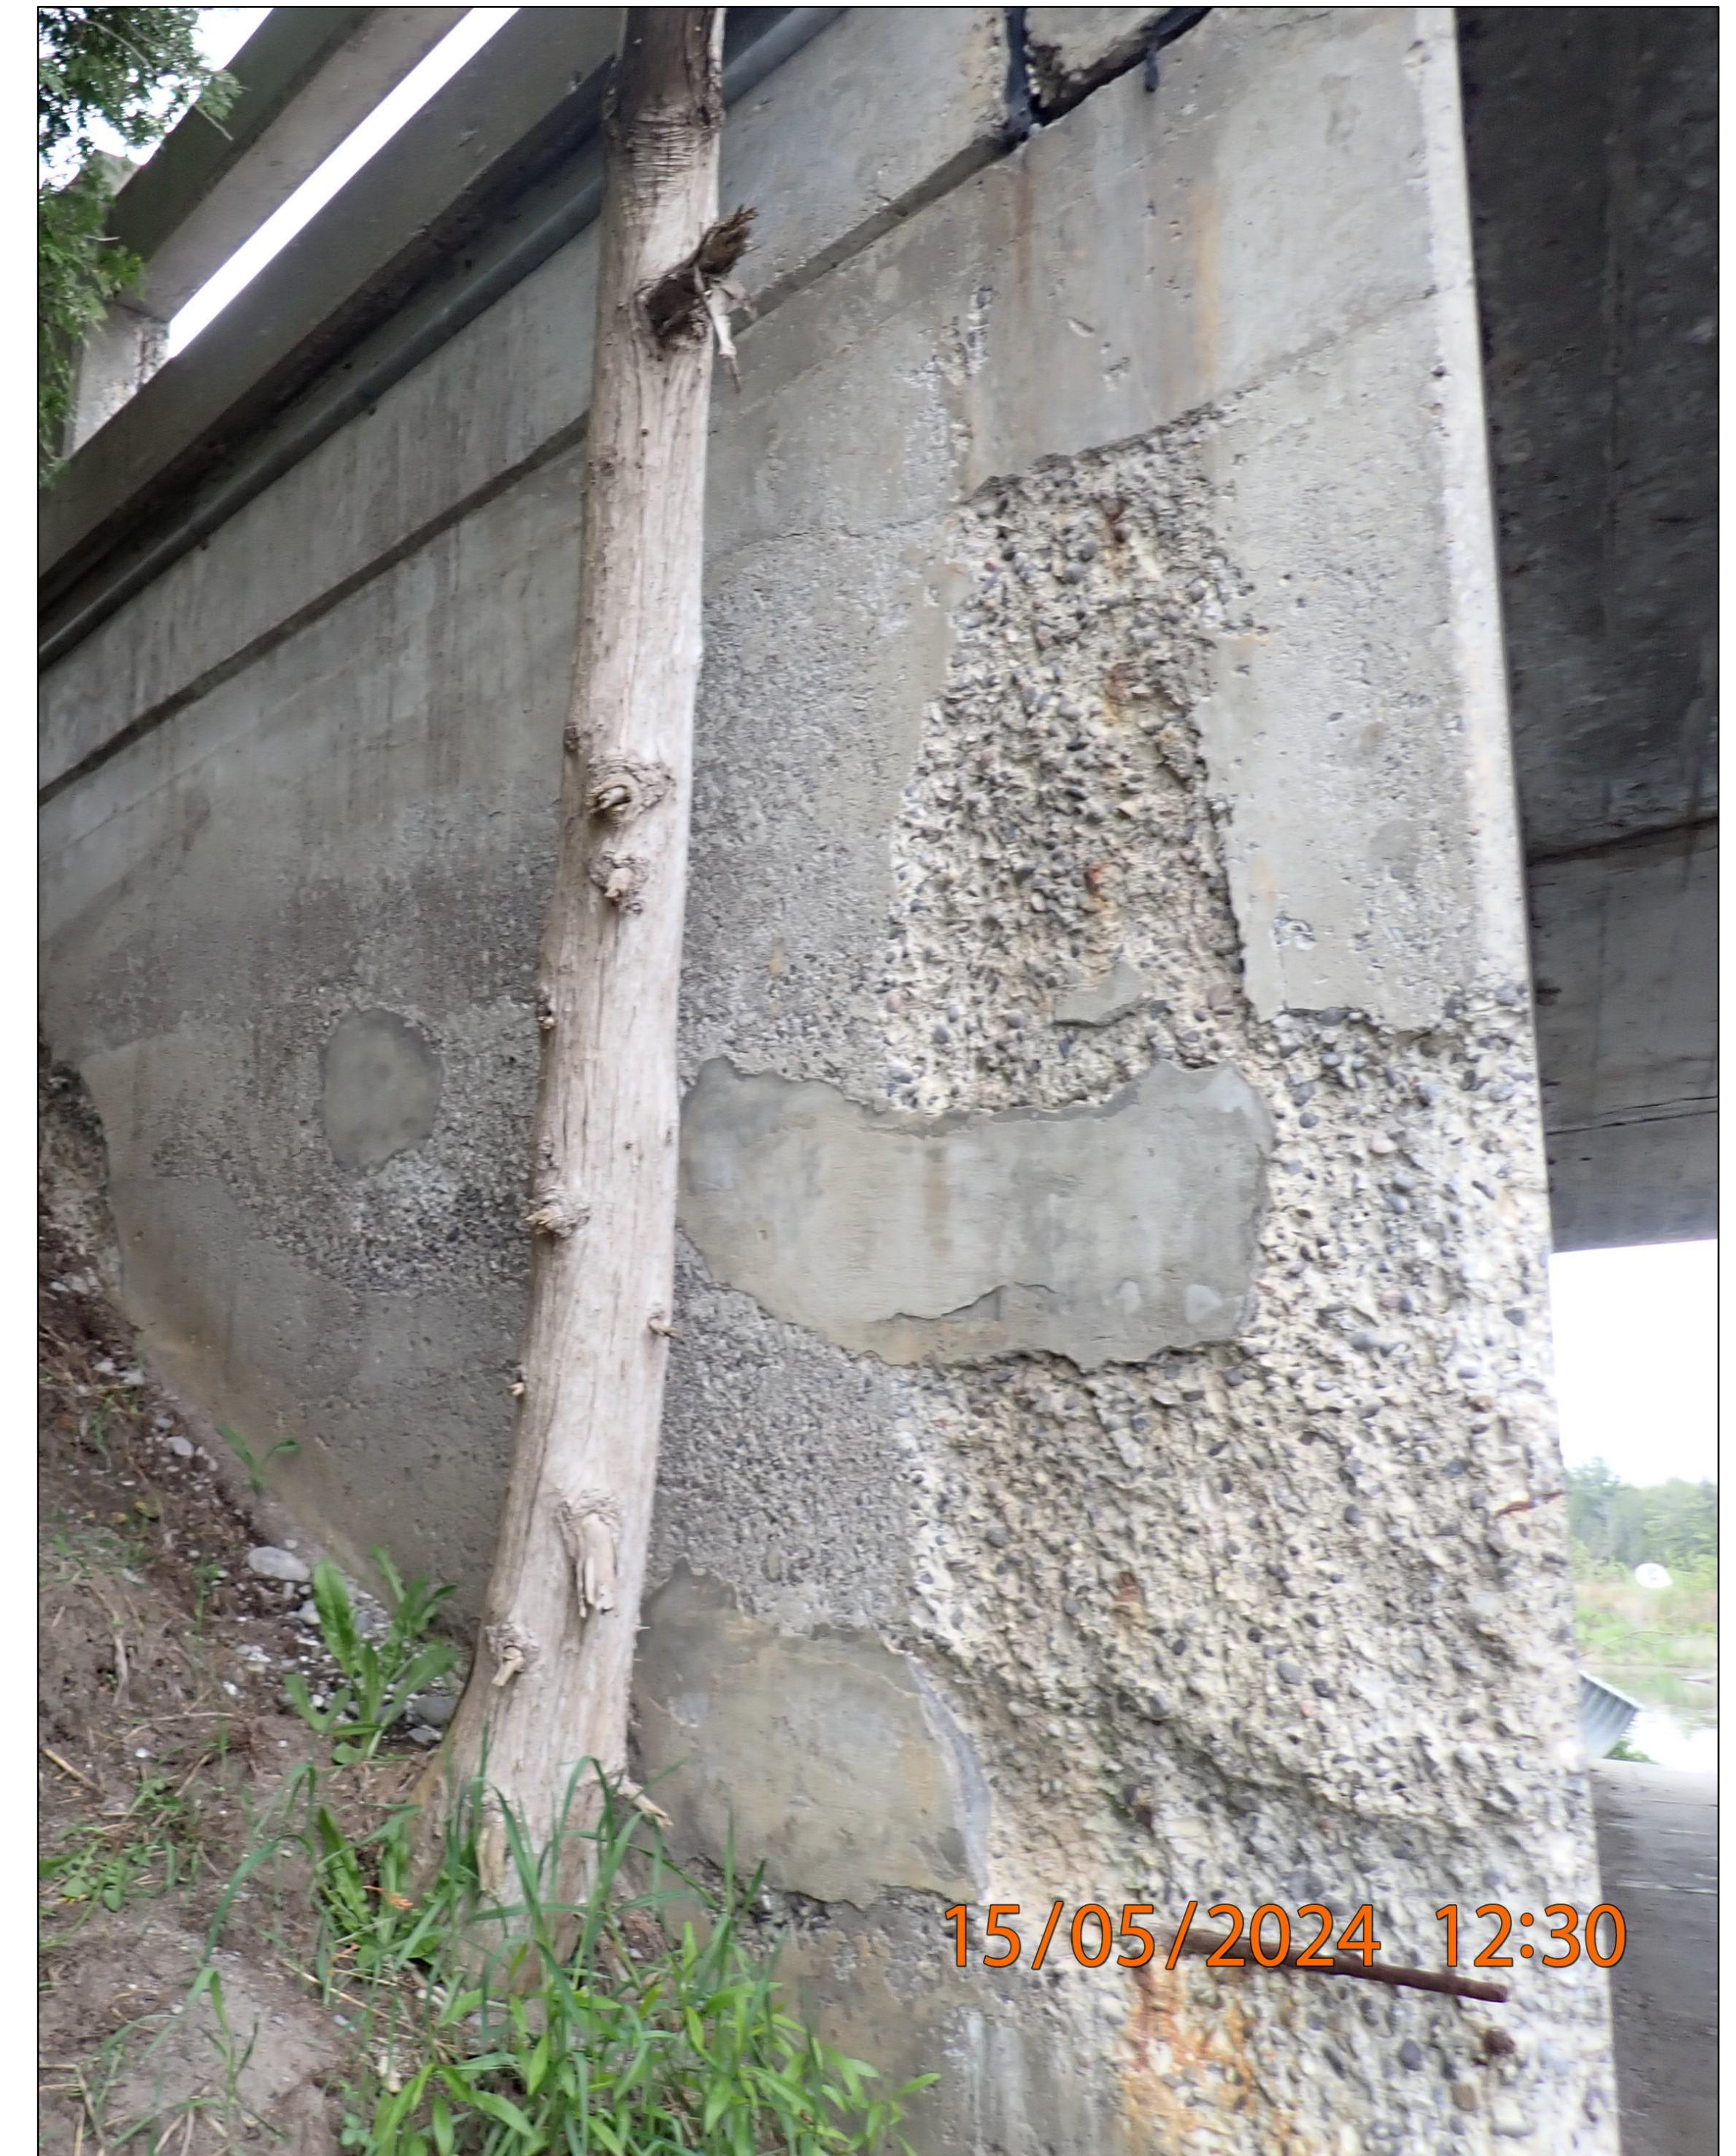
An Enhanced OSIM inspection completed in 2024 highlighted the following structural deficiencies:

- Medium to severe raveling and light wheel track rutting and settlement on approach wearing surfaces
- Medium unsealed cracks, medium raveling and wheel track rutting throughout the deck wearing surface.
- Absence of standard sawcut groove at expansion joints, causing wide irregular transverse cracks above the joints at both deck ends.
- Delamination and spalling on concrete deck top estimated to exceed 50 m².
- Medium to severe cracking, delamination, spalling and scaling on soffit and fascia.
- Medium to severe corrosion on all eight deck drains.
- Narrow to wide cracks, severe scaling and disintegration on wingwalls.
- Medium to severe erosion and loss of slope protection observed at all four embankments.

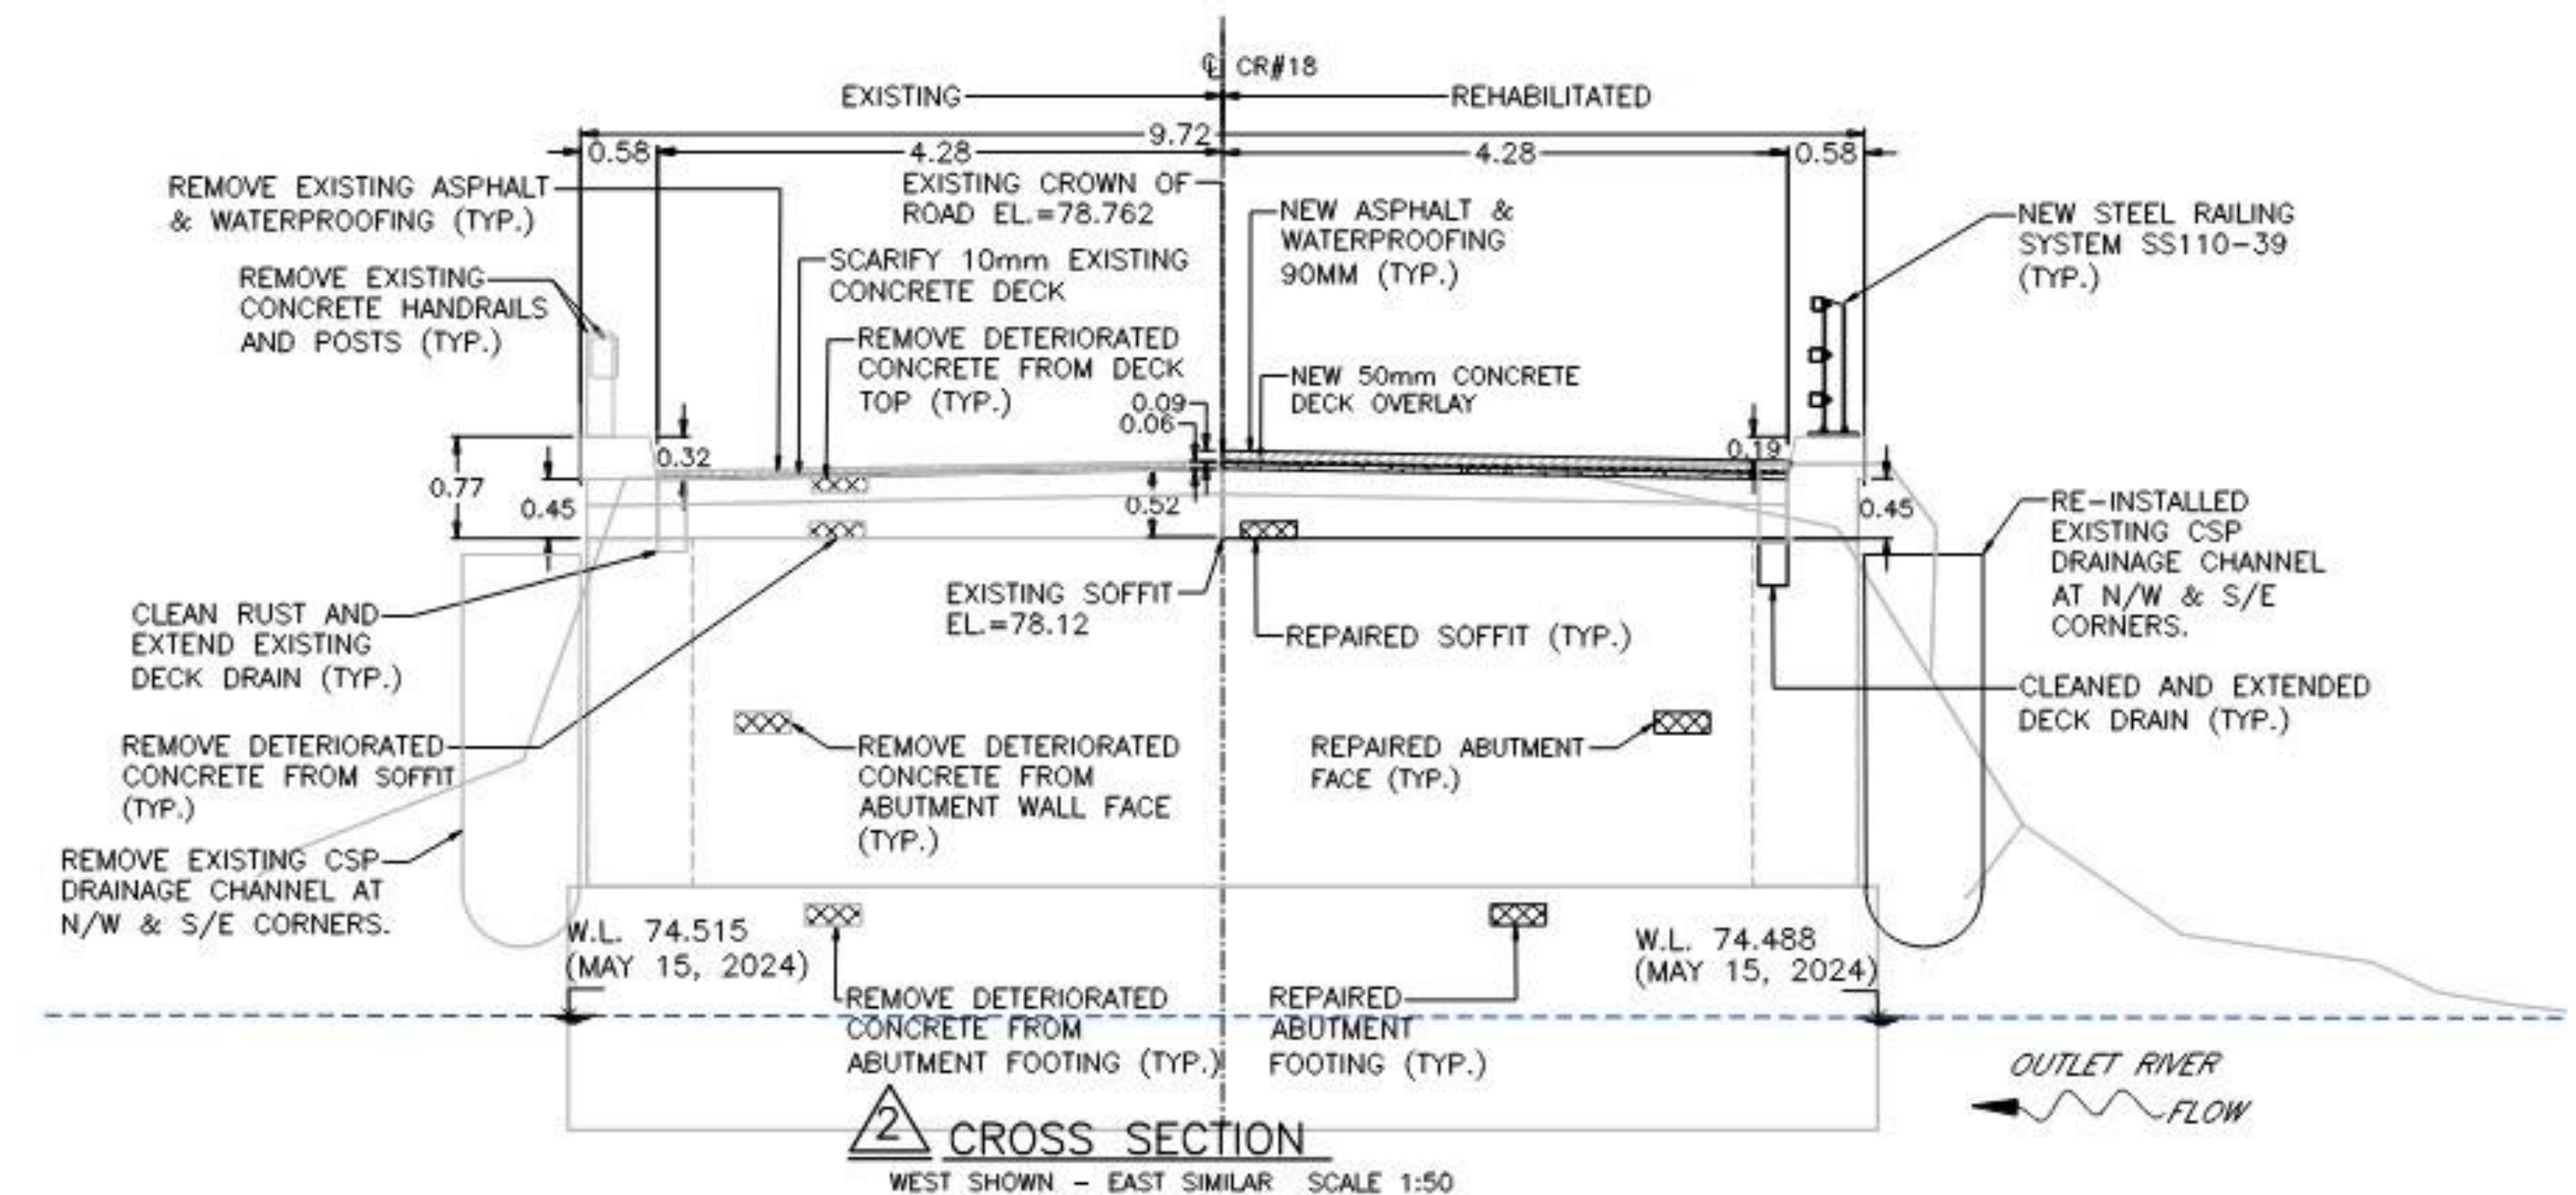
Structural Rehabilitation with New Traffic Barrier

- Concrete patch repair to structure and pier shafts
- New waterproofing and asphalt overlay
- New approach slabs
- Bridge barrier system replacement

Proposed Bridge Barrier System

- Steel tube railing system designed for vehicular traffic

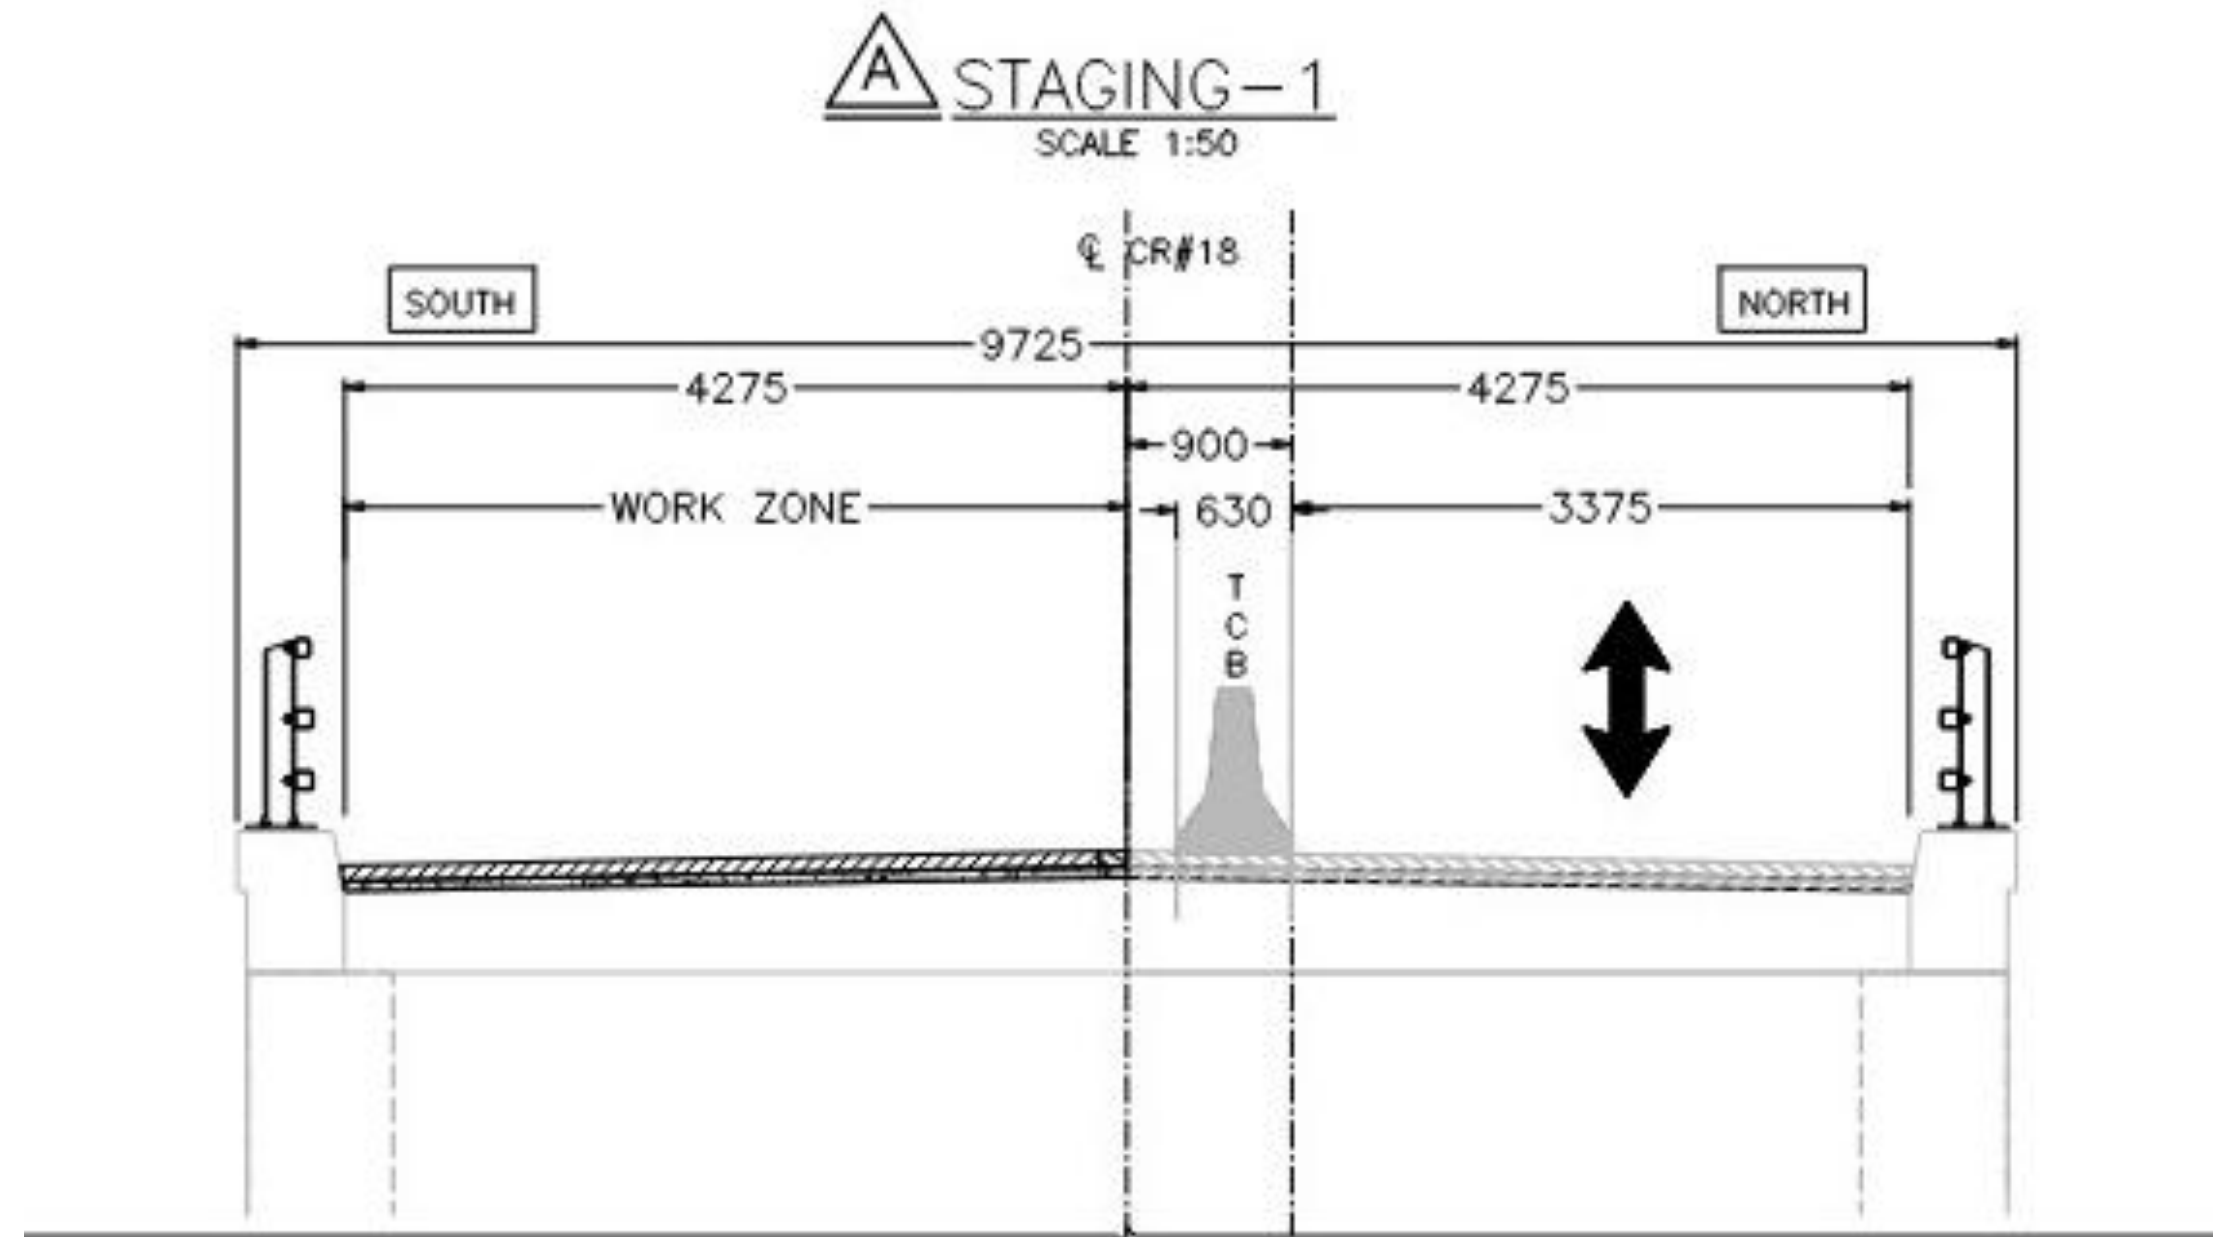
STAGE 1

- Stage 1: South lane to remain open while work on the north side is completed. Temporary concrete barrier to be installed and traffic to be controlled via portable temporary traffic signals.

- Two stage construction with a single lane closure and one lane of traffic remaining open for the duration of construction. A minimum lane width of 3.375 m will be maintained during construction, and the duration of each temporary lane closure is anticipated to be 8-10 weeks.

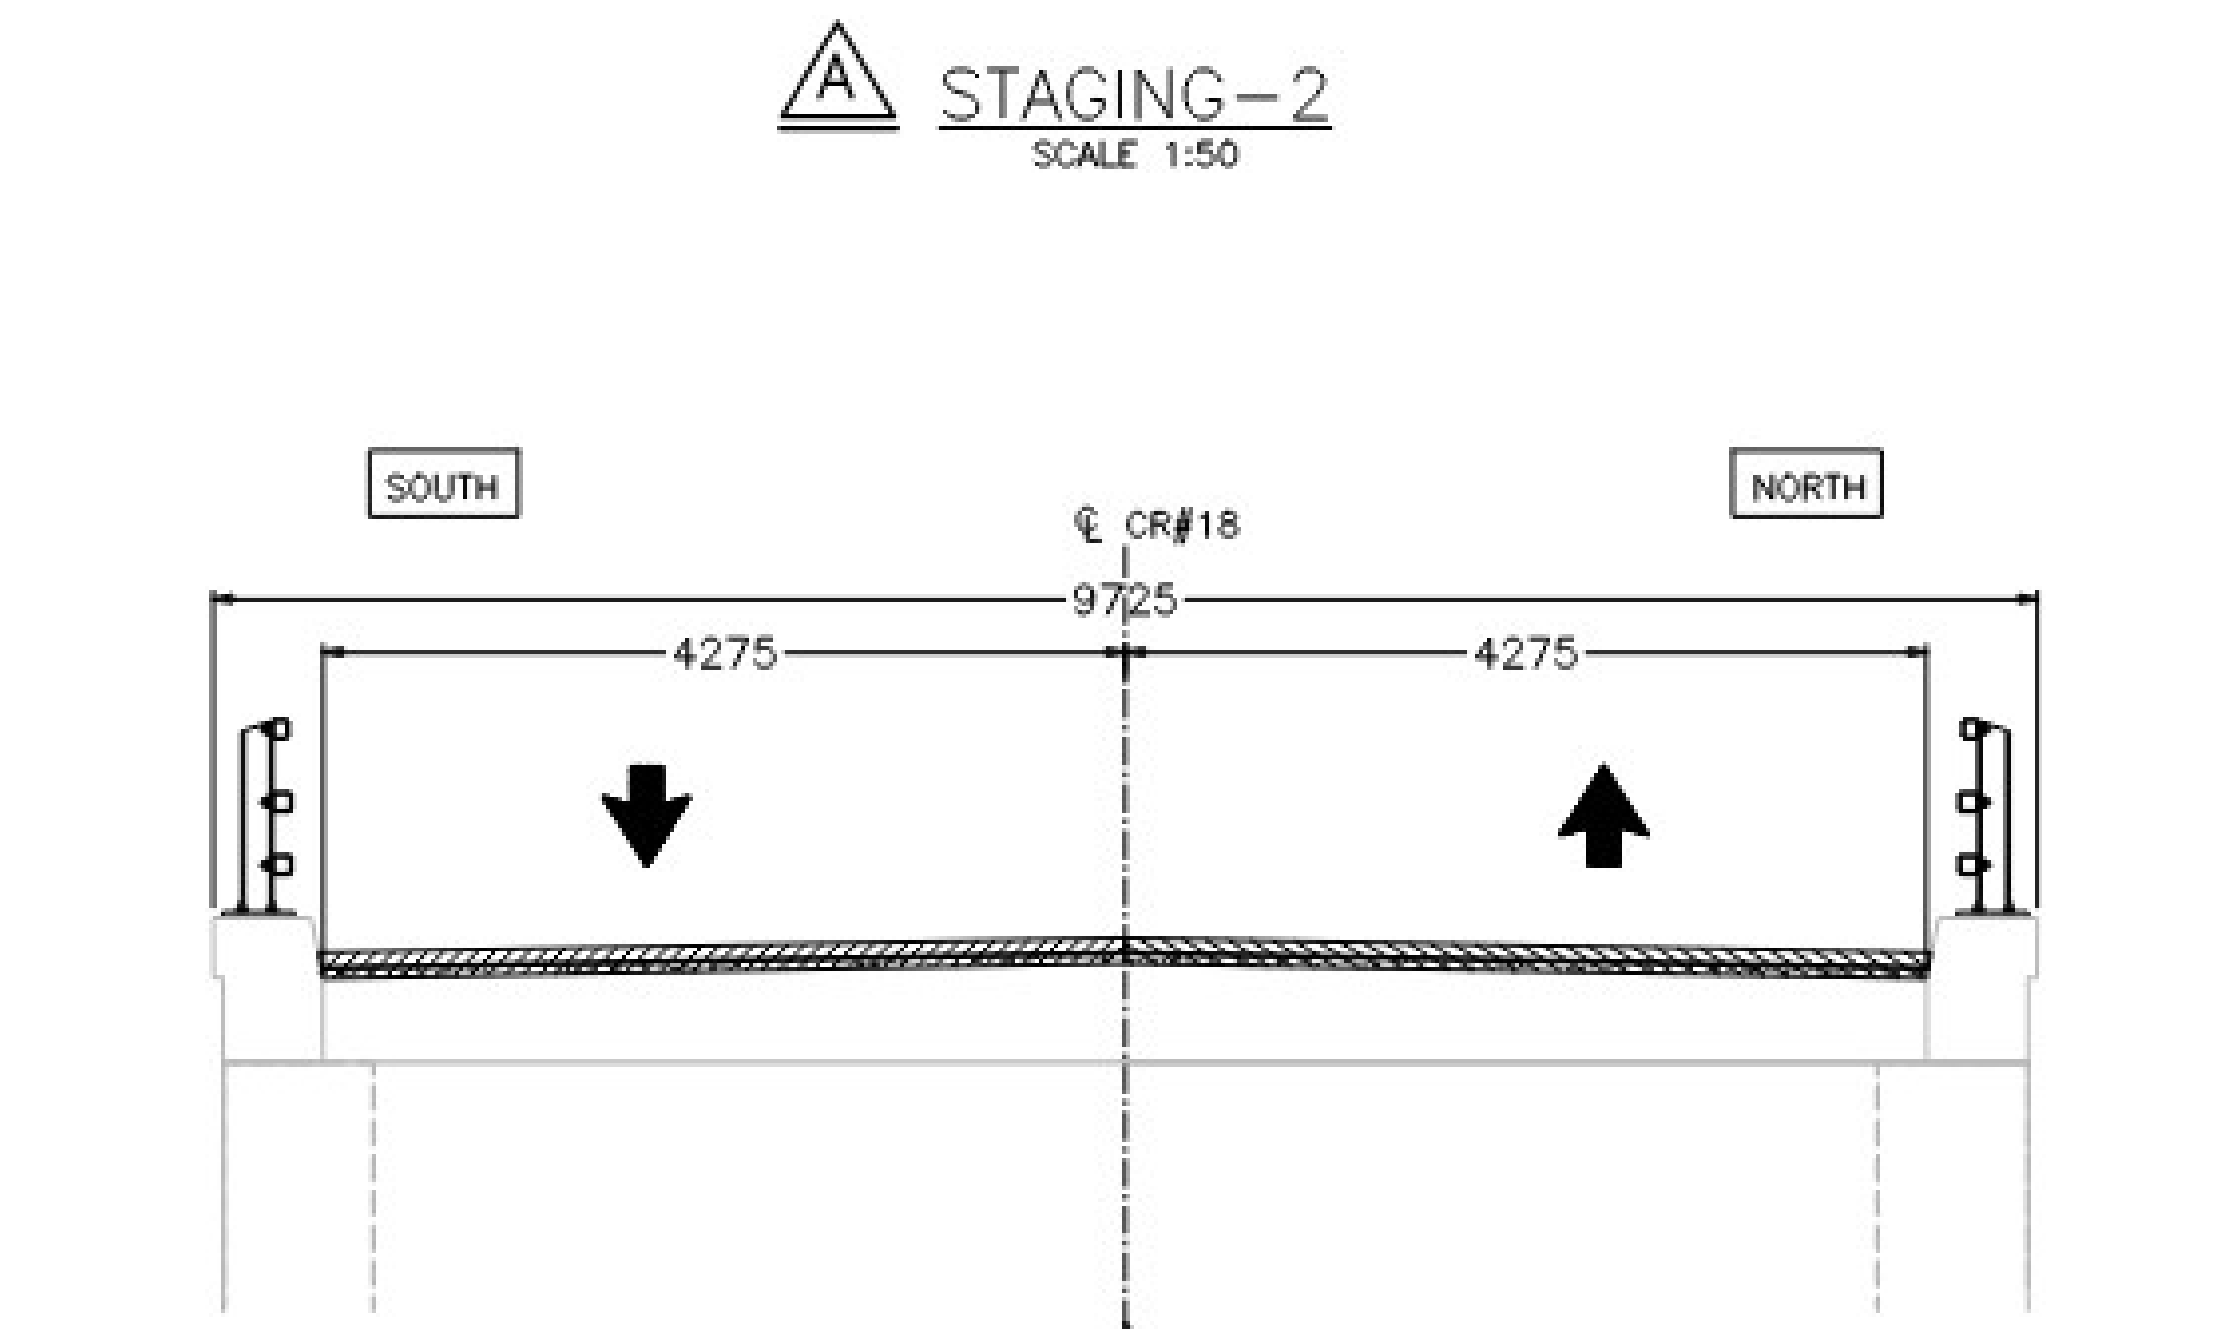
STAGE 2

- Stage 2: North lane to be opened while remaining work on the south side is completed. Temporary concrete barrier to be installed and traffic to be controlled via portable temporary traffic signals.
