# Tree Inventory and Preservation Plan – 35 Barker Street, Picton, Ontario

Prepared for: Homes First Queen Elizabeth  
Residences Inc.

Cambium Reference: 23284.002

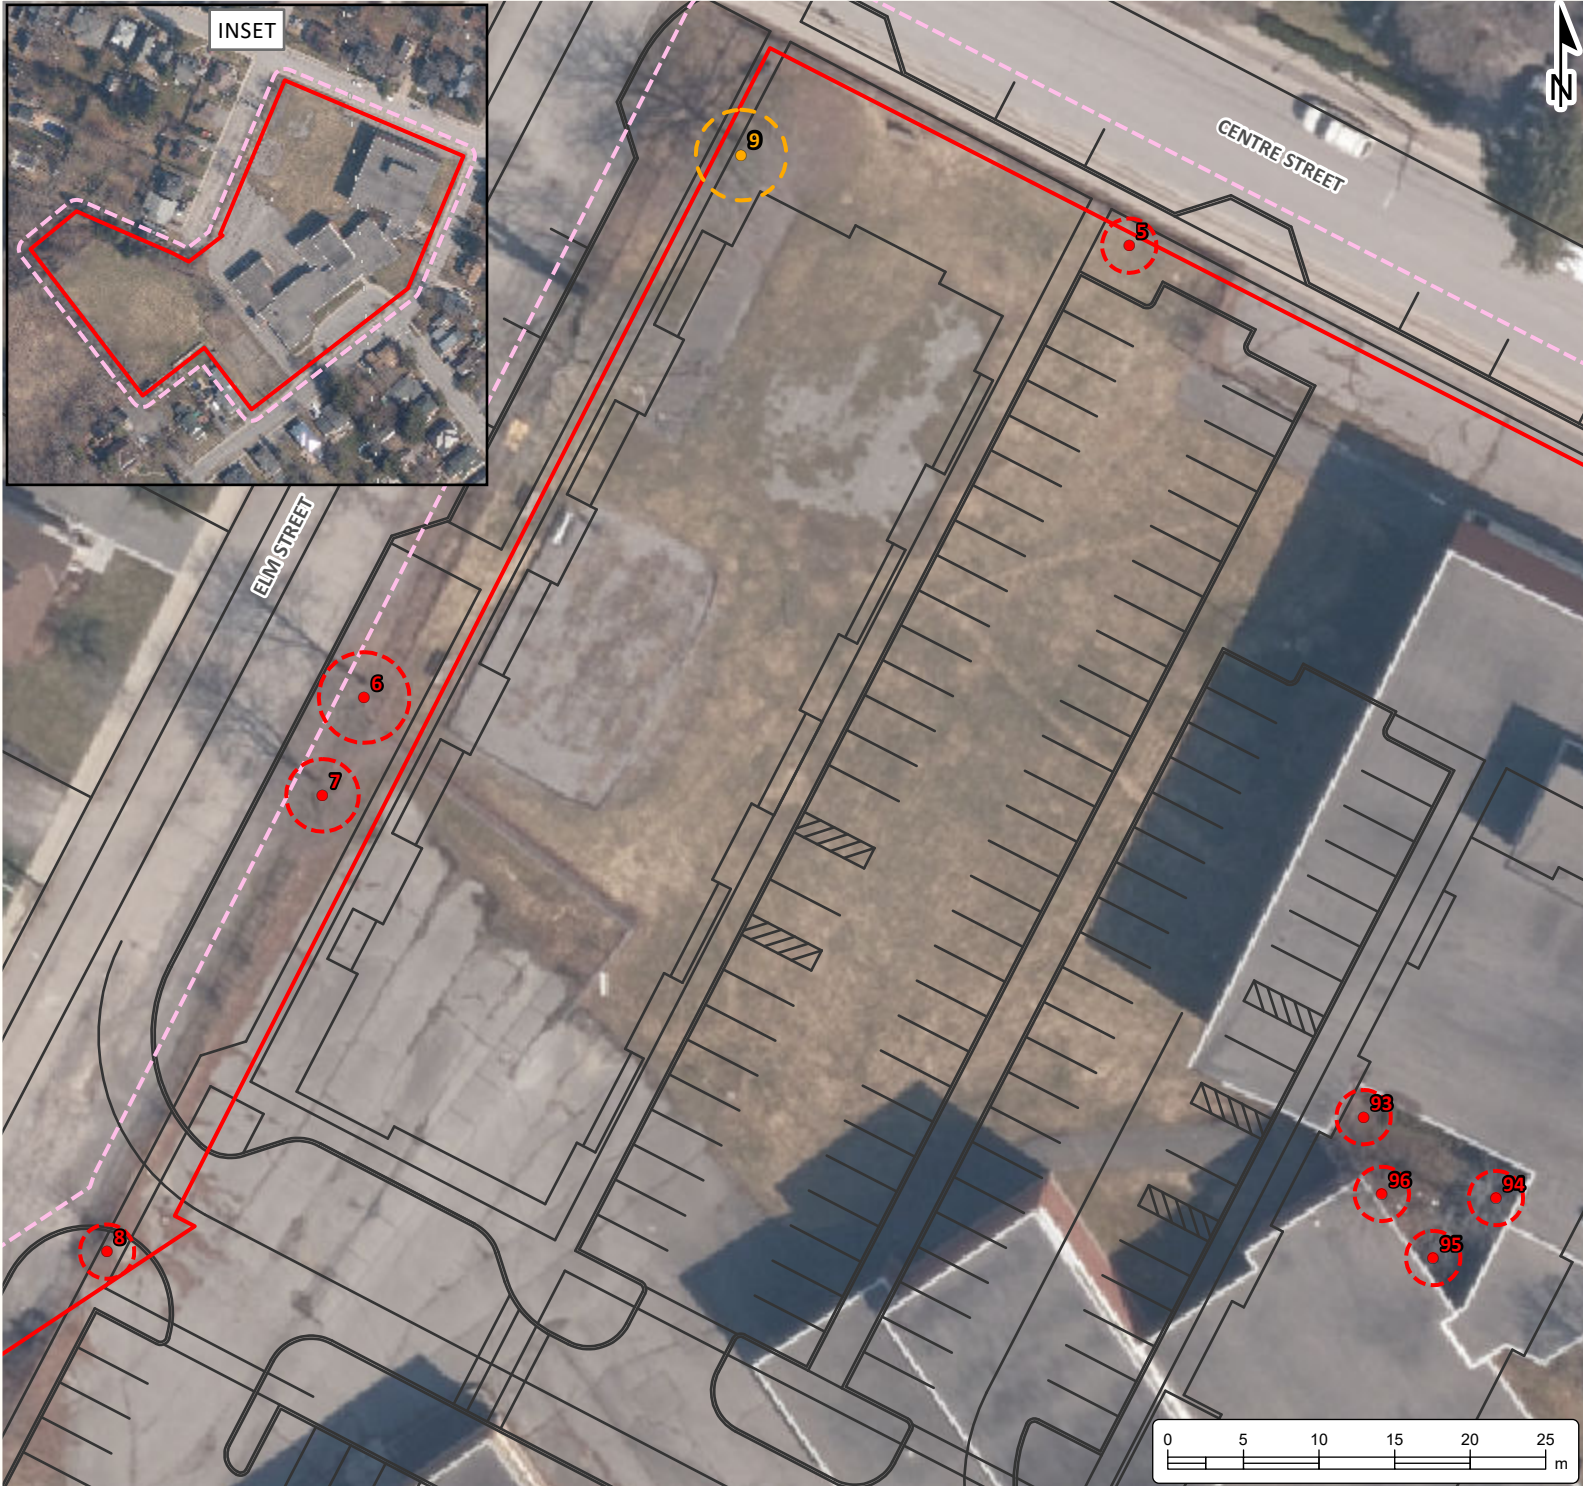
| Figure:<br><b>4</b> | |

**TREE INVENTORY AND  
PRESERVATION PLAN**  
HOMES FIRST QUEEN  
ELIZABETH RESIDENCES INC.  
35 Barker Street  
Prince Edward County  
Picton, Ontario
