# **Geotechnical Investigation Report – Proposed Residential Development – 35 Barker Street, Picton, Ontario**

June 8, 2026

Homes First Queen Elizabeth Residences Inc.

Cambium Reference: 23284-001

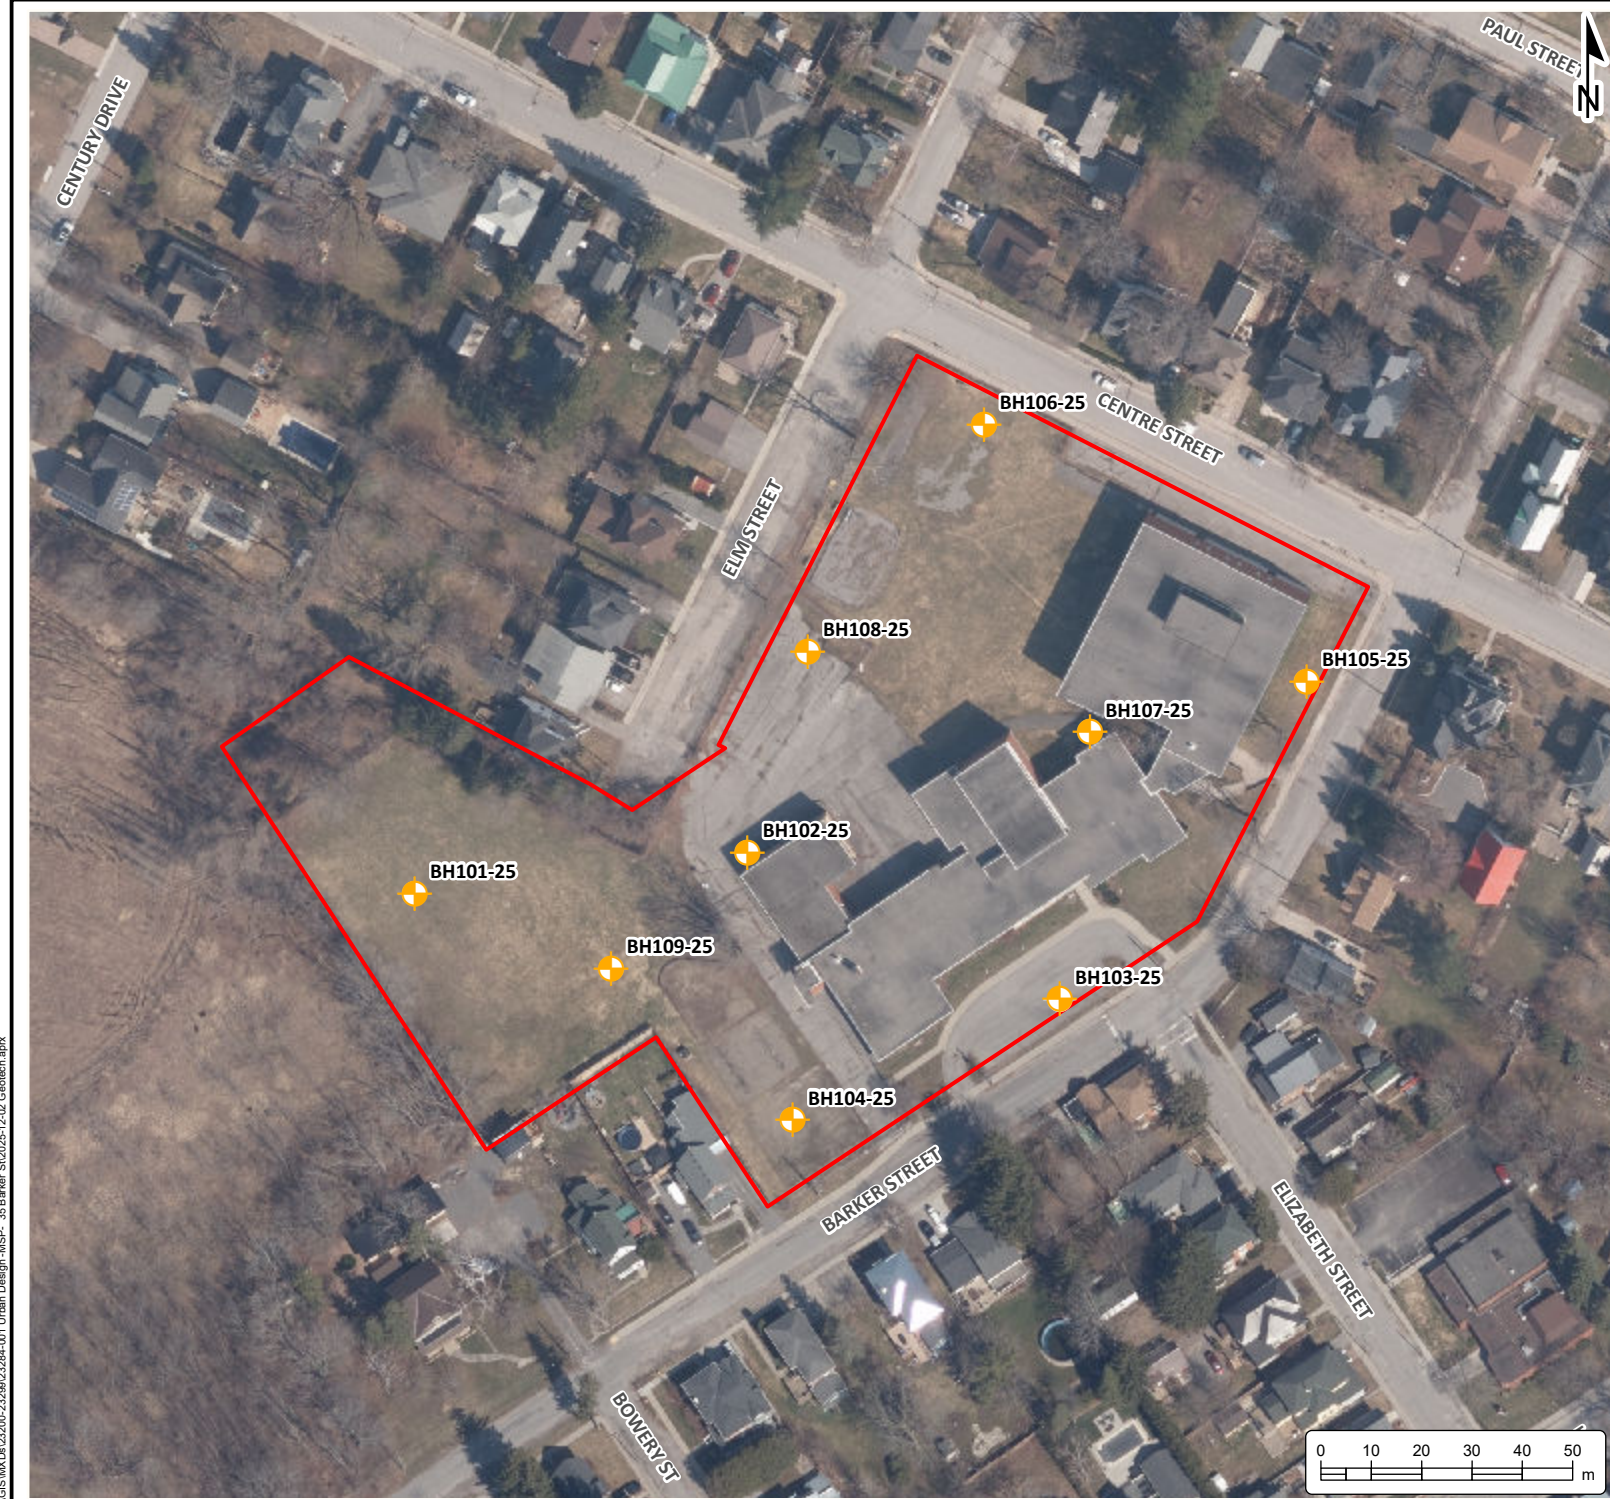
| Figure: | | | <b>2</b> |

**BOREHOLE LOCATION PLAN  
EXISTING CONDITIONS**

The geotechnical field investigation was conducted on October 20<sup>th</sup> to 21<sup>st</sup>, 2025, during which time nine (9) boreholes, designated as BH101-25 to BH109-25, were advanced across the Site. Table 2 provides a summary of the boreholes. The boreholes for the investigation were terminated at depths ranging from 2.1 to 6.9 metres below ground surface (mbgs). The approximate borehole locations relative to existing conditions are shown on the Borehole Location Plan – Existing Conditions, Figure 2, and relative to the proposed conditions on the Borehole Location Plan – Proposed Conditions, Figure 3.
