**SLOPE STABILITY REVIEW
DRAKE DEVONSHIRE HOTEL ADDITION**

June 10, 2021

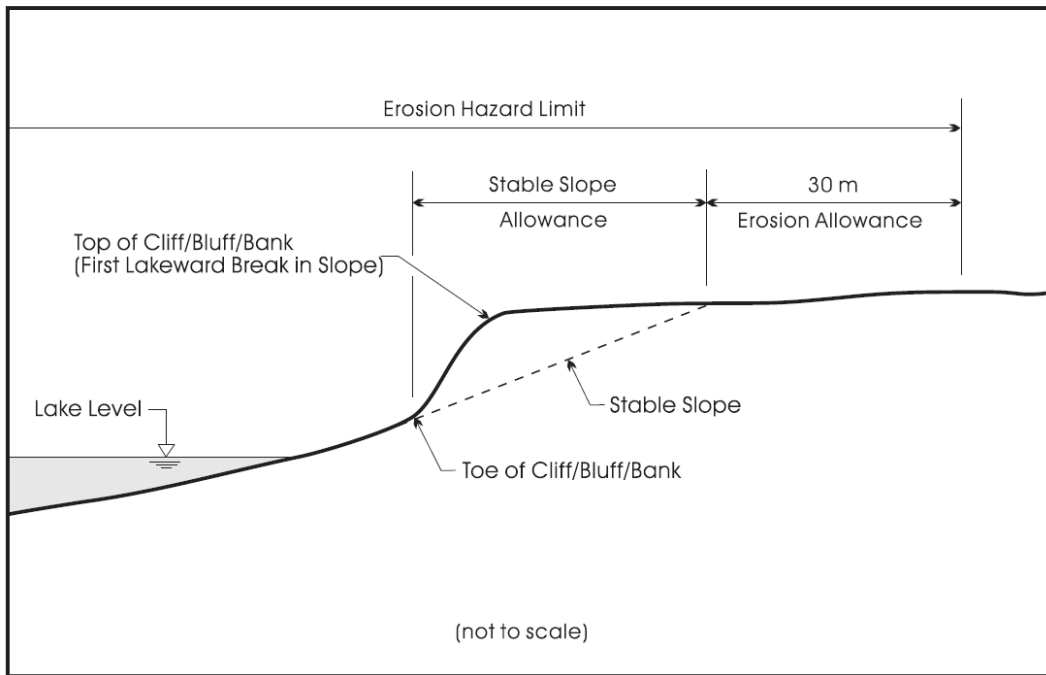
Figure 1-2: Erosion Hazard Limit (MNR Technical Guidance, 2002)

The Erosion Hazard Limit is the area of the shoreline that is susceptible to erosion over a 100-Yr period and consists of the *stable slope allowance* and the *erosion allowance*. The stable slope is determined by extending a 3:1 line from the toe of the bank inland until it reaches the ground surface. The erosion allowance is the distance that erosion may progress inland within 100 years. Figure 1-2 shows a graphic published in the technical guidelines that illustrates the Erosion Hazard that may be assumed in regions of Lake Ontario where there are not good records of the shoreline recession rate. The 30m allowance shown on Figure 1-2 is based on a conservative allowance of 0.3m/yr recession rate over 100 years.
