August 20, 2018

AG File No. 17546-1

**Ref: FINAL Slope Stability Investigation Report
The Reach Resort – 1315, 1329 and 1357 County Road 7
Prince Edward County**

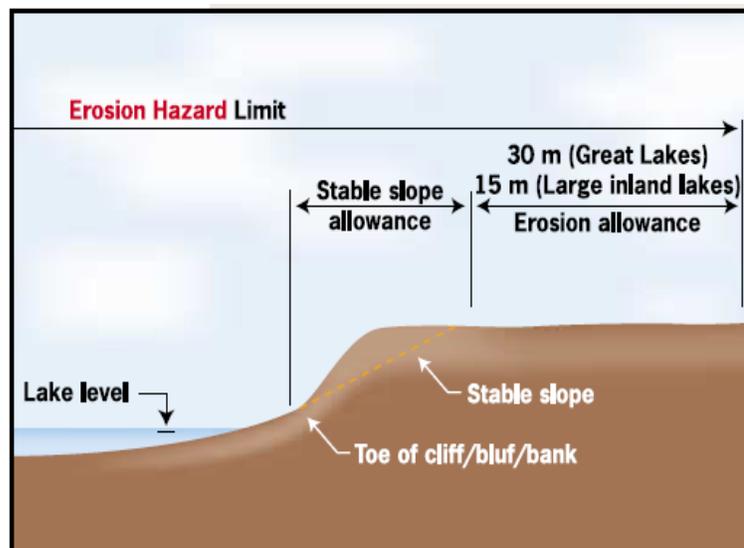
- Stable slope allowance: The stable slope allowance is the horizontal distance measured landward from the toe of the shoreline cliff, bluff or bank that is three times the height of the cliff, bank or bluff (for soil slopes) or one times the height for bedrock cliffs, banks or bluffs. This distance can also be determined using geotechnical engineering studies to determine the existing slope stability.
- Average annual recession: The recession rate average for the site where there is at least 35 years or reliable recession information.
- Erosion allowance: Where there is no reliable recession information, the province suggests a setback distance to allow for erosion along the shoreline.

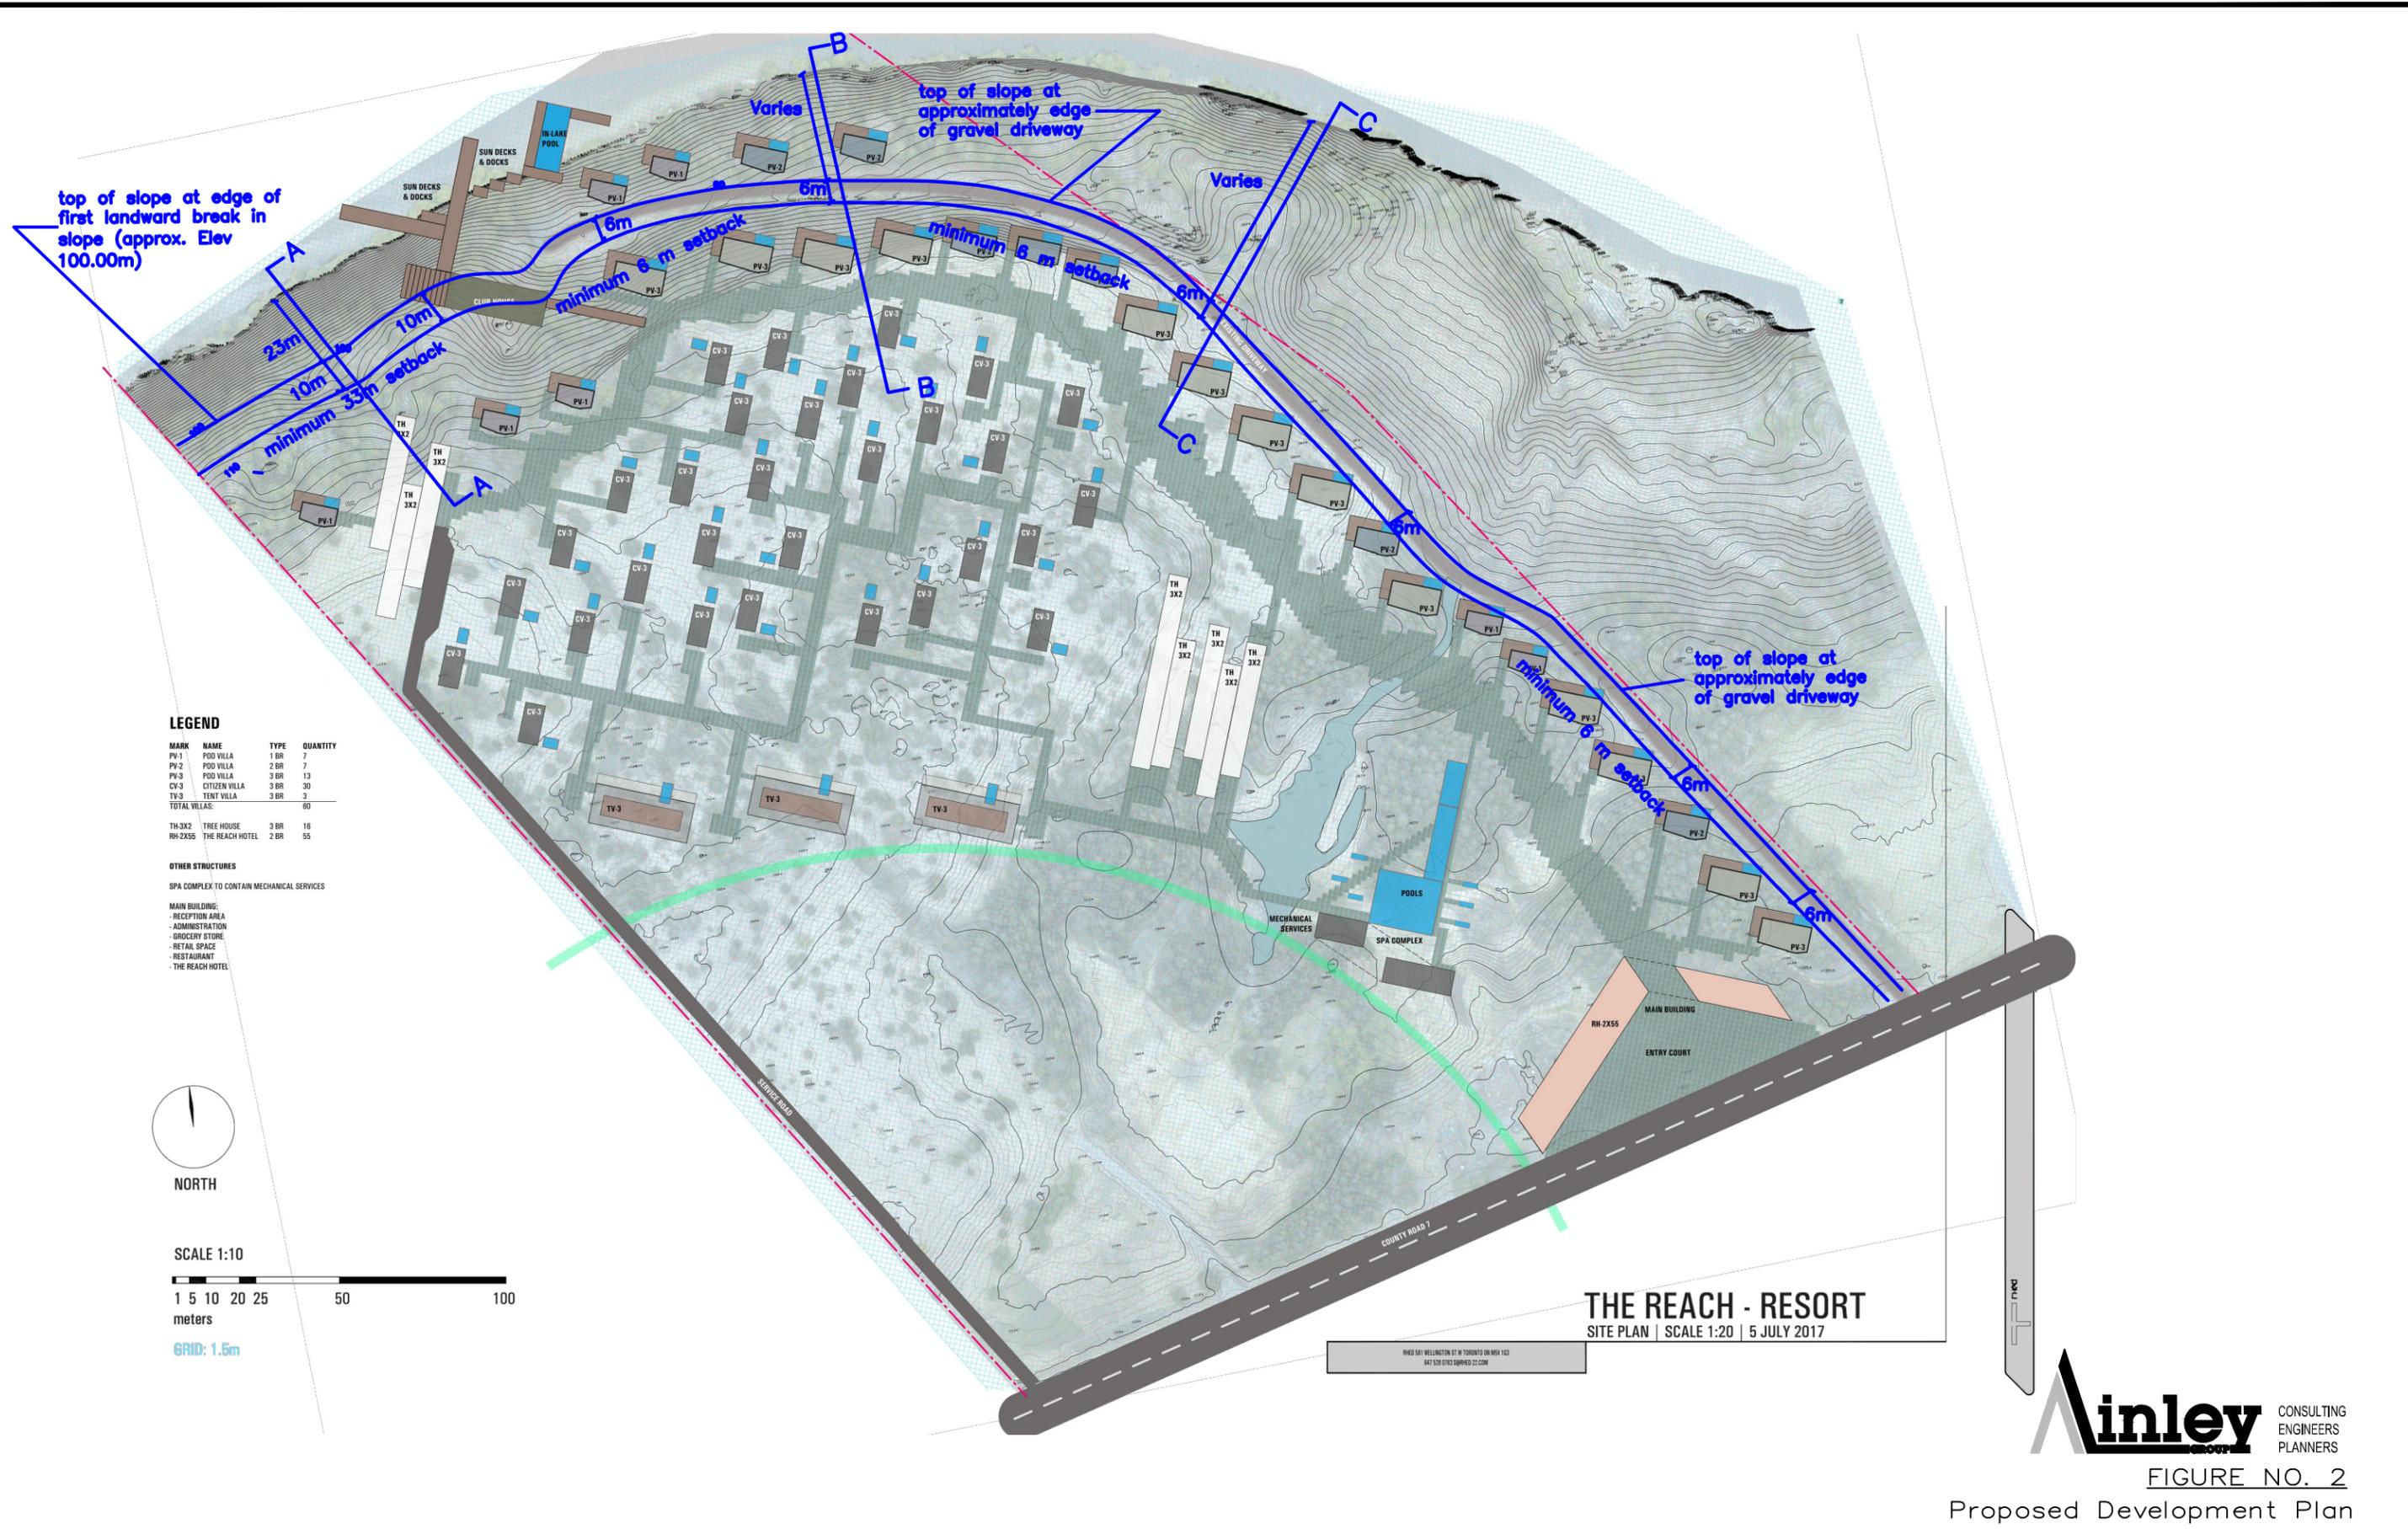
The recommended setback distance is determined to be 33 m measured from the toe of slope at the lake level (or 10 m from the edge of the first landward break) as depicted on **Figure No. 2**.

The recommended setback distance is determined to be 6.0 m measured from the north edge of the existing driveway as depicted on **Figure No. 2**.

The recommended setback distance is determined to be 6.0 m measured from the east edge of the existing driveway as depicted on **Figure No. 2**.
